Maintaining Your Platen Assembly

Replace your platen assembly immediately if you see any of the following signs:

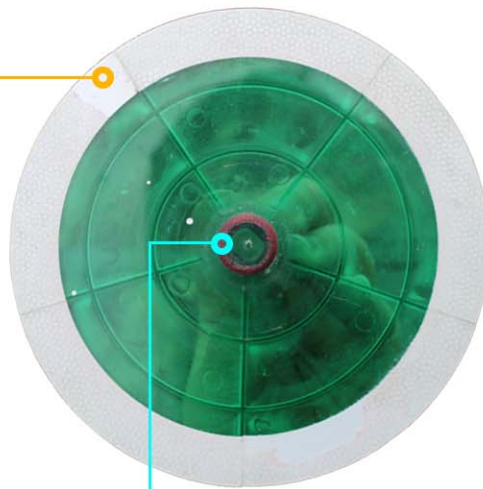
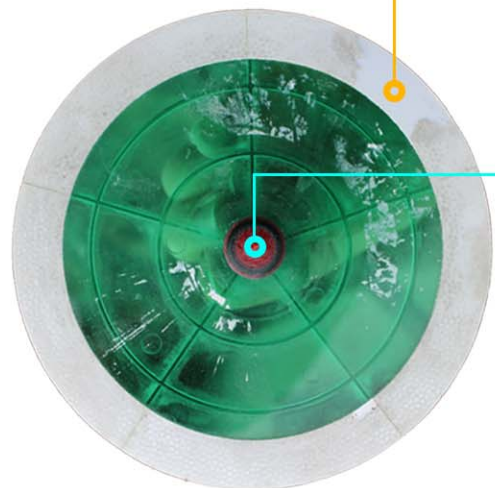
White ring is worn, peeling, or disintegrating

This is normal wear that indicates it's time to replace the platen.

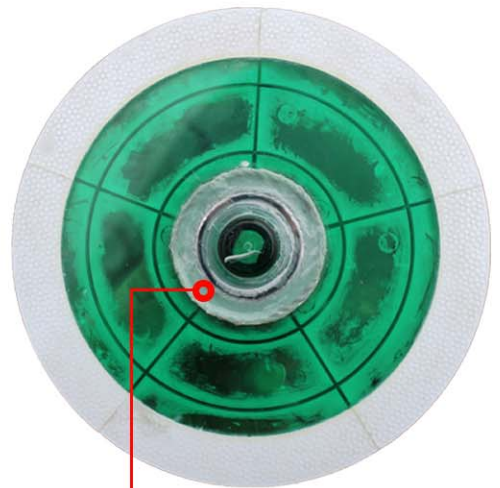
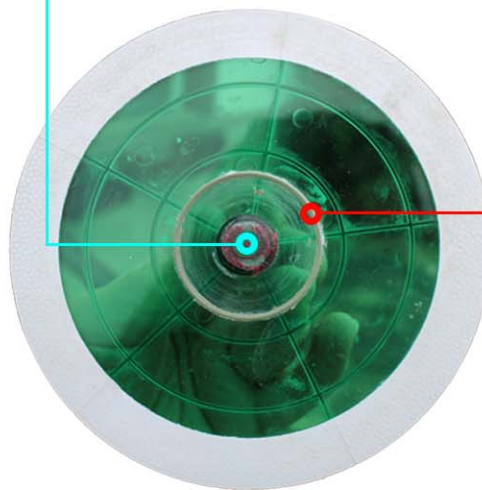
Red or pink residue

This is damage caused when the Hybrid is operated improperly with the red jet nozzle cover still installed.*

**The jet nozzle cover is used only on the original Hybrid machine to prevent the tubing from drying out. Always remember to remove it before operating the machine.*
