Water is leaking from the hole beneath the diverter knob

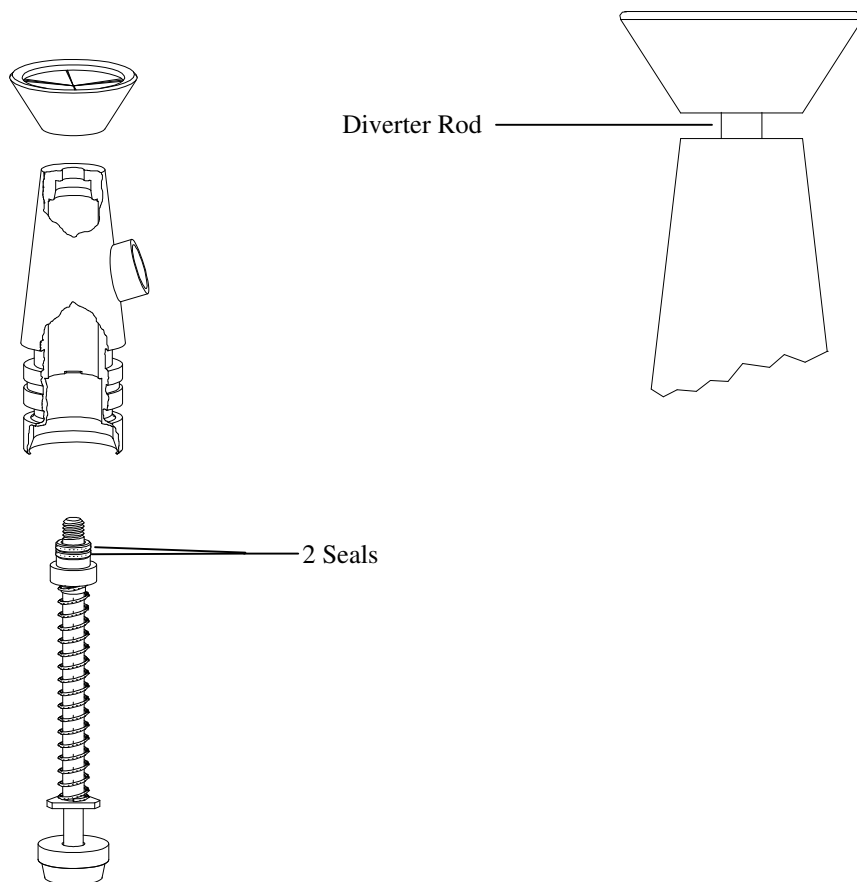
If the diverter rod X-ring seals become dry they may harden and not seal as they should.

Lift the diverter knob all the way up. Apply a small amount of non-toxic plumber's grease to the diverter rod.

Work the diverter rod up and down to push the grease down into the seals located in the spout base.

If the leak has not stopped, repeat the procedure or flip the two diverter seals over. See K31088 Diverter Assembly instructions.

If neither of the above procedures stop the leak the two seals should be replaced with S0228 Diverter Seals or K31088 Diverter Assembly.
