Project Name	RAMONA RETAIL CENTER
Existing roof system	1/2" plywood deck, mineral surfaced fiberglass cap sheet built-up roof system
Existing roof problems	There were a lot of roof top penetrations this roof from the laundromat below. There are also a few duct work extensions coming off the swamp coolers penetrating the roof. The roof had not been maintained for several years and there was a lot of debris in the waterways and around the drains. The swamp coolers had been leaking on the roof so there was a lot of sediment on the roof. The existing roof was 12 years old.
Products and systems used, and How APOC products solved the problem	AM2-PE-252. Power washed roof to remove dirt and debris. Three course all roof penetrations with APOC #501 Neoprene Cement & fiberglass webbing. Cut, nailed and three coursed splits and blisters in existing roof membrane using APOC #501 and fiberglass web. Applied two layers of 40" polyester, each layer embedded in 4 gals APOC #300 Asphalt Emulsion, allowed to cure. Cleaned roof and applied 3 gals APOC #252 Sun White Acrylic Coating. Coating applied in two passes: 1 1/2 gallons #252 grey base coat and 1 1/2 gallons #252 Sun White Acrylic

Project pho

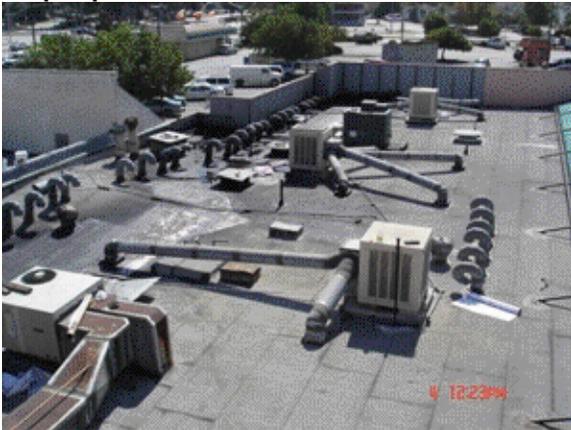
Left, "Before" showing areas being patched and prepped. Right, "After" showing completed job.

APOC pre-application support	Application of an additional layer of APOC #300 Asphalt emulsion and polyester mesh in the waterways to reinforce a potential ponding water area. Cut out perimeter metal and install new with a layer of APOC 12" Pro-Tack. Lift A/C units and install a layer of APOC Pro-Tack for reinforcement.
APOC support during & after application	APOC technical department was on the roof everyday to ensure the project was running smoothly and answer any questions the installation crews may have.
Notes and quotes from the contractor	"APOC products are great to work with. (APOC technical manager) John Athanasion's support and knowledge of restoration systems is valuable to Hunt Brothers Roofing and our crews," said Brad Hunt, owner of Hunt Brothers Roofing.
Improvements noticed by facility owner/manager	The owner was concerned with the noise and if the laundromat would be affected by the work in progress. There was no effect on the laundromat business or the other business below for that matter. Mr. Keeler was getting re-roof cost 50% and higher than what he paid for the APOC restoration system applied. "APOC was referred to me by a Roofing contractor in Phoenix, AZ. Their follow up and professionalism was remarkable. The restoration of my building was cost effective and the finish product was well above my expectations. It is the prettiest roof I have ever seen," said Fred Keeler, building owner.
