**Test Report** No.: NBHL2206011877SD-01 Date: JUN. 23, 2022 Page: 1 of 2

The following sample(s) was/were submitted and identified by the client as: Sample Description : AL-GARD TOOL LANYARD

Item No. : ALG-TL2-10

## Loading Test (As per client's requirement)

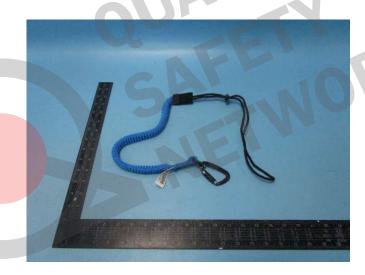
## Sample Photo:

Number of Tested Samples:	1 Piece
Number of Controlled Sample	1 Piece
Test Procedure:	<ol> <li>Visual check the sample for any imperfection prior to testing.</li> <li>Load the sample with 12kg weight as per client's specification.</li> <li>Remove the load from the sample after 24 hours.</li> <li>Inspecting the sample for any damage.</li> </ol>
Test Result:	No cracking or visual change was found on the tested sample.
