# MONOGRAM

## Close-Up 14

# COCKPIT INTERIORS

PART 1

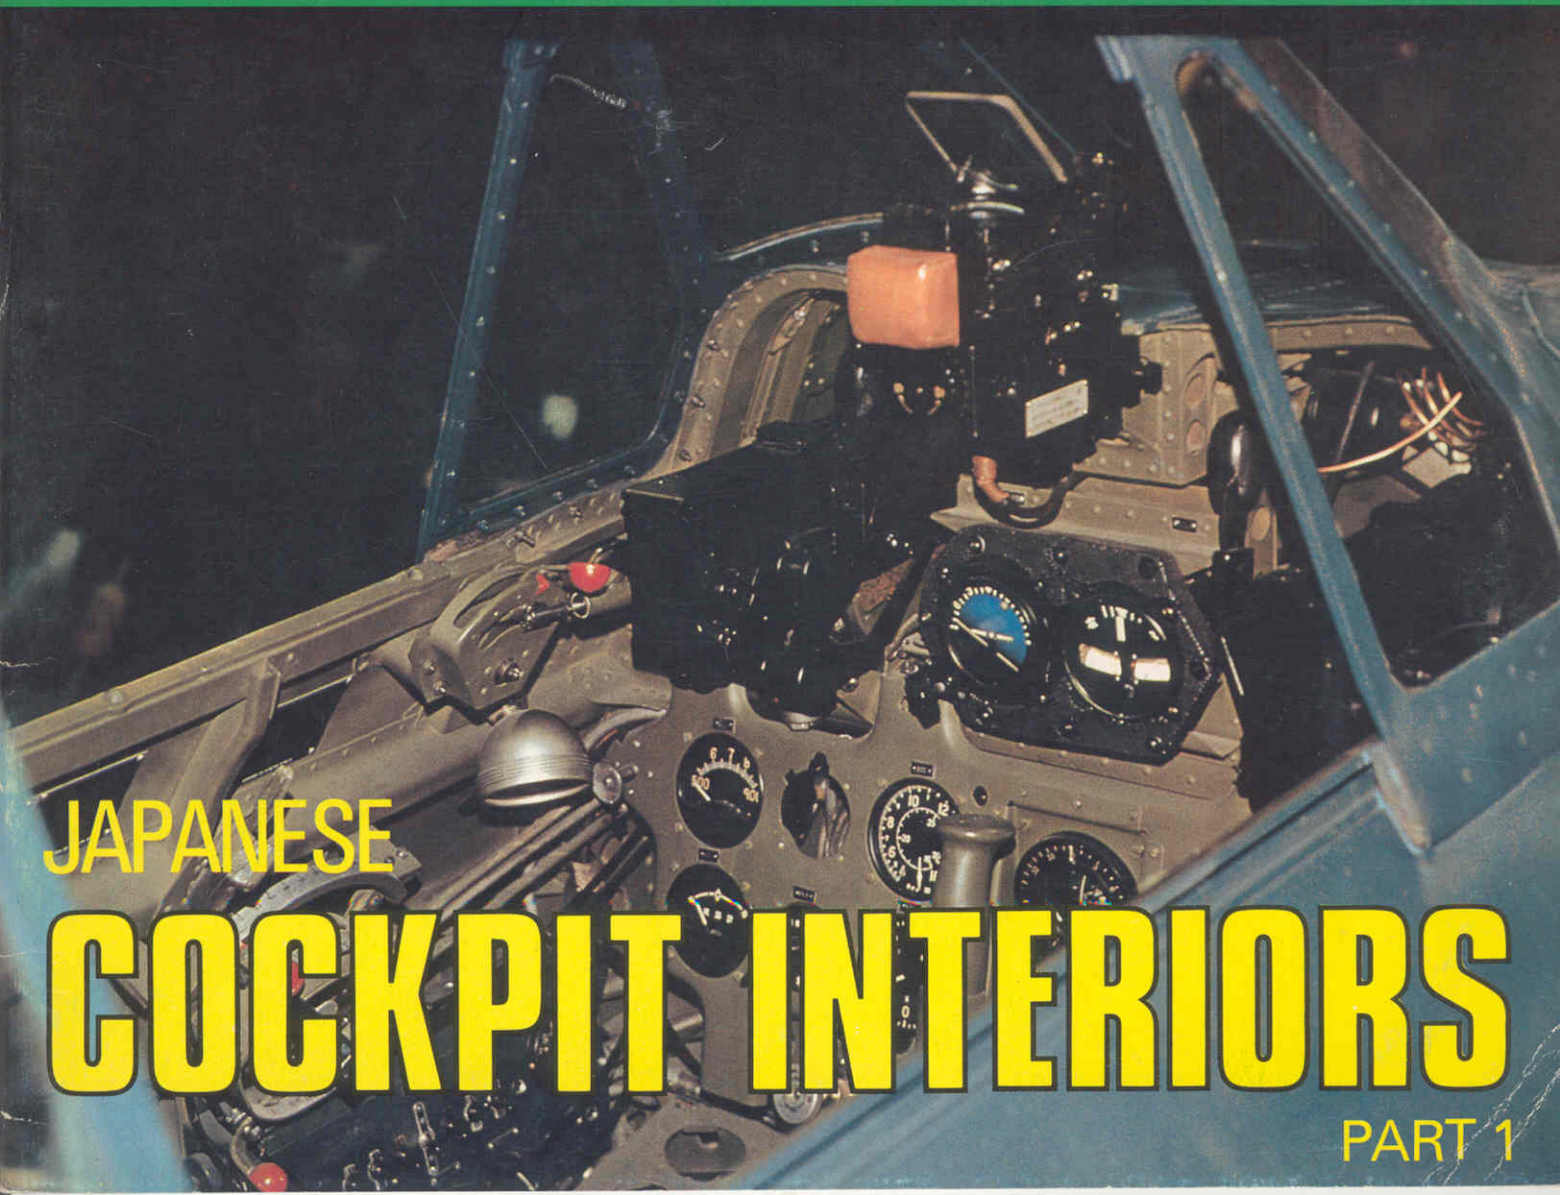
Restored cockpit of the Mitsubishi A6M5 ZERO in the National Air and Space Museum.

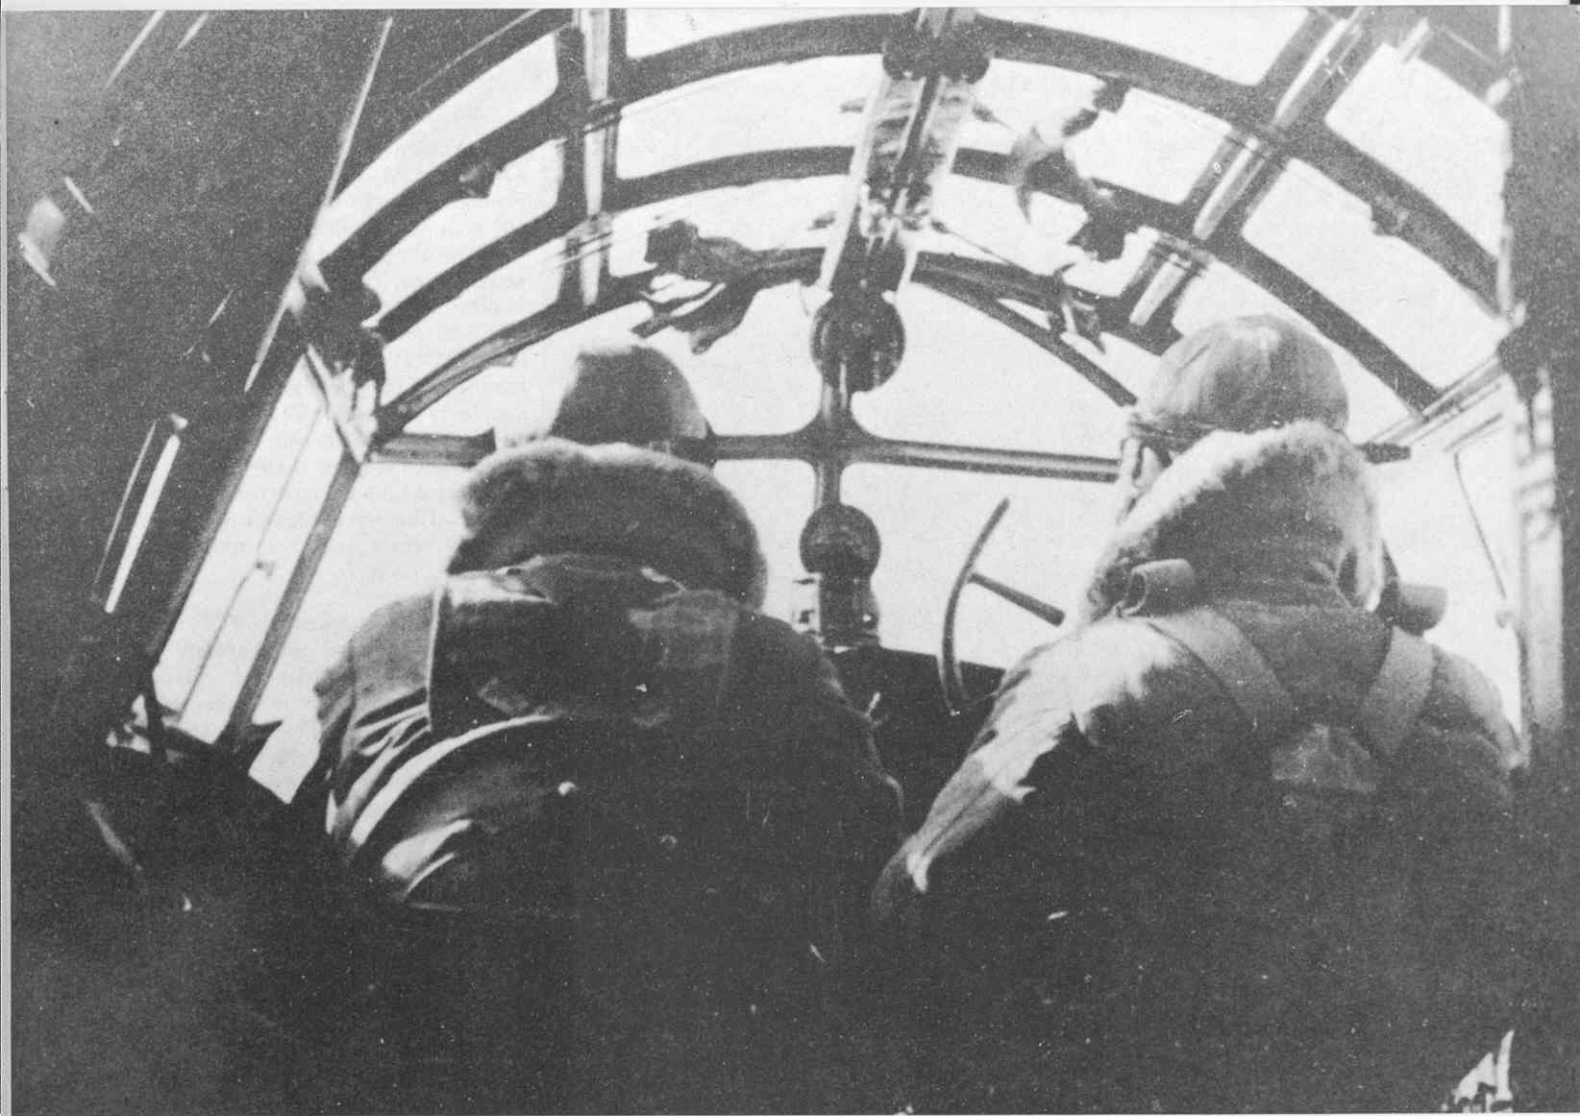
A rare Japanese photo taken inside the pilot's compartment of a Mitsubishi Ki.21 SALLY. Only in aircraft having an abundance of natural light were pictures such as this possible.

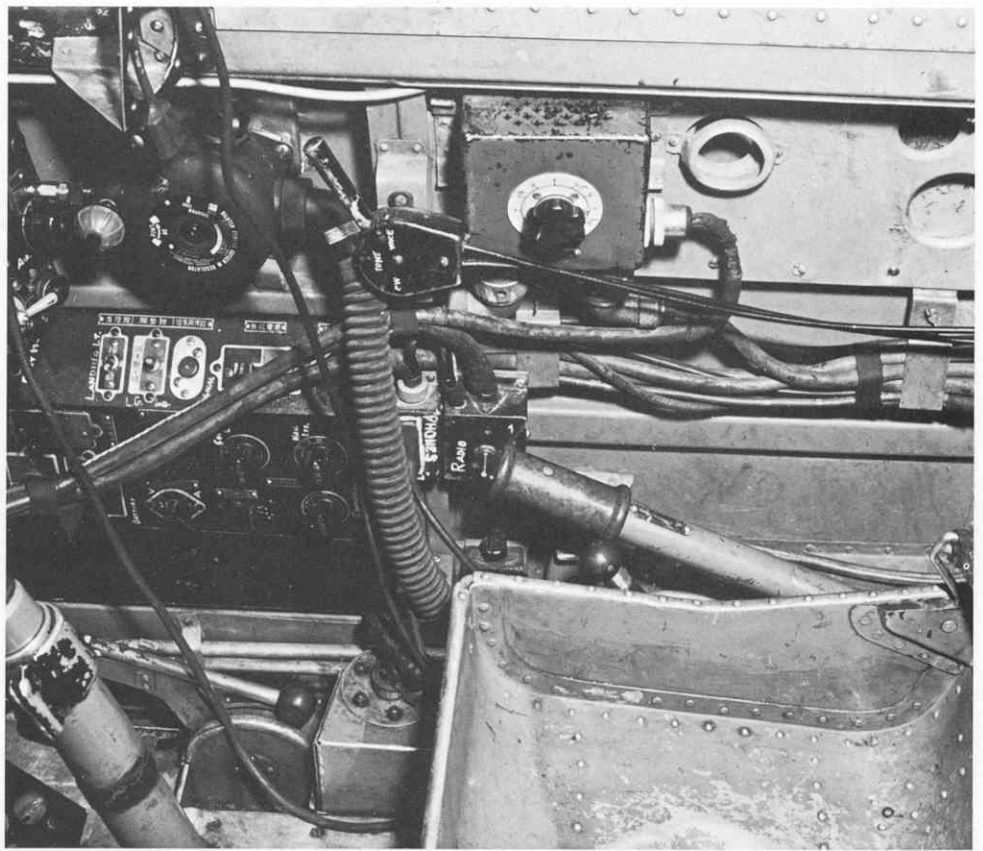
The right side of the cockpit primarily contained electrical and radio equipment. This captured TONY was flown by American pilots for evaluation. For this purpose an American made oxygen system was installed and all switches and instruments were marked in English. The large handle to the right of the seat is an emergency hydraulic hand pump, while the knob just below it is for seat adjustment.

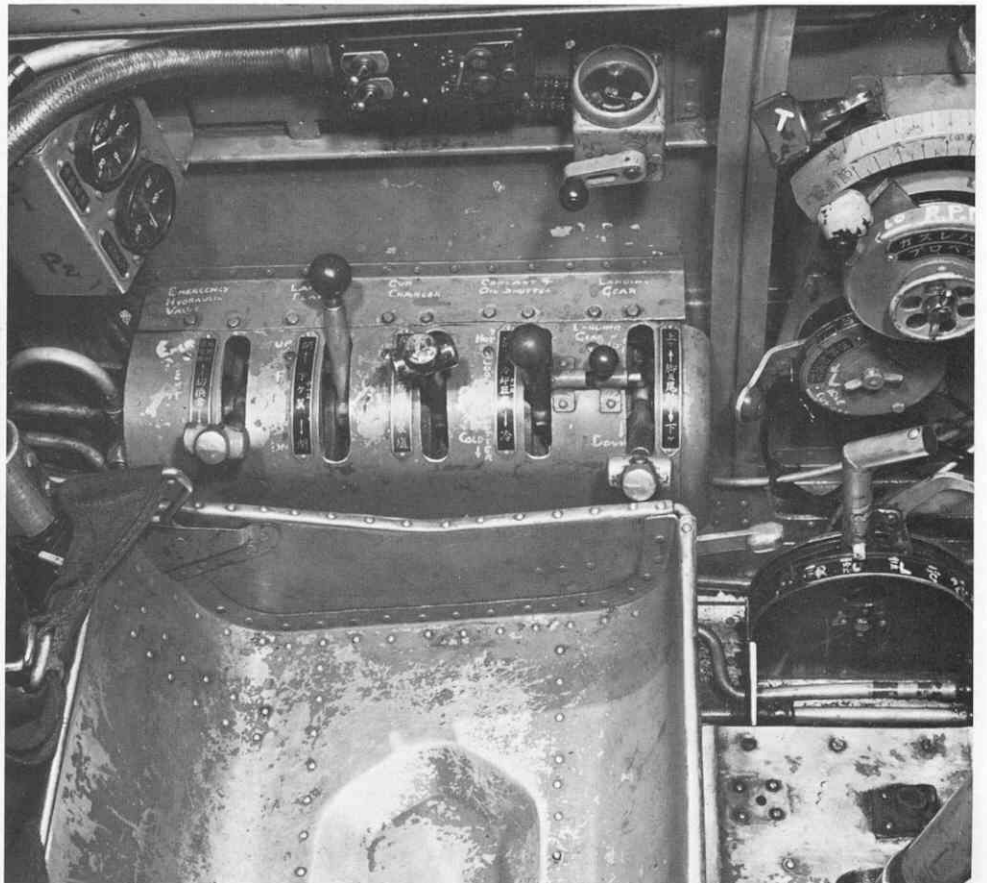
This view shows the left side of the cockpit of TONY. In the upper right hand corner is the throttle and propeller control, below which is the mixture control. The small crank at the top center was for elevator trim with a position indicator. Two pressure gauges above the rear control handle for "Emergency Hydraulic Valve" indicates there may have been two hydraulic pressure accumulators. One isolated by this control valve handle from the normal actuating system was to be used in the event of main system failure. Similar systems reserved this emergency pressure to handing gear extension only. An auxiliary hand operated pump operated all systems provided hydraulic lines were not severed.

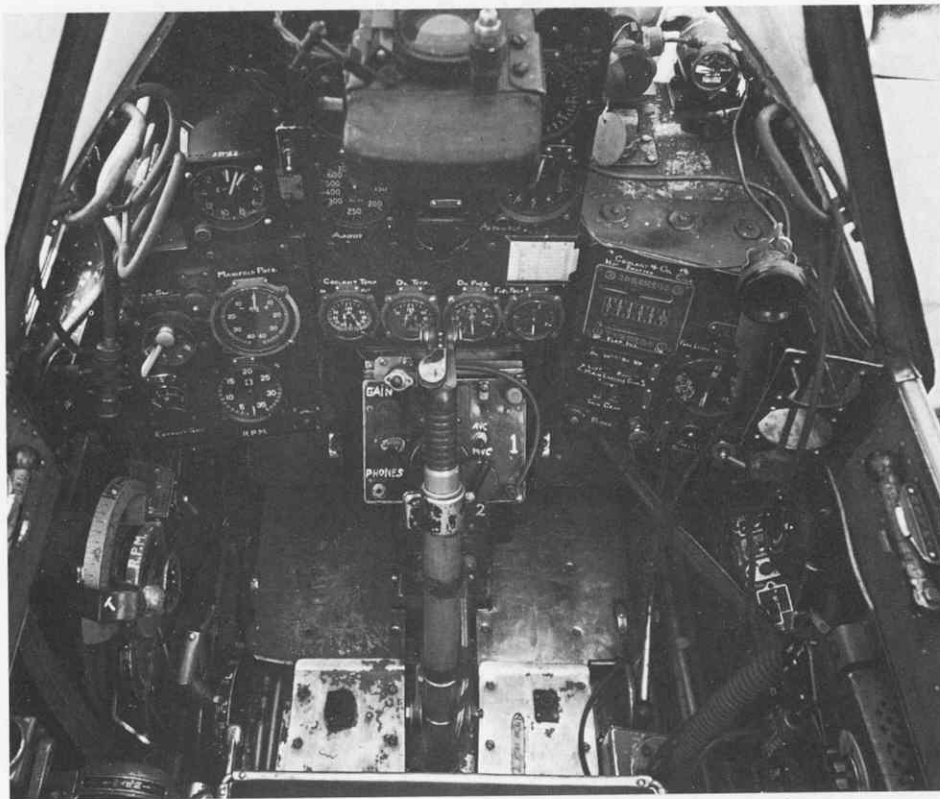
Flight instruments in the Kawasaki Ki.61-1 TONY were well grouped for the pilot to cross check. Noticeably absent were gyro-stabilized artificial horizon and heading indicator. Few fighters of that period carried gyro instruments as their tumble limits were exceeded easily, rendering them useless until righted and reset again after attaining level flight.

The hand-held microphone was an American installation as was most of the voice communication equipment which was used while being evaluated by Allied Forces.

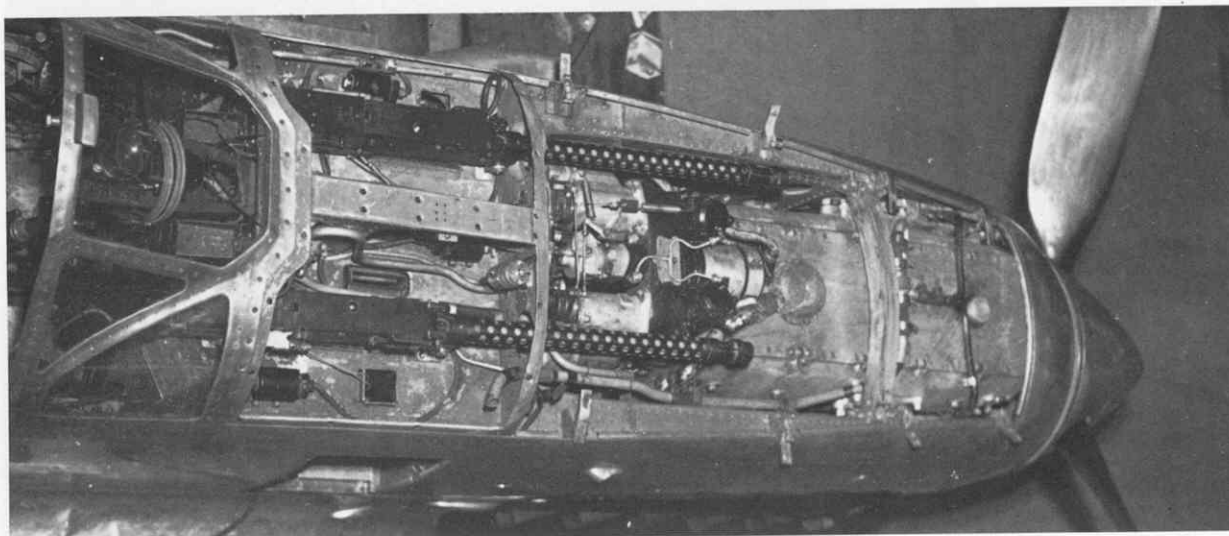
Late model TONYs carried two 20 mm Ho.5 cannon in the fuselage like this field stripped weapon acquired from a TONY at San Pablo, Luzon, on October 30, 1944.

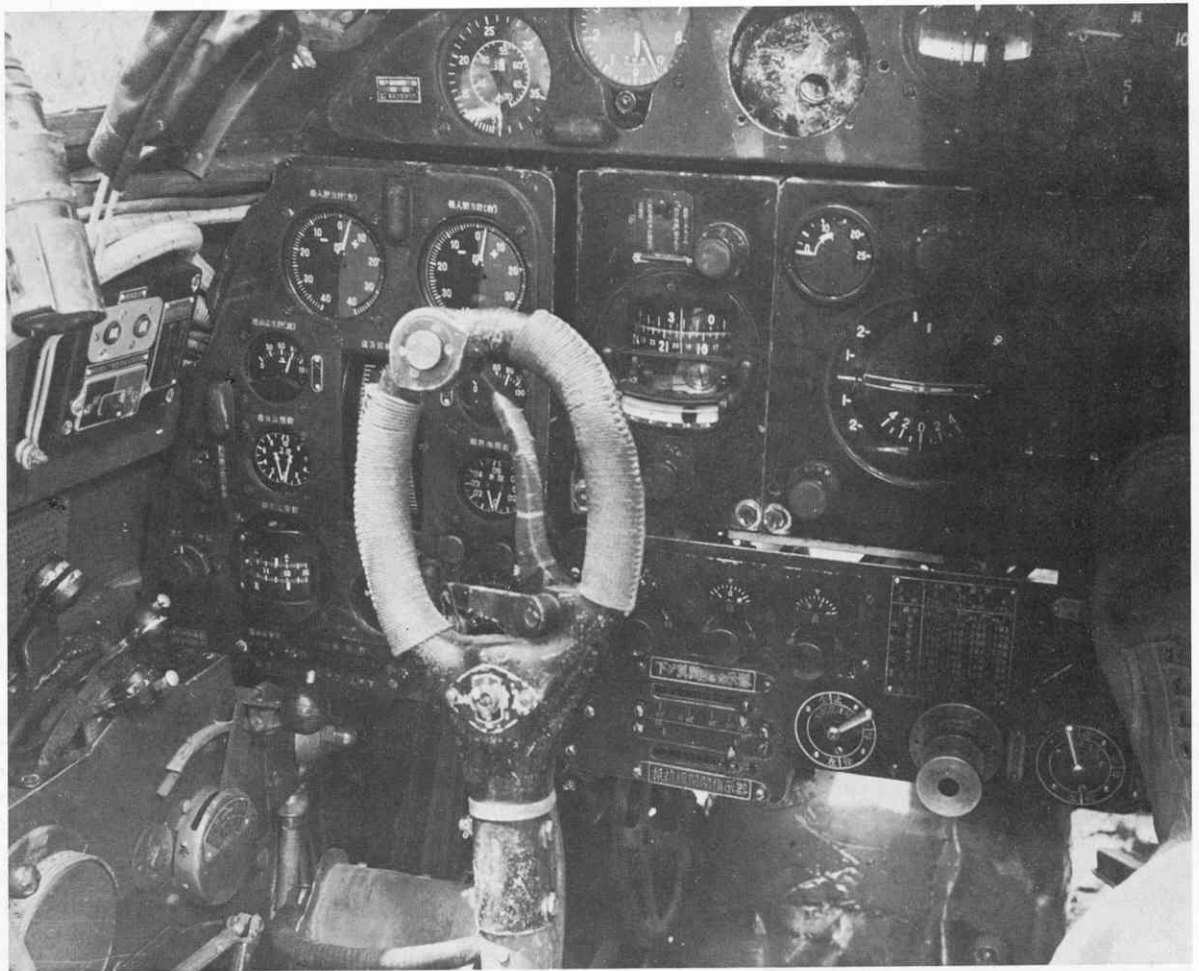
Kawasaki Ki.48 LILY Instrument Panel

| <ol style="list-style-type: none"> <li>1. Automatic Pilot Turn Gyro Control Unit</li> <li>2. Automatic Pilot Bank-Climb Gyro Control Unit</li> <li>3. Automatic Pilot Vacuum Gauge</li> <li>4. Airspeed Indicator</li> <li>5. Altimeter</li> <li>6. (Removed)</li> <li>7. Turn and Bank Indicator</li> <li>8. Rate of Climb Indicator</li> <li>9. Clock</li> <li>10. Inclinator</li> <li>11. Accelerometer</li> <li>12. Voltmeter</li> <li>13. Airspeed Indicator</li> <li>14. Component Manufacturing Ident.</li> <li>15. Manifold Pressure Indicator, Left</li> <li>16. Manifold Pressure Indicator, Right</li> <li>17. Oil Temperature Gauge, Left</li> </ol> | <ol style="list-style-type: none"> <li>18. Oil Temperature Gauge, Right</li> <li>19. Engine Tachometer (Dual)</li> <li>20. Vacuum Instrument Pressure Control</li> <li>21. Oil Pressure Indicator (Dual)</li> <li>22. Fuel Pressure Indicator (Dual)</li> <li>23. Pitot Static Selector Valve</li> <li>24. Fuel-Air Ratio Gauge (Dual)</li> <li>25. R.P.M. Synchronizer</li> <li>26. Cylinder Head Temperature, L. &amp; R.</li> <li>27. Landing Gear Warning Lights</li> <li>28. Wing Flap Position Indicator</li> <li>29. Dive Brake Position Indicator</li> <li>30. Automatic Pilot Sensitivity Controls</li> <li>31. Instrument Vacuum Source Selector</li> <li>32. Engine Primer Fuel Pump</li> <li>33. Instrument Vacuum Source Selector</li> <li>34. Automatic Pilot Hydraulic Press.</li> <li>35. Ki.48 Fuel Quantity Chart</li> </ol> |

The Kawasaki Ki.48 LILY was a small bomber, yet the pilot was given a well organized, uncramped cockpit. He sat slightly to the left of center while the Bombardier/Gunner sat to his right rear. Access to the nose compartment for this crew member was through the crawl way at the lower right.

LILY was equipped with a hydraulically operated automatic pilot, very similar to the Jack & Heintz type found in the American built C-47 as shown on page 23. Controls for this automatic pilot unit are the small knobs near the directional and attitude gyro indicators in the center of the instrument panel. The three knobs immediately below are sensitivity controls for pitch, yaw, and roll of the aircraft.

Above the throttle quadrant on the left side is the armament panel. The top buttons are for bomb doors "open" and "close," while the lower toggle switch is for bombs "safe" and "armed."

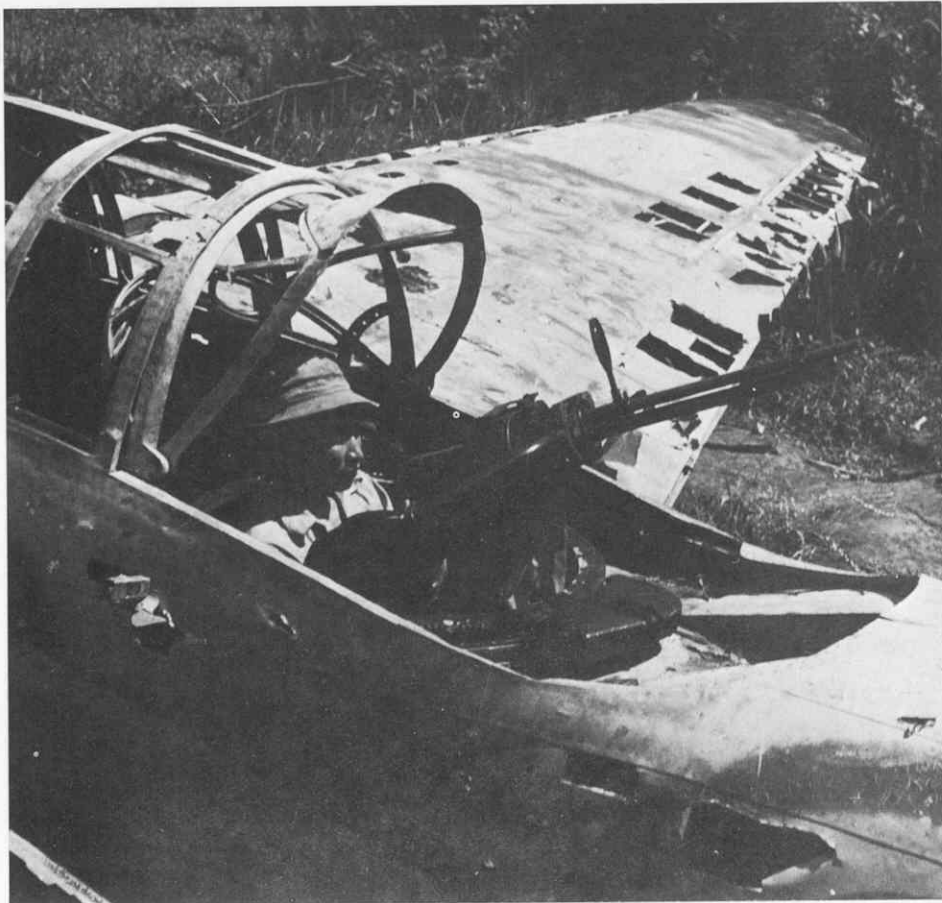
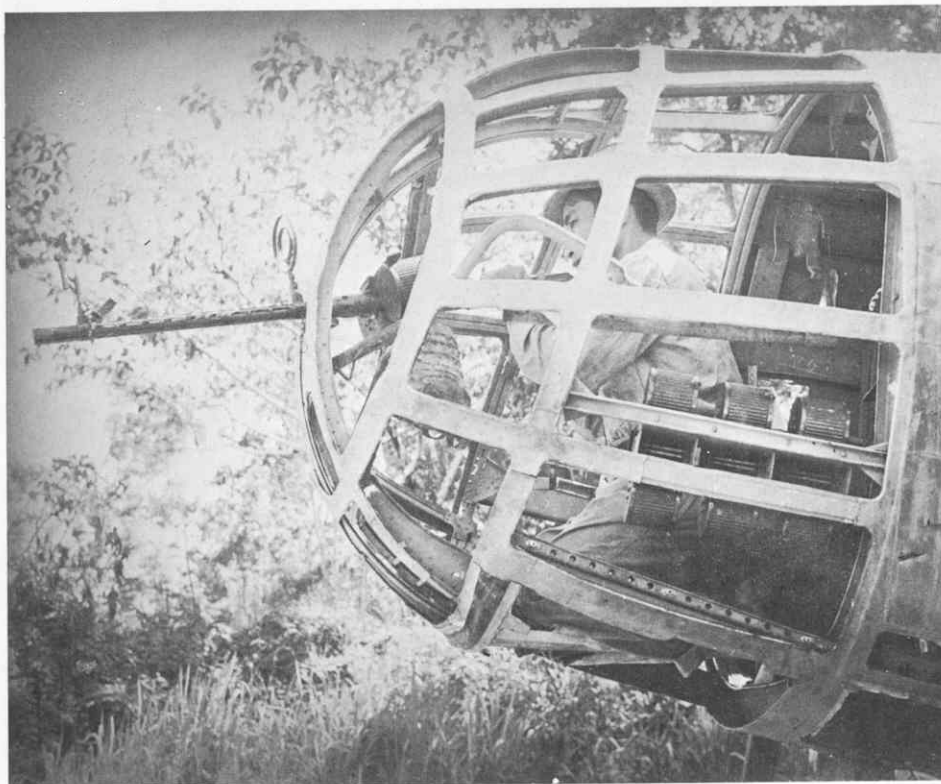
A local islander simulates the rear gunner in this abandoned remains of a LILY light bomber (above). The nose gun position is demonstrated (below) in what appears to be the same aircraft. This gun mount can be raised and lowered on the movable forward round housing that is mounted on a circular track. Note the storage of additional magazines on the left side. At the right, in the nose position, a Japanese crewman prepares to launch a guided air-to-ground missile being tested.

The Kawasaki Ki.48 LILY normally carried a crew of four. In addition to the one pilot was the Bombardier/Gunner in the forward section, a Navigator/Gunner who manned the ventral gun position, and a Radio Operator/Gunner to man the flexible dorsal gun. In later models of LILY this latter gun station changed from a 7.7 mm Type 89 machine gun to a 12.7 Type 1.

At left, the dorsal gun position is being demonstrated in the wreckage of a discarded LILY that was left behind by the Japanese. Note how the rear folding enclosure when slid forward forms a wind deflecting shield for the gunner.

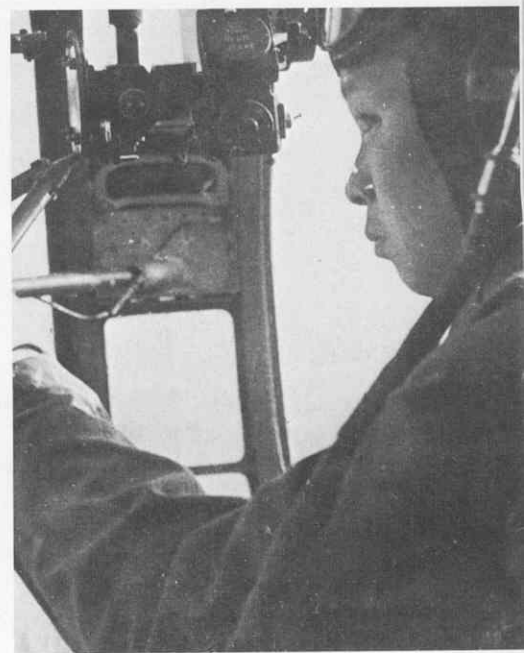
As small twin-engine bombers, LILYs were a natural vehicle for testing new equipment. One program in which a LILY was used was for the air launching of Japan's experimental I-Go-1B, a radio controlled flying bomb. The picture below shows a crewman preparing to operate the launching and control equipment mounted on the nose section of a LILY. The war ended before the I-Go Weapons became operational.

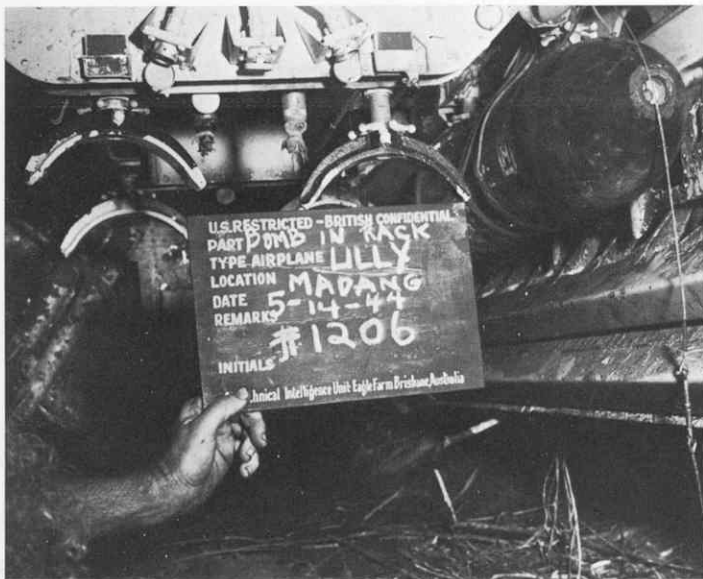
Defused bomb still hangs in wreckage of a LILY that was found at Madang, New Guinea, in May 1944. Eight of these 50 kg bombs could be carried by LILY to equal her near 800 kg bomb load.

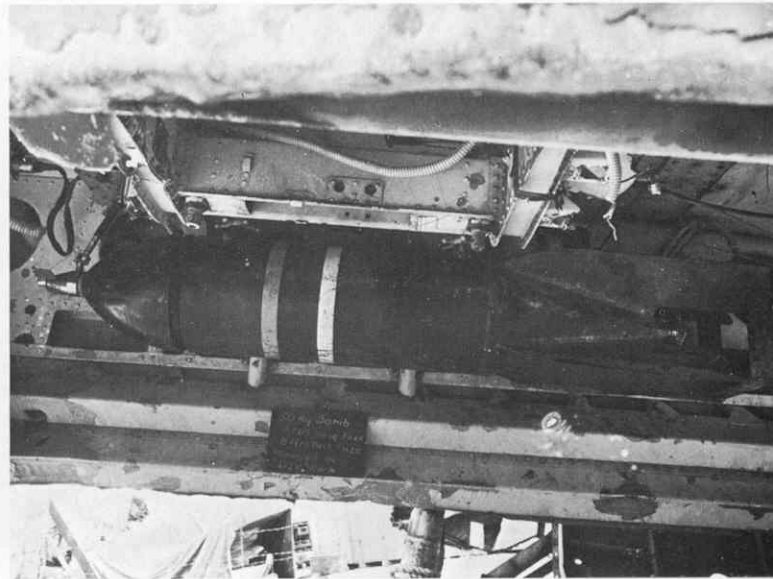
View of another Type 94, 50 kg bomb hanging in a rack of LILY. This type of bomb is painted black with a red band around the nose. The forward color band around the body of this bomb was yellow, with a white band behind to denote picric acid high explosive filling. Overall length not including fuse was 41 inches and weighed 110 lbs.

Bomb load capability of LILY was relatively small for its size. Normal load consisted of eight 50 kg general purpose bombs. Double that capacity was sometimes carried in the later model Ki.48-IIbs due to improvements in the aircraft, primarily increased horsepower.

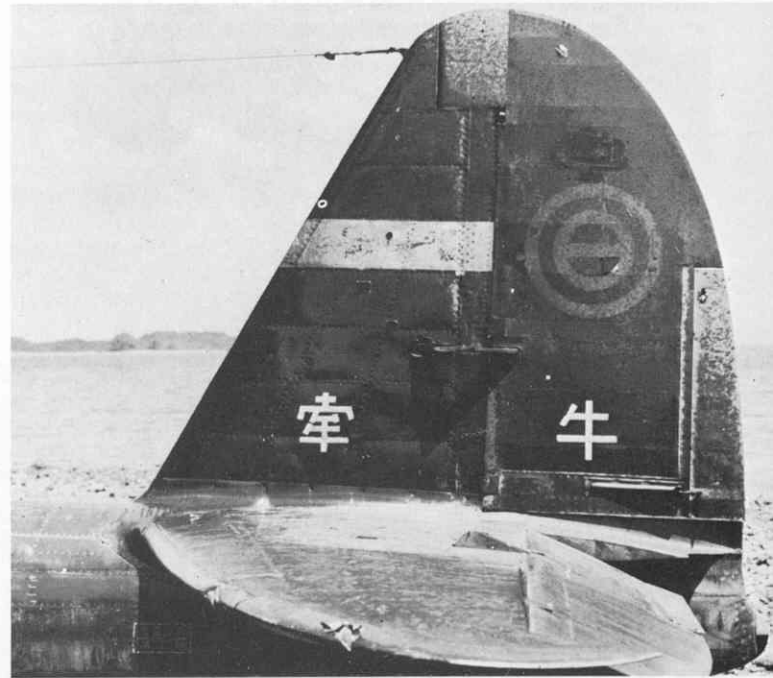
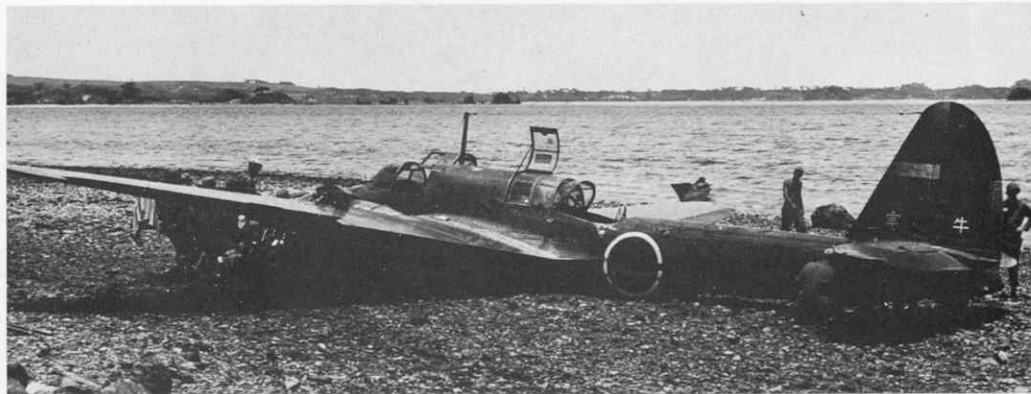
The aircraft pictured at the right and lower right is the LILY from which the preceding cockpit pictures were made. It was not until very late in the war that a complete aircraft of this type fell into Allied hands for detailed study of all their components. This aircraft was photographed some time after April 1, 1945, for the pictures were taken by a Marine photographer on the south shore of the Motobu Peninsula on Okinawa.

This LILY carries the unit marking of the 90th Sentai or Group which was active throughout most of the South Pacific operation. Instead of assigning aircraft numbers, this unit used names of stars for identification. This example carries the name "Kesgyusei" or "Altar" on the tail. Of further marking interest is the placard printed on the fuselage just under the stabilizer in a manner similar to that which the Japanese Navy used to apply its aircraft identification placard. In this case however, it reads "Metal Paint" on the first block, followed by "Number (or Class) 2."

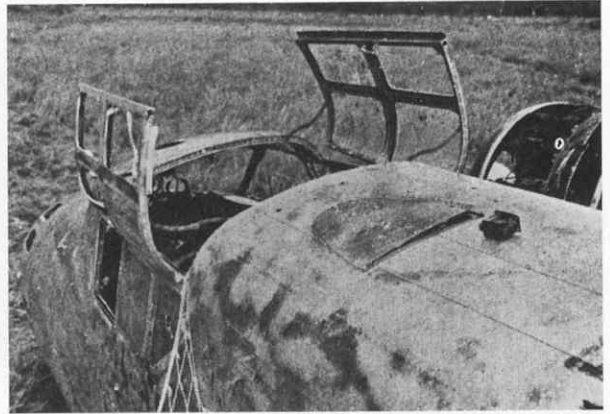
The wide opening hatch allows easy access into the cockpit of this HELEN which is stripped of all servicable parts.

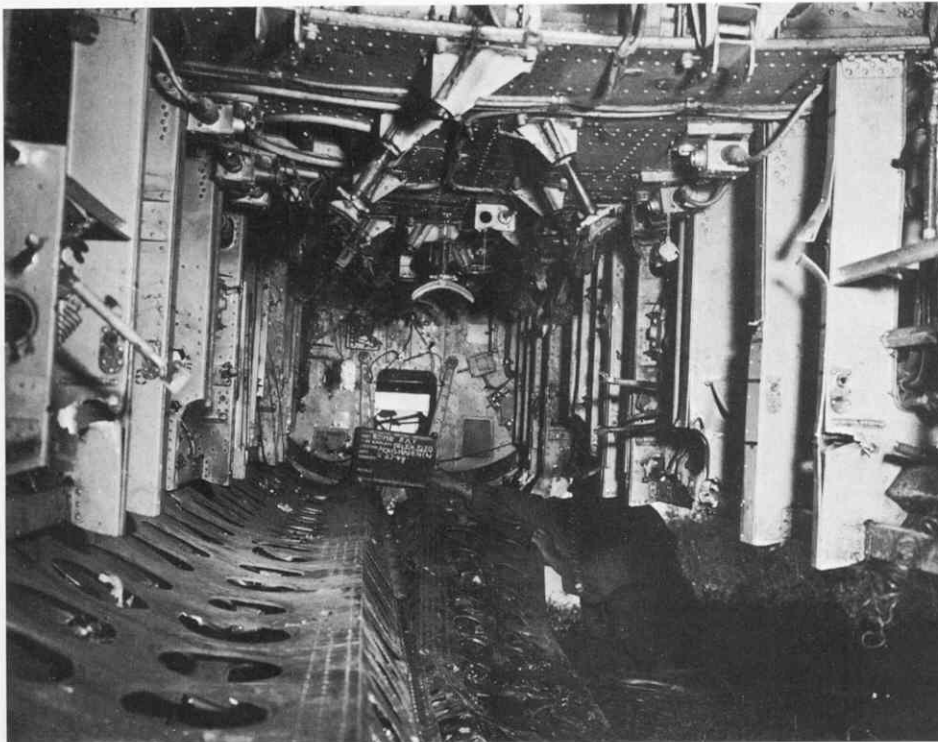
A wrecked HELEN found in New Guinea, May 1944, reveals full fuselage width bomb bay.

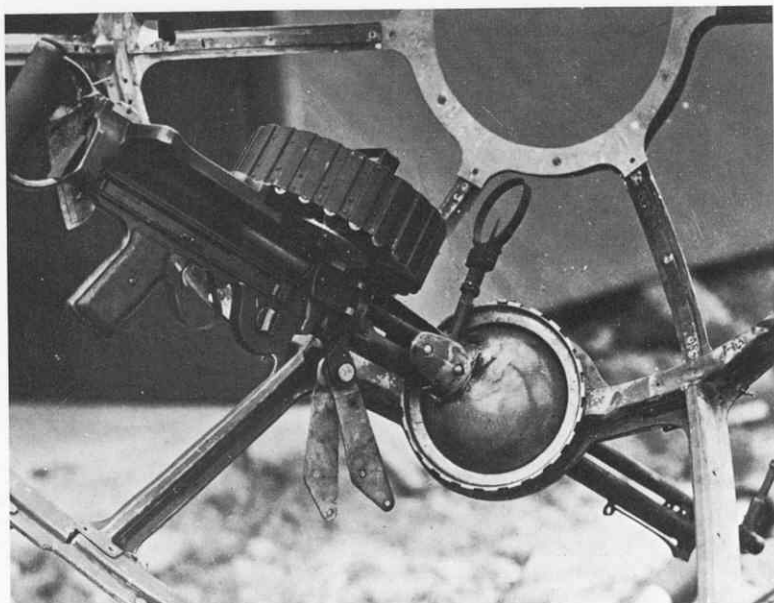
Nakajima Ki.49 HELEN gun stations. Mounted in the nose receptacle at upper left is a 7.7 mm Lewis type machine gun. This nose enclosure can be rotated to place the gun in the best firing position. At right, a 7.92 mm machine gun is demonstrated in the port waist position.

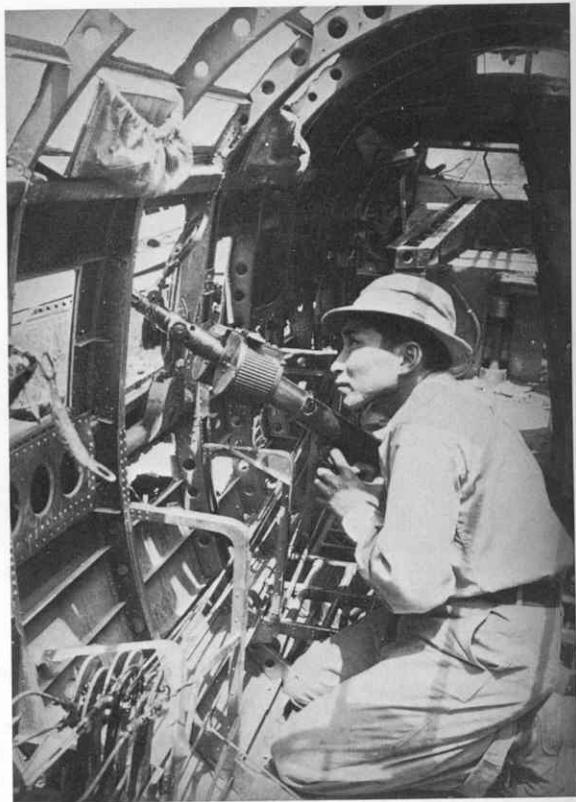
With two waist guns secured in place, the firing position of the ventral gun is shown. Note the stowed upright positions of the weapons in the picture at the lower right, and the canvas bags, some containing spare ammunition magazines.

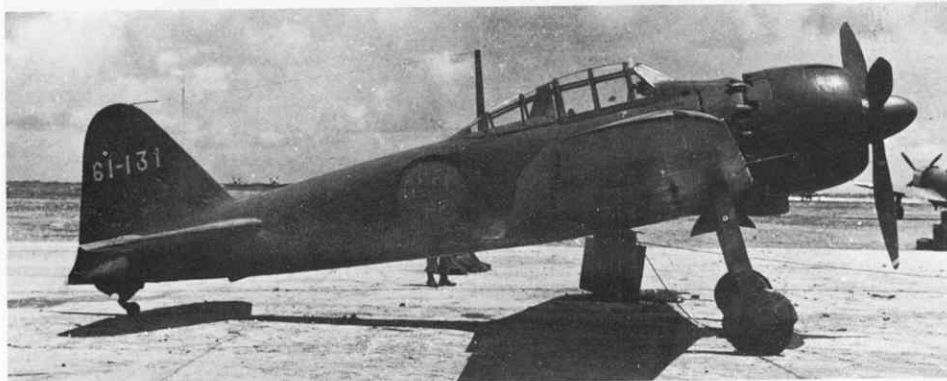
A Mitsubishi A6M5 ZERO (above) captured on Saipan in June 1944, and later taken to the United States for evaluation. Below is the cockpit of a ZERO with seat removed to show instrument panel details.

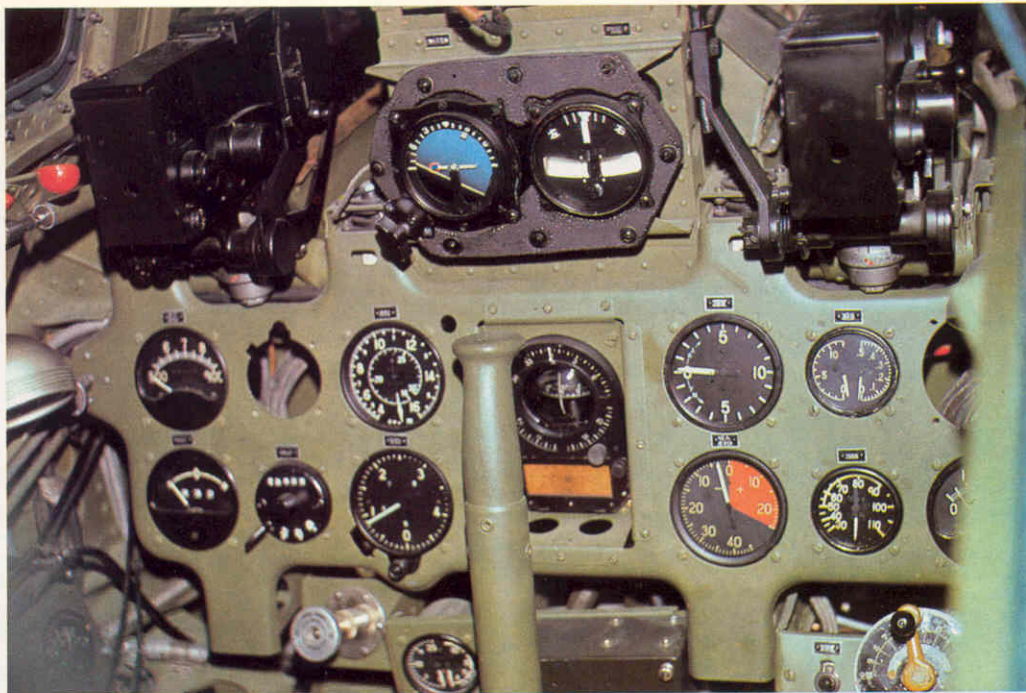
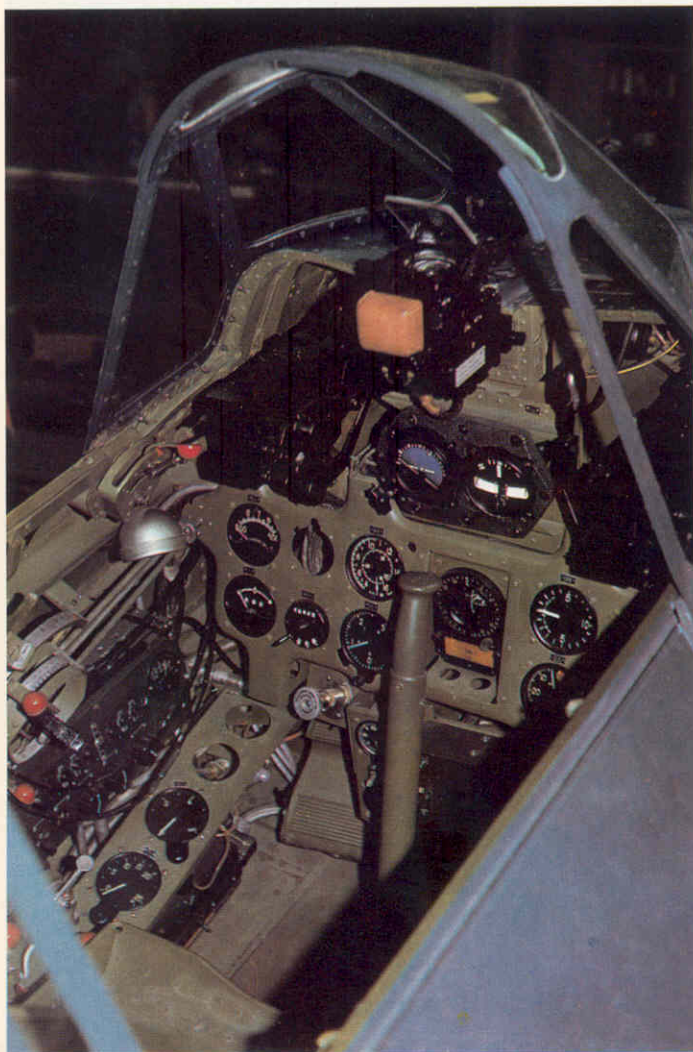
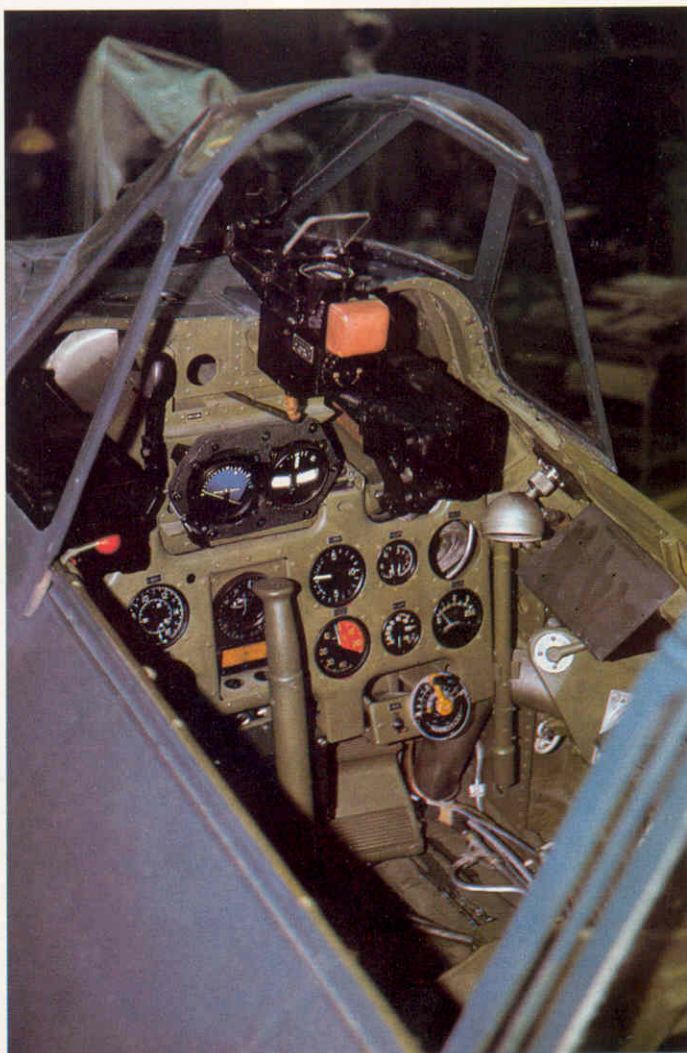
All color pictures of the ZERO are of the restored aircraft of the National Air and Space Museum. Colors were matched carefully with originals and are represented reasonably here with the exception of the exterior. This is actually a very dark green, contrary to the blue which is the result of film exposure unbalance.

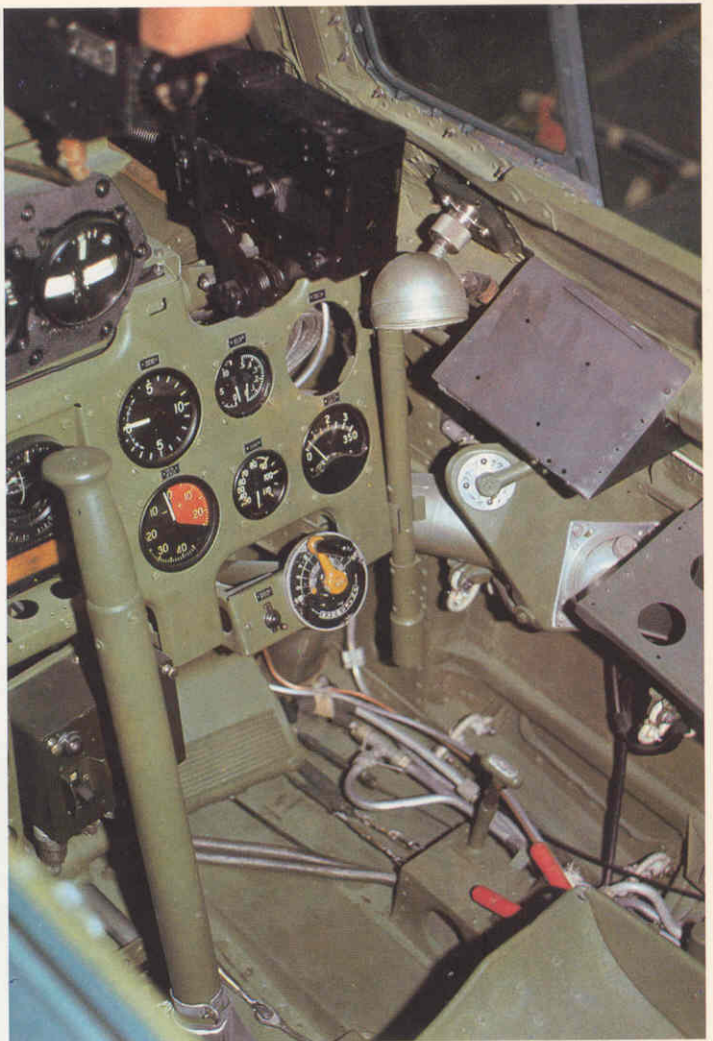
Above is left side of cockpit. Lighting control box is darker green from rest of interior. Rearmost red knobs are bomb release handles, while red "T" handle releases drop tank.

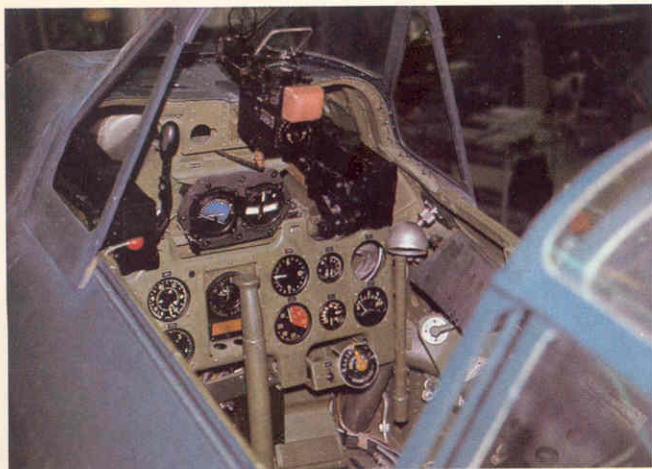
General view of cockpit (above). Below is a rear facing view of pilot's seat and head rest. Bungee cord balances seat to ease in adjusting.

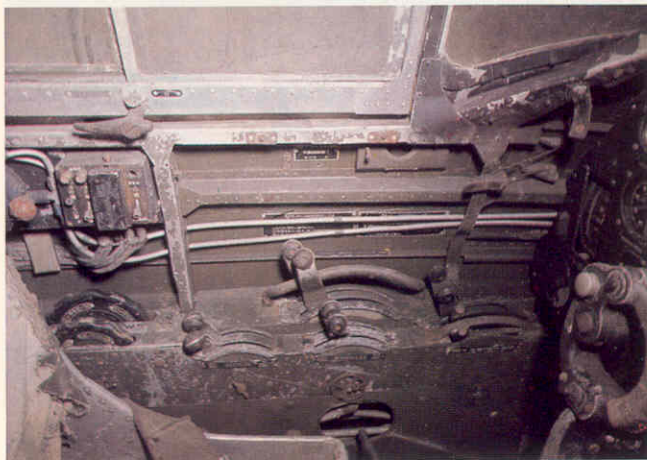
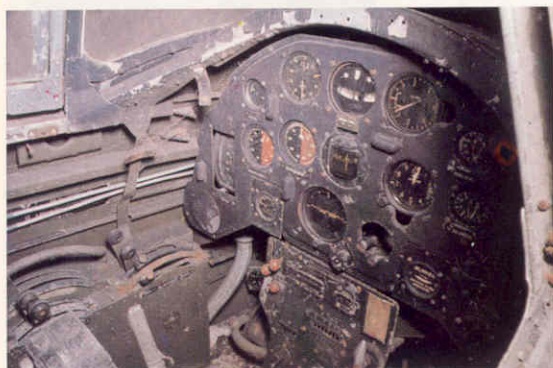
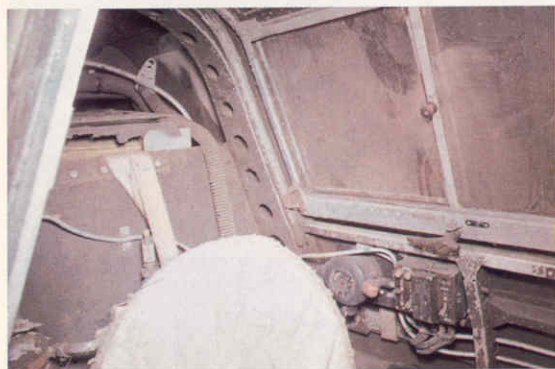
These color views are of the Kawasaki Ki.45 Kai-C NICK in storage at the National Air and Space Museum. All colors and markings, though weathered, are original and show a variety of greens used within the cockpit. Top left: left side of front cockpit. Second from bottom: pilot's seat looking to left rear. The two bottom views are of the rear seat compartment. Looking forward (below) the two brown objects are the twin 20 mm cannon mounted obliquely. To facilitate this installation, fuselage center-section fuel tanks had to be deleted. Note the American made radio gear mounted under the decking behind the gunner's position (lower left) for use during U.S. flight testing.

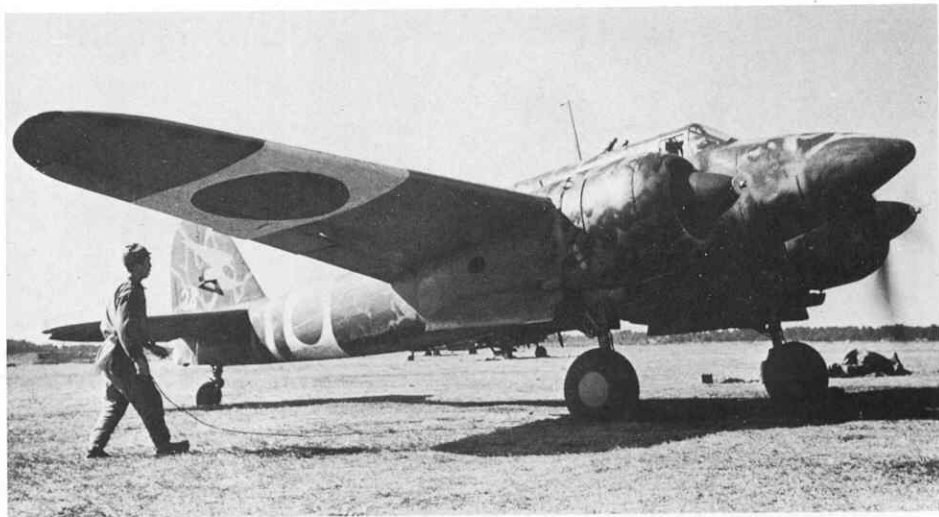
Kawasaki Ki.45 Kai-C Toryu NICK, assigned to the 53rd fighter Group. Home station was Kashiwa Air Base, near Tokyo's new Narita International Airport.

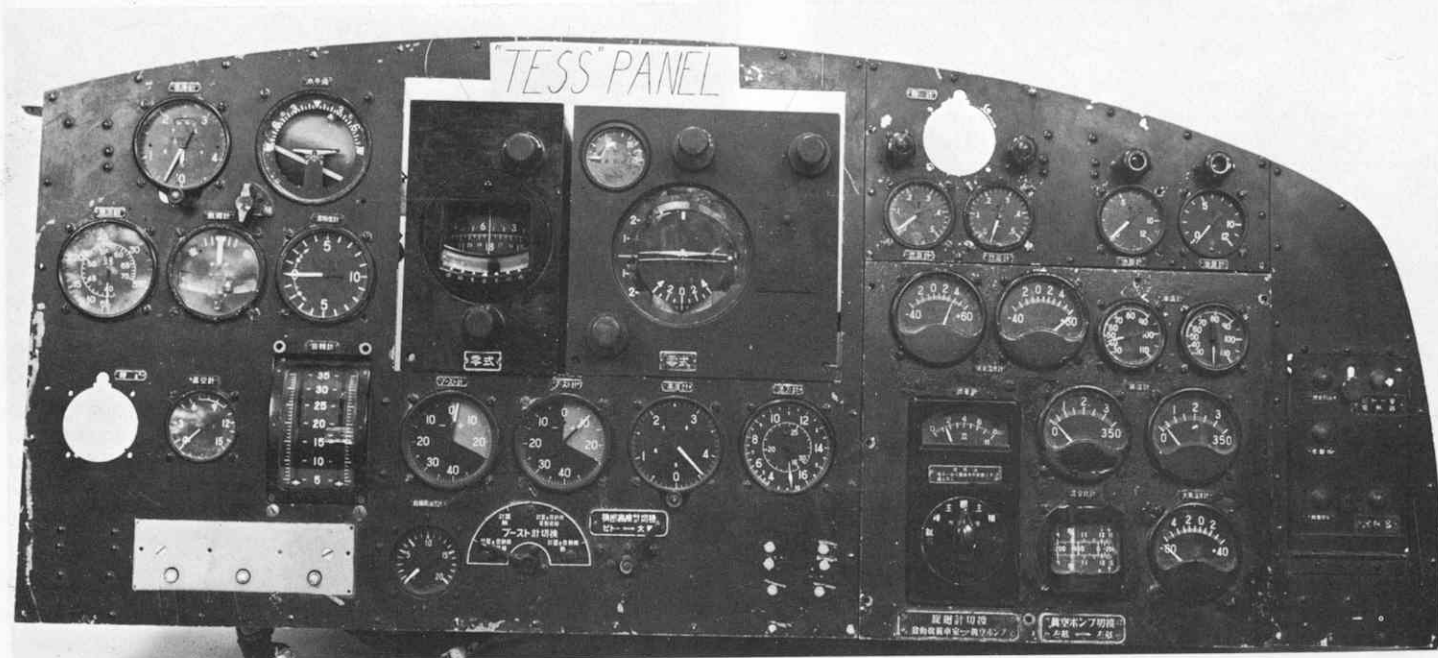
The instrument panel above was obtained from a Nakajima assembled DC-2. This has more advanced instrument grouping than the earlier Douglas-built arrangement shown at the right. Main differences are the Jack & Heintz type automatic pilot system in the center of the Japanese version, and primary flight instruments placed in front of the pilot. Note that the power control quadrant of the DC-2 contains only the two throttles, whereas later modifications and DC-3s included propeller pitch and fuel mixture controls. A majority of Japanese twin-engine aircraft tachometers were of the dual, vertical reading type. This instrument is just below the left flight instrument grouping on the TESS panel. The DC-3 was a development of the DC-2 and the instrument panel of TESS more closely resembles that of the later DC-3 than does the Douglas-built DC-2. (See page 68 showing the DC-3 instrument panel layout.)

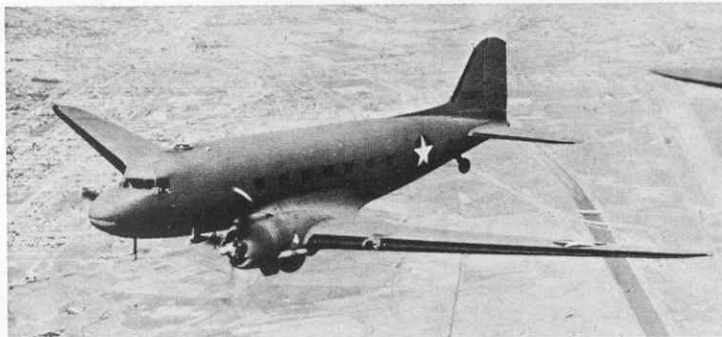
These cockpit pictures of TABBY are of the aircraft pictured above being evaluated by U.S. Forces at Zamboanga on the Philippine island of Mindanao, May 3, 1945. Slender cowling and the addition of propeller spinners are the main feature difference from the U.S.A.A.F. C-47 at right.

The central units for the automatic pilot have been removed from the instrument panel of this TABBY. These are similar in design to the Jack & Heintz model used in the DC-3. Japan had manufacturing rights to a large number of American aircraft components.
