# MONOGRAM

## Close-Up 14

# COCKPIT INTERIORS

PART 1

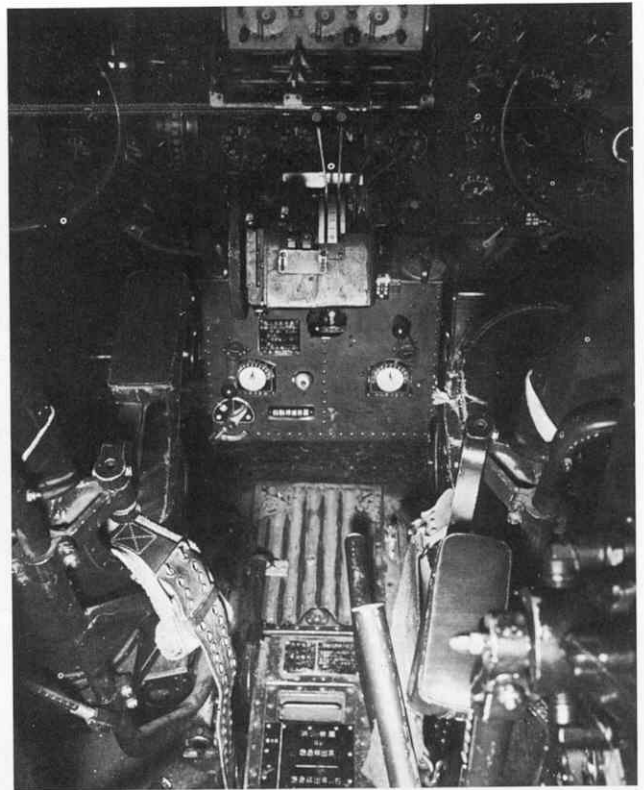
Close-up view of Nakajima L2D3 TABBY throttle quadrant above. The handle on the floor to the right of the pilot's seat is the landing gear positive down lock. Hand operated hydraulic pump is opposite at right, and engine fire extinguisher system is under cover on floor. Top left: Overhead electrical panel for L2D. Left: Same for DC-3. Below: C-47 instrument panel and pedestal.

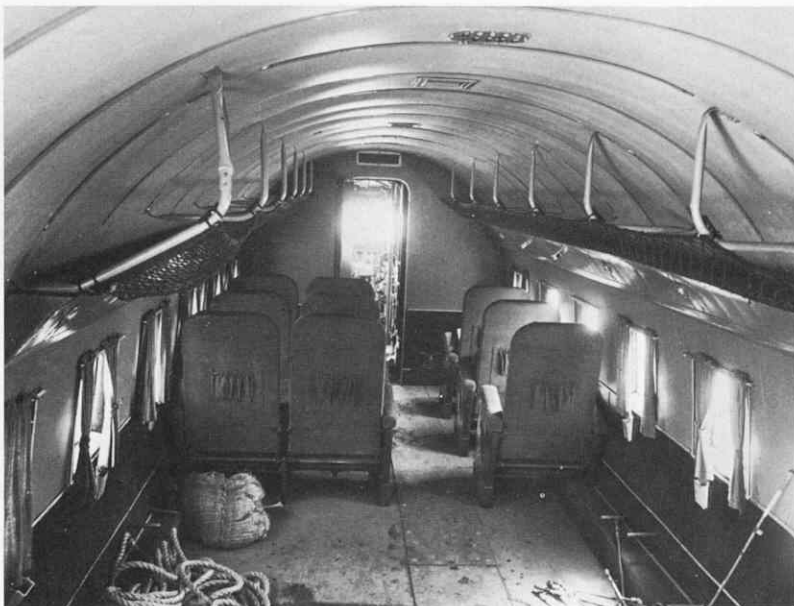
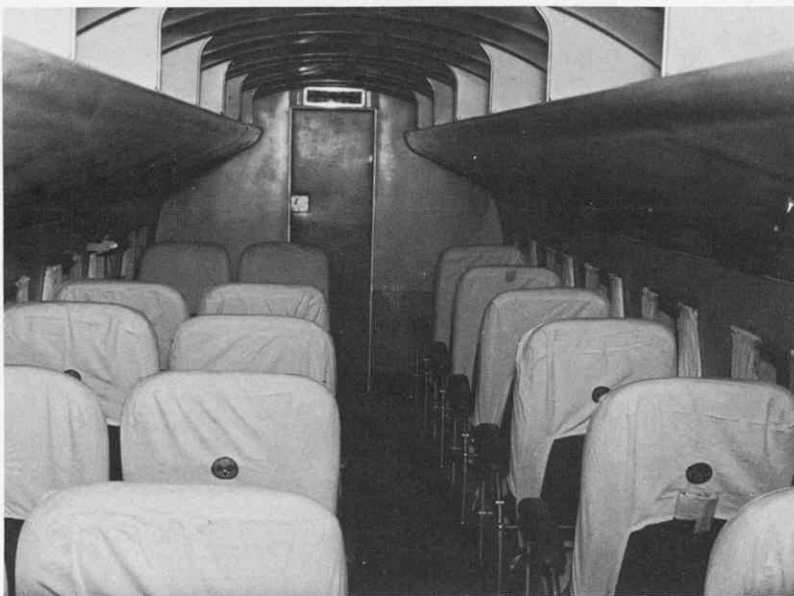
Top picture is looking forward in a half-cargo, half-passenger version of TABBY. Below is a full passenger configured Douglas C-47D, circa 1949.

The Nakajima L2D TABBY was an adaptable Imperial Japanese Navy transport able to serve a wide variety of purposes. Like the American derivative, its military mission was primarily a cargo hauler, however both were easily converted into passenger carriers. Pictured here for comparison purposes are American and Japanese military versions of the Douglas DC-3s that have been passenger configured, yet are easily converted back to full cargo carrying duties. Normal passenger capacity was 21 when utilizing this type of seat.

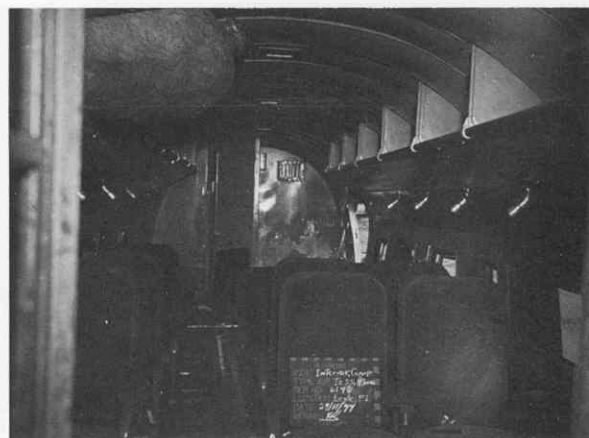
Photographed on Leyte, November 1944, and erroneously identified as the smaller TESS, the TABBY above is also part cargo and passenger configured. 'McArthur seats' in VC-47A below have a less comfortable appearance, but this aircraft was equipped with an electric galley in the rear.

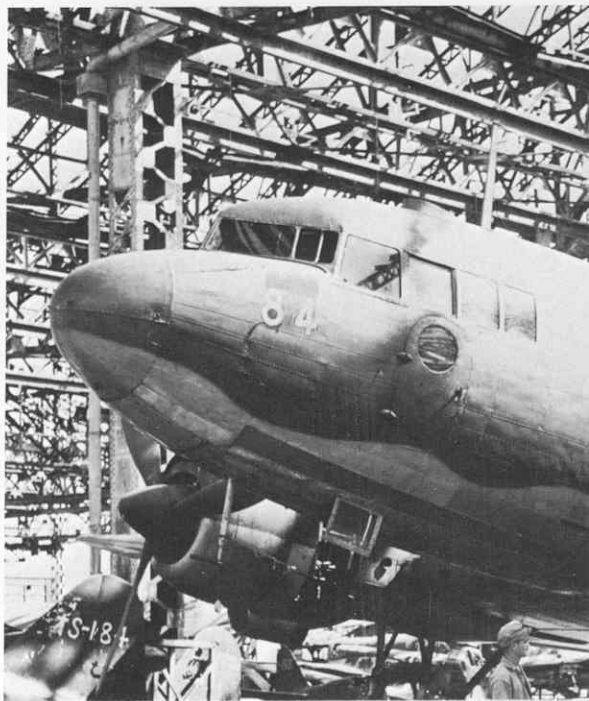
Nakajima produced seventy-one of the TABBY type transports, while the major share of production was carried by Showa Aircraft Company by producing an additional 416 machines. The Showa built L2D3 TABBY (below) was easily recognizable by the addition of three windows on either side of the cabin and the access door window, a deviation from the Douglas design.

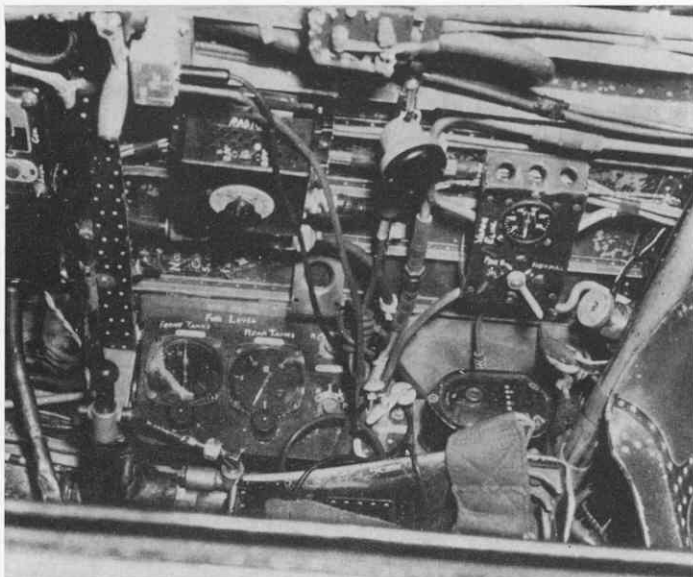
Right side of cockpit. Auxiliary hydraulic hand pump is in lower left corner with retracted telescoping handle.

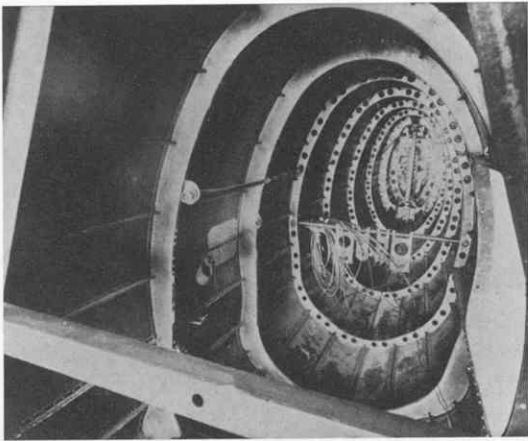
View of aft fuselage section interior.

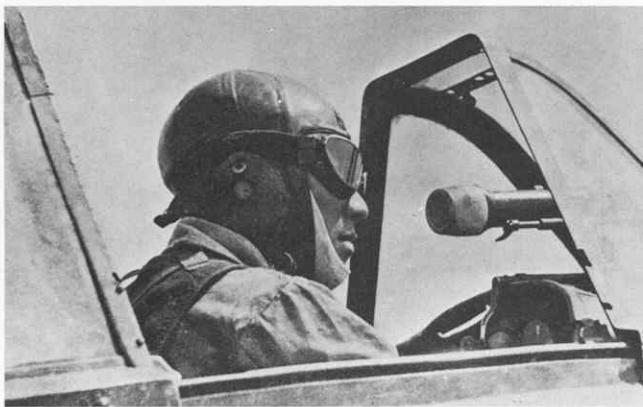
The telescope gun sight and flat canopy top identifies this as the early model of OSCAR. Japanese flying gear included a cotton hood that extended across the chin, worn under the leather helmet.

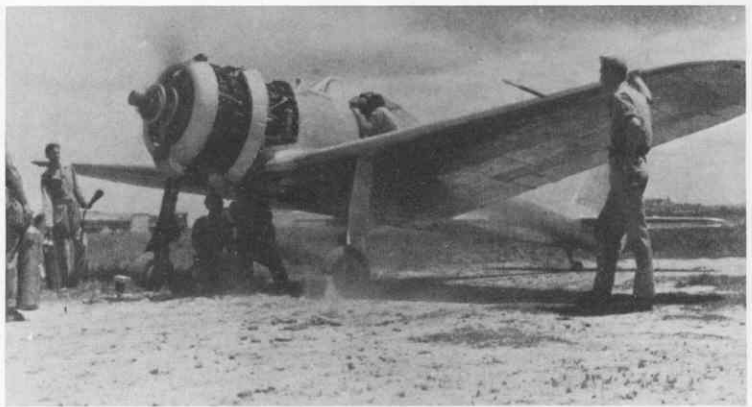
Final engine adjustments are made to the OSCAR before being buttoned-up for evaluation flying by the Americans. Components of several captured OSCARs were sent to Brisbane, Australia where this one flyable example was assembled and flown for the first time on March 17, 1944.

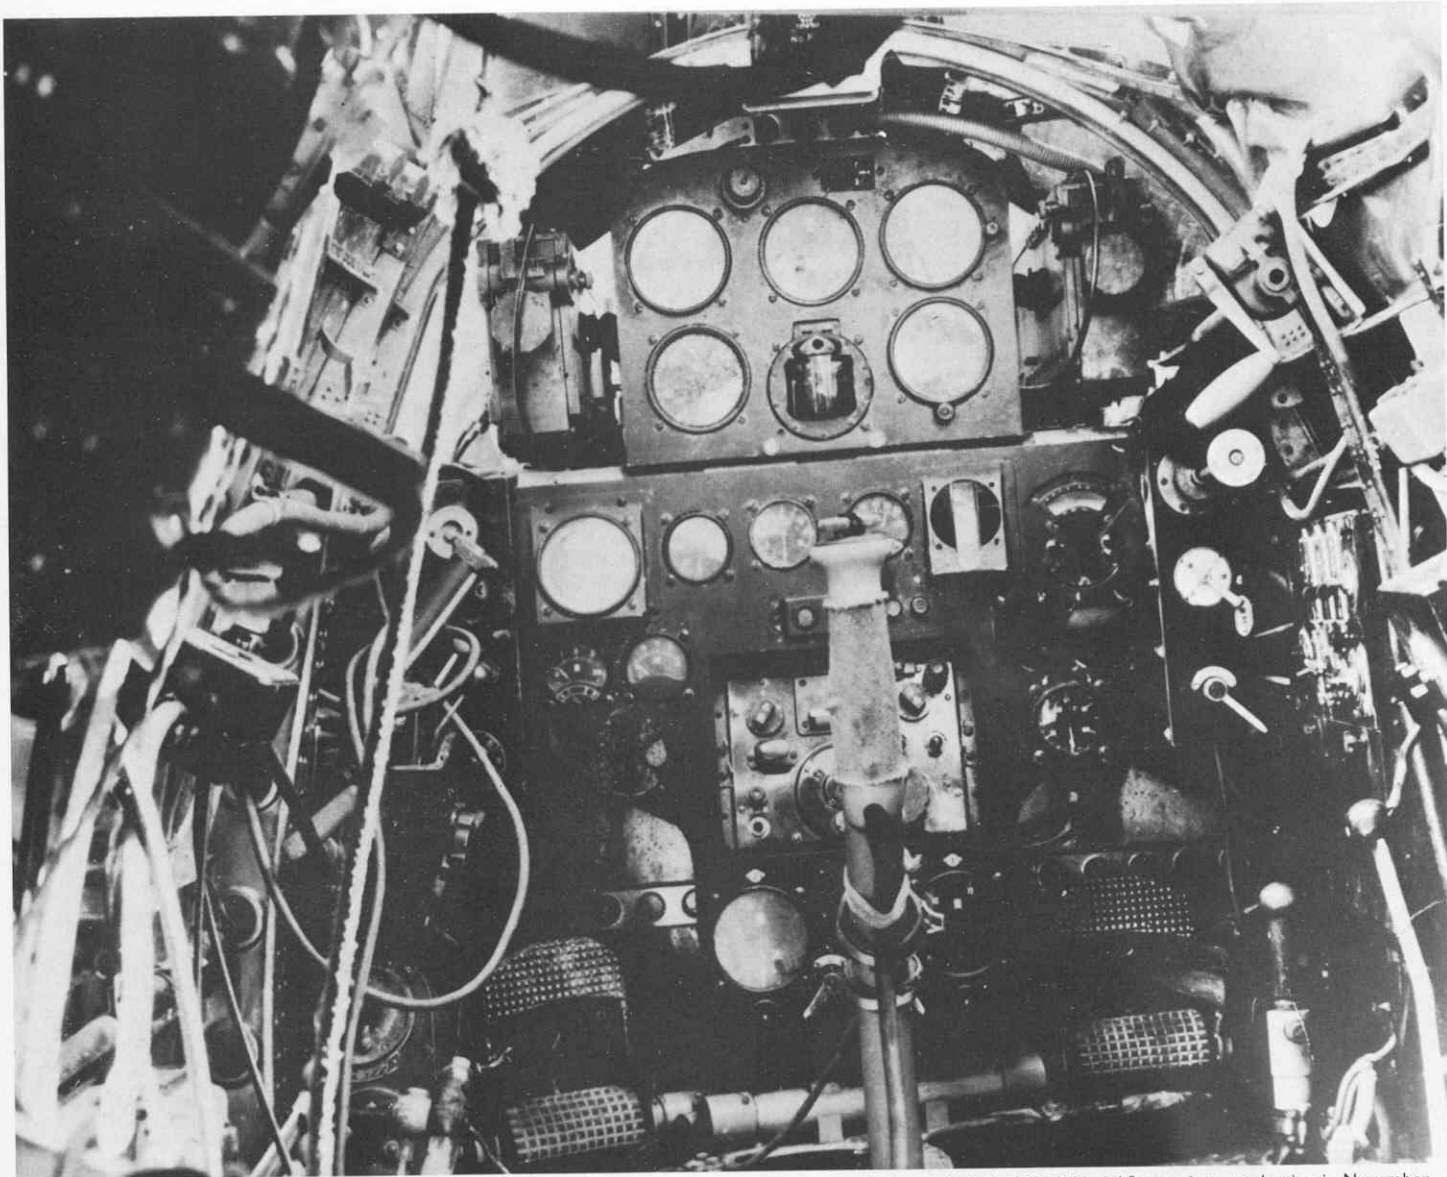
The more advanced Ki.43-II OSCAR Model 2 went into production in November 1942 with many advanced features over the Model 1. Cockpit was fully redesigned.

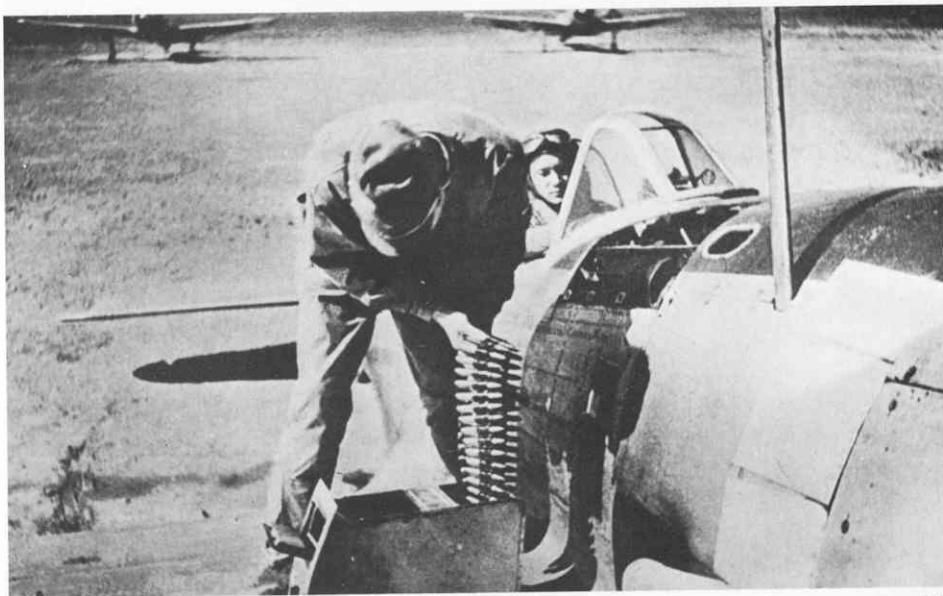
Appearing in 1942 was the refined Nakajima Ki.43-II OSCAR. Improved performance resulted from a new three-bladed prop and rounded canopy, an increase in engine power and a decrease in wing span.

A new instrument panel incorporated the compact grouping of flight instruments and collected all other gauges together. Fuel quantity indicators are mounted centrally just below the radio control box. Armament of two 12.7 mm machine guns located on either side of the upper instrument panel was light in comparison to Allied aircraft.

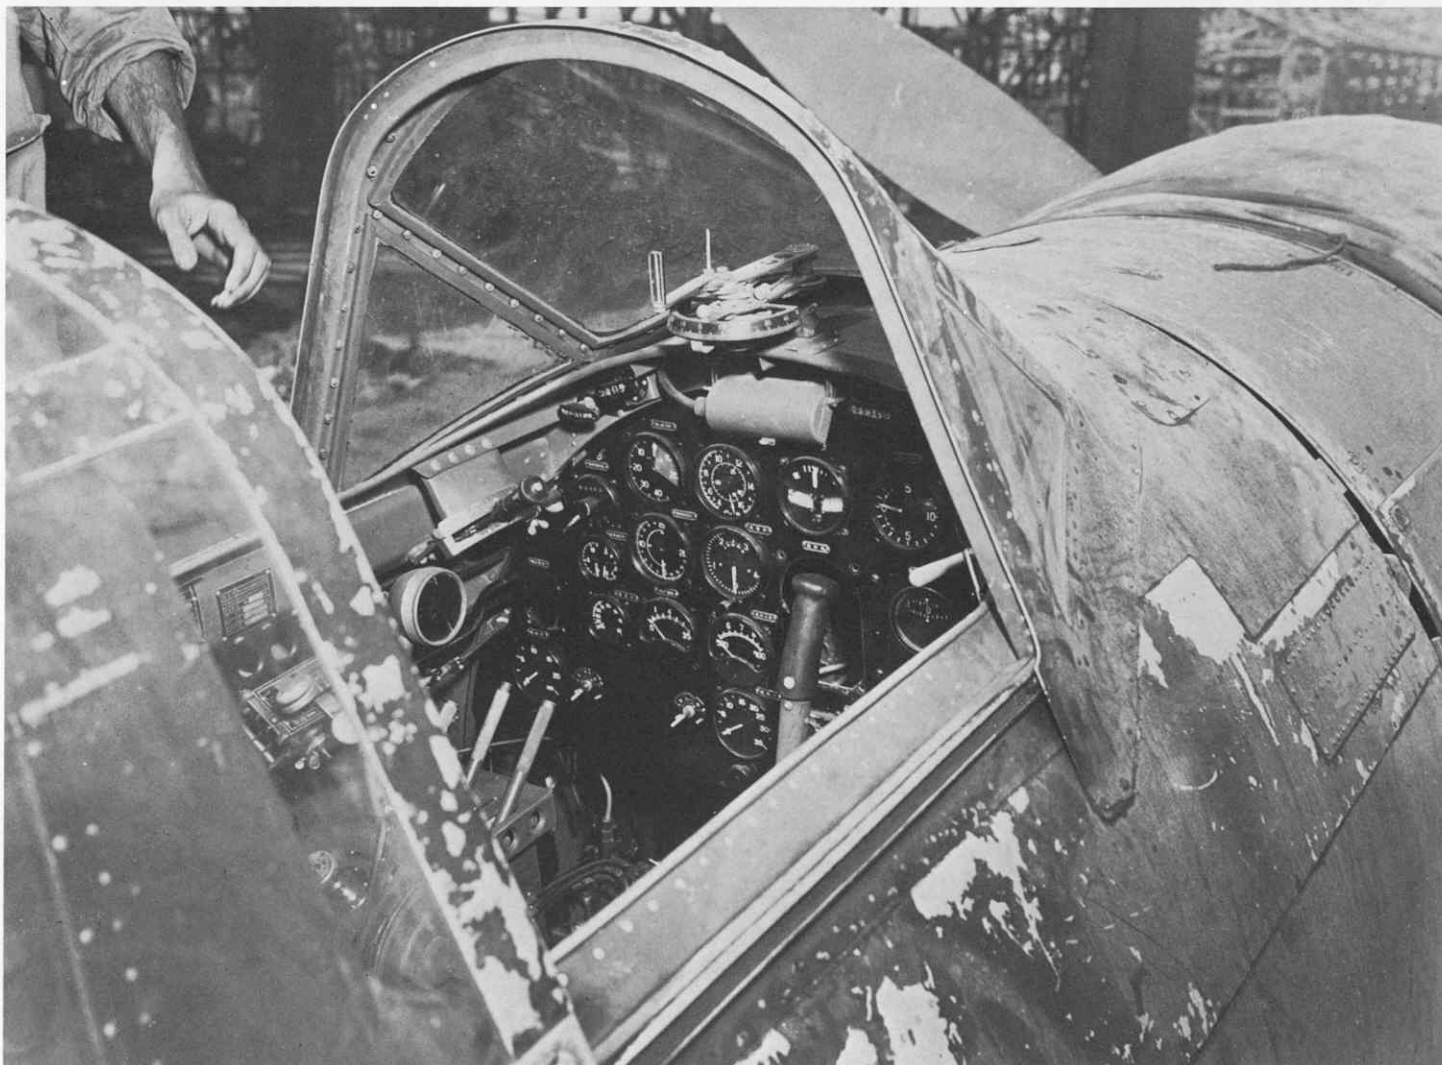
# KATE, Nakajima B5N2

The first KATE to be evaluated by the Americans fell into Allied hands during the capture of Saipan in June 1944. The picture below shows this KATE at Aslito Air Field (later named Isley Field) being readied for placement aboard an

aircraft carrier with ZERO fighters, to be carried to the United States. All interior photos are of this plane.

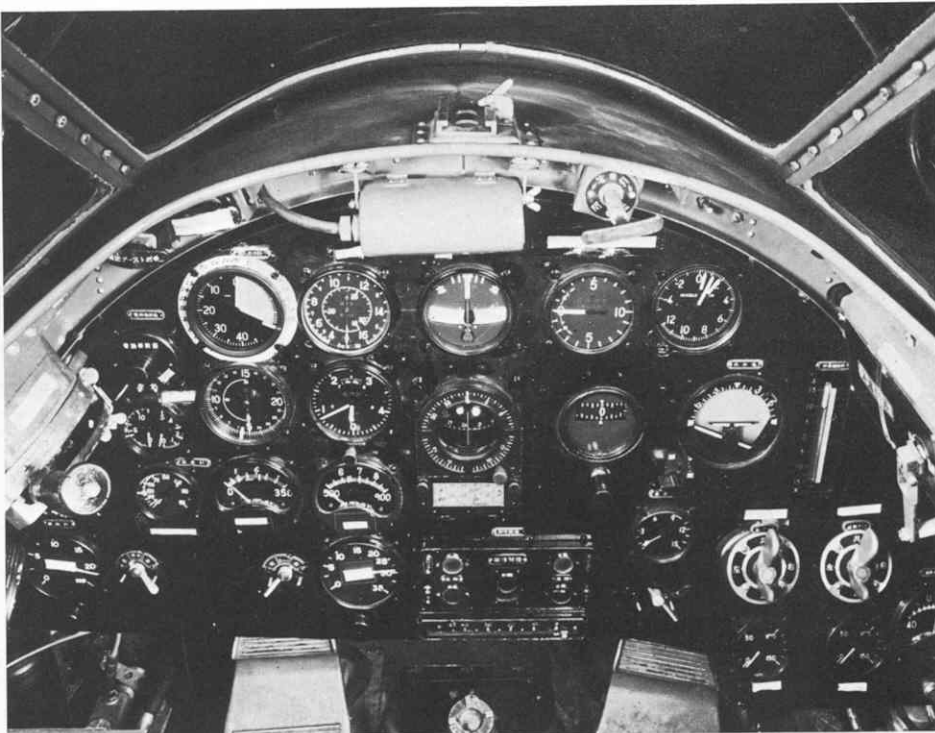
The cockpit of the Nakajima B5N2 KATE was found to be very cramped for American pilots, particularly since adjustments of the rudder pedals to their fullest extension was not sufficient for comfort. Trim tabs were easy to operate for the ailerons and rudder which were on the left console, however the more often used elevator trim was higher and further back in an awkward location. The wing flap and landing gear handles were on the right side of the cockpit, an unusual arrangement. Since the wheels had to be retracted before reaching 100 knots airspeed on climbout this necessitated a quick change of hands across the control column in order to get the gear up.

1. Manifold Pressure Indicator
2. Airspeed Indicator
3. Turn and Bank Indicator
4. Rate of Climb Indicator
5. Accelerometer (U.S. Install.)
6. Engine Tachometer
7. Altimeter
8. Magnetic Compass
9. Directional Gyro
10. Artificial Horizon
11. Cylinder Head Temperature
12. Fuel-Air Ratio Gauge
13. Fuel Quantity, Outboard Tanks
14. Engine Ignition Switch
15. Fuel and Oil Pressure Gauge

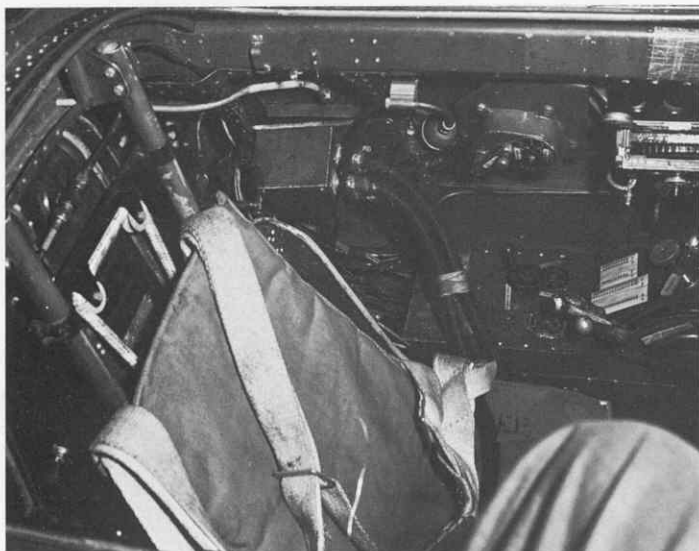
Left rear view of pilot's cockpit shows clearly that the entire area was painted interior olive green which is contrasted with black details.

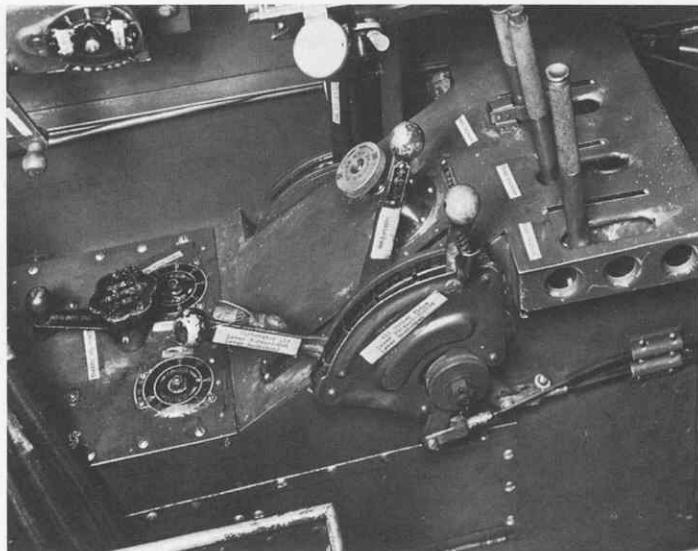
Pilot's left console with engine controls in center just below throttle knob at top of picture. Bomb and torpedo manual release handles are at the right in picture.
