**LABORATORY MEASUREMENT OF
THE REDUCTION OF TRANSMITTED
IMPACT SOUND OF THE FIRST CLASS
CARPET TILE**

Project Floors
PO Box 99.
Silverdale
Auckland, 0944

**LABORATORY MEASUREMENT OF THE
REDUCTION OF TRANSMITTED IMPACT
SOUND BY FLOOR COVERINGS ON A
STANDARD FLOOR.**

(According to ISO 10140-3)

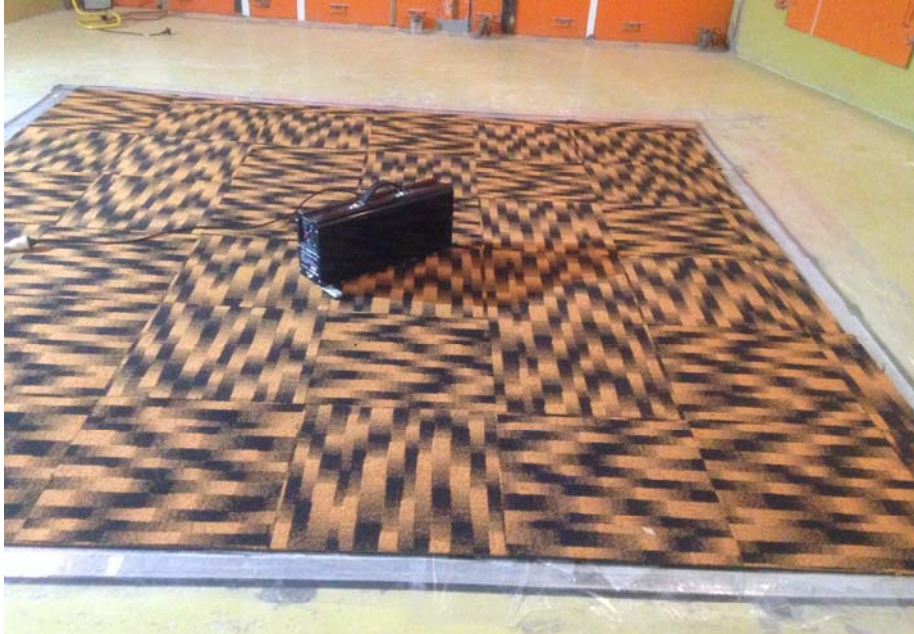
Figure 1: Sample installed in chamber with tapping machine on sample.

The tapping machine is placed on the three different covering samples. The impact sound pressure level is measured in the room below the floor, using a rotating microphone, in third octave frequency bands.
