**LABORATORY MEASUREMENT OF
THE REDUCTION OF TRANSMITTED
IMPACT SOUND OF THE HUKA FALLS
CARPET TILE**

Date: 4th May 2016

**LABORATORY MEASUREMENT OF THE
REDUCTION OF TRANSMITTED IMPACT
SOUND BY FLOOR COVERINGS ON A
STANDARD FLOOR.**

(According to ISO 10140-3)

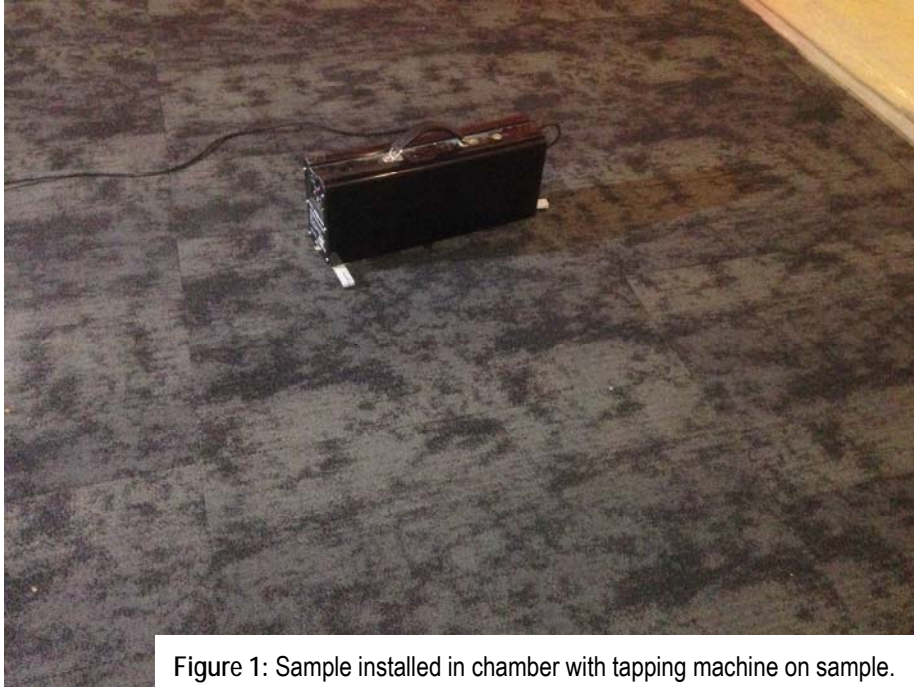
Figure 1: Sample installed in chamber with tapping machine on sample.

The tapping machine is placed on the three different covering samples. The impact sound pressure level is measured in the room below the floor, using a rotating microphone, in third octave frequency bands.

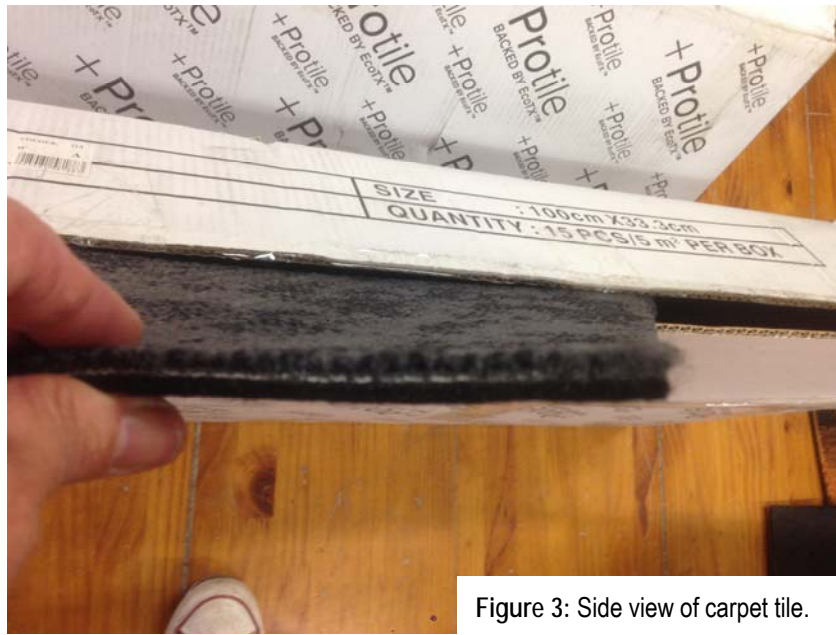
Figure 3: Side view of carpet tile.

A 3.17m x 3.17m sample of 1000mm x 333mm x 10mm thick *Profile* carpet tiles with *EcoTX* backing adhered to the test slab with *ProjectStik 2 Carpet Tile Adhesive*.

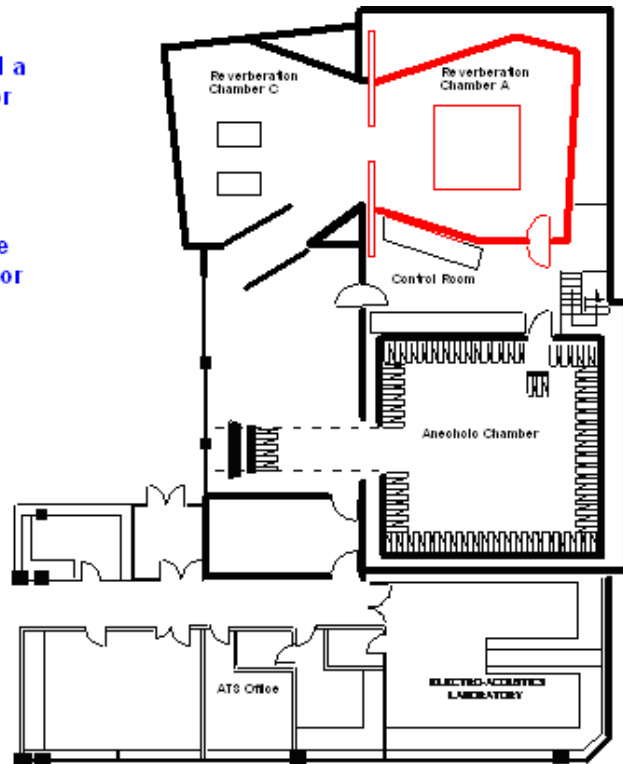
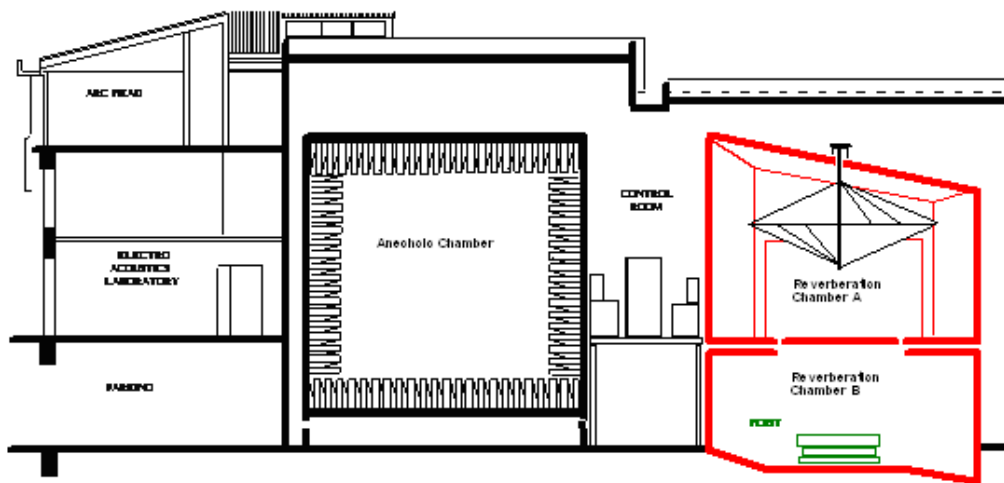
There are three large interconnected reverberation chambers at the Acoustics Research Centre, two at ground level (Chambers C and A) and the third (Chamber B) below A.

All three reverberation chambers may be described as hexagonal prisms; each have 6 vertical sided walls, perpendicular to the floor. The roofs of chamber A and C are plane, but inclined at 12 degrees from horizontal. Chamber B has a plane, horizontal roof which is the floor of chamber A above it. The floor of chamber B is also horizontal, but has two angled sections at its north west and south east ends. The centre section is horizontal because a floor jack is installed there. The floor jack may be raised hydraulically to the ceiling of chamber B, the centre of which consists of a floor plug between the two chambers. This plug may be disconnected from chamber A and lowered down into chamber B, leaving a 3.2m x 3.2 m opening between the two chambers. This allows for the measurement of airborne and impact insulation of floor and roof elements.

The three Reverberation Chambers are linked by heavy steel doors and a removable Standard Industrial Floor Section which is removed and repositioned by a hydraulic hoist. The three chambers are vibration isolated from one another so that sound can only pass from one to the other via the intervening Test Wall or Test Floor/Ceiling Section.
