**LABORATORY MEASUREMENT OF
THE REDUCTION OF TRANSMITTED
IMPACT SOUND OF ACOUSTIC VINYL
PLANKING**

AUCKLAND UNISERVICES LIMITED
a wholly owned company of
THE UNIVERSITY OF AUCKLAND

**LABORATORY MEASUREMENT OF THE
REDUCTION OF TRANSMITTED IMPACT
SOUND BY FLOOR COVERINGS ON A
STANDARD FLOOR.**

(According to ISO 10140-3)

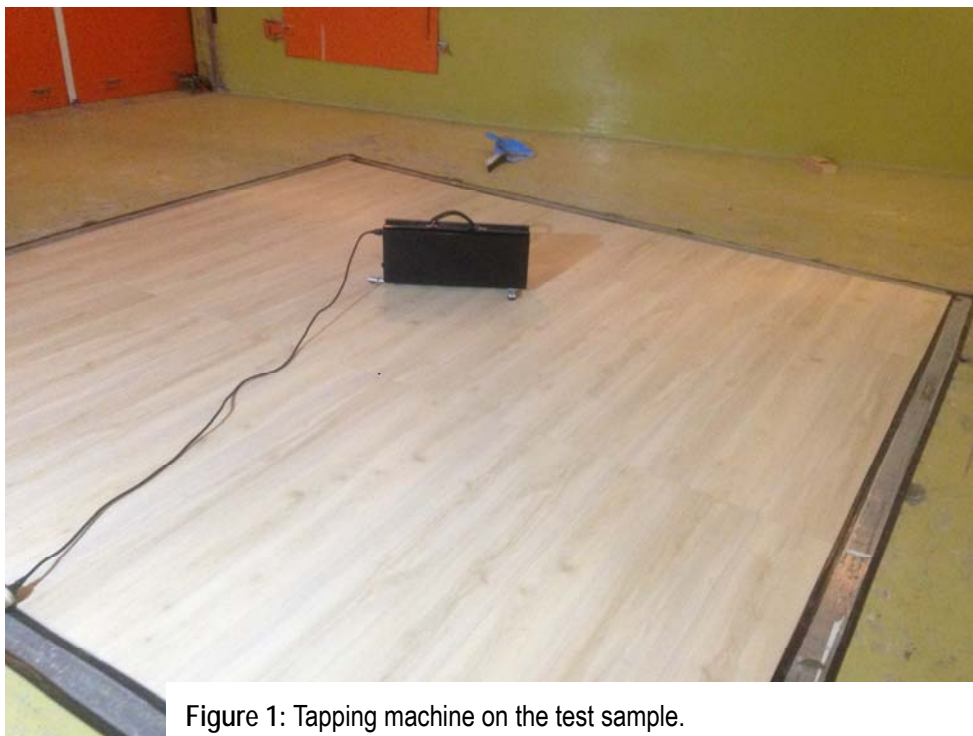
Figure 1: Tapping machine on the test sample.

The tapping machine is placed on the three different covering samples. The impact sound pressure level is measured in the room below the floor, using a rotating microphone, in third octave frequency bands.

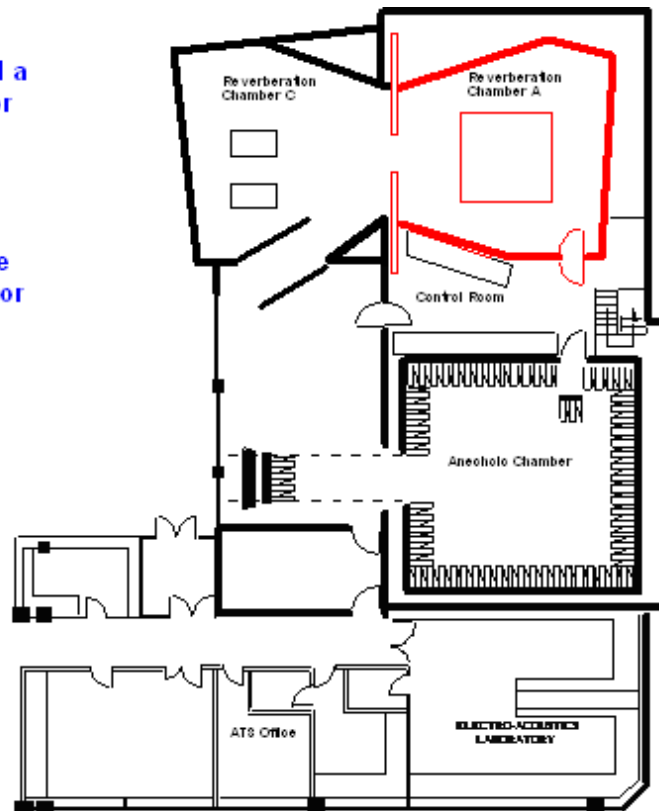
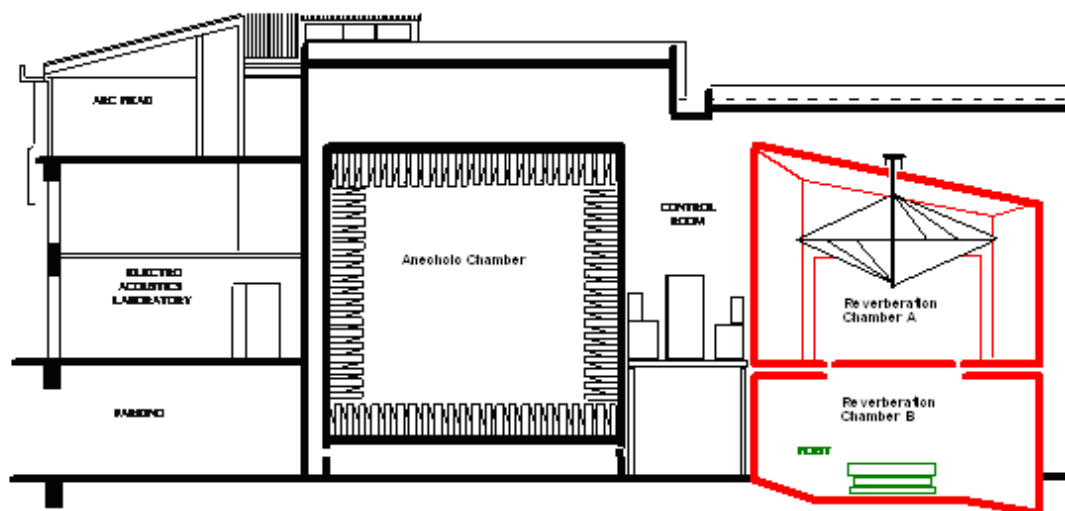
DESCRIPTION OF REVERBERATION CHAMBERS AT THE ACOUSTICS RESEARCH CENTRE

There are three large interconnected reverberation chambers at the Acoustics Research Centre, two at ground level (Chambers C and A) and the third (Chamber B) below A.

All three reverberation chambers may be described as hexagonal prisms; each have 6 vertical sided walls, perpendicular to the floor. The roofs of chamber A and C are plane, but inclined at 12 degrees from horizontal. Chamber B has a plane, horizontal roof which is the floor of chamber A above it. The floor of chamber B is also horizontal, but has two angled sections at its north west and south east ends. The centre section is horizontal because a floor jack is installed there. The floor jack may be raised hydraulically to the ceiling of chamber B, the centre of which consists of a floor plug between the two chambers. This plug may be disconnected from chamber A and lowered down into chamber B, leaving a 3.2m x 3.2 m opening between the two chambers. This allows for the measurement of airborne and impact insulation of floor and roof elements.

The three Reverberation Chambers are linked by heavy steel doors and a removable Standard Industrial Floor Section which is removed and repositioned by a hydraulic hoist. The three chambers are vibration isolated from one another so that sound can only pass from one to the other via the intervening Test Wall or Test Floor/Ceiling Section.
