# 1964-67 CUTLASS

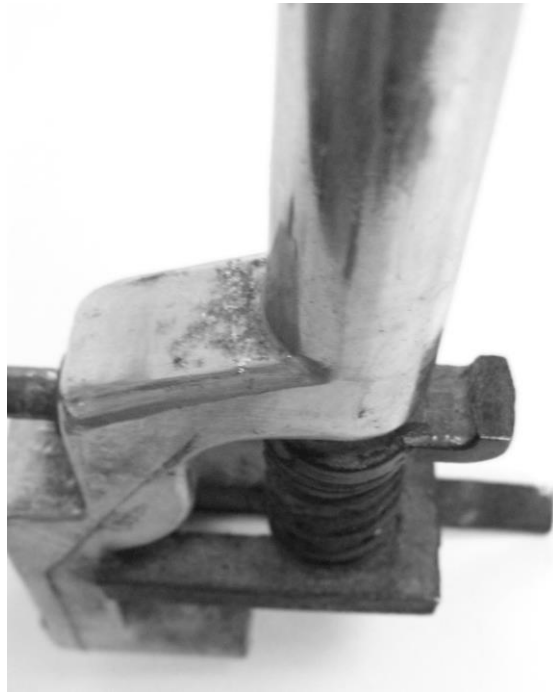
Handle removed from shifter base. The tab that must be ground down to a more narrow profile is easily seen in Photo 2 on the right side.

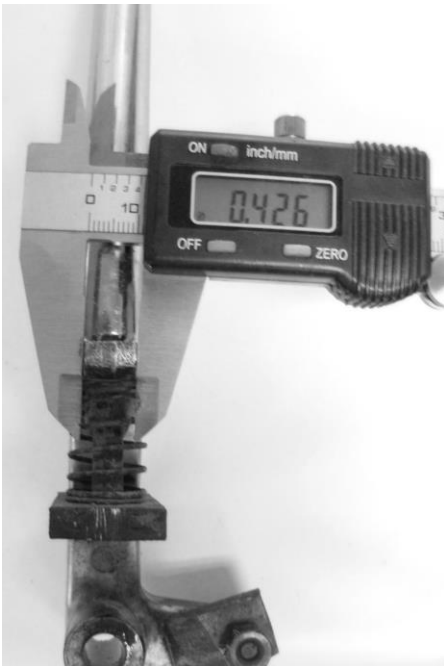
Photo 3 shows the width of the tab prior to grinding, and photo 4 shows the tab after reduction.
