HARO TECHNICAL BULLETIN

Date: February 19th 2021 / MY21 Bulletin #1

Models involved: 2021 Thread Two & Thread Slope.

Concerns: Rotor plate position on the headset spacers stack.

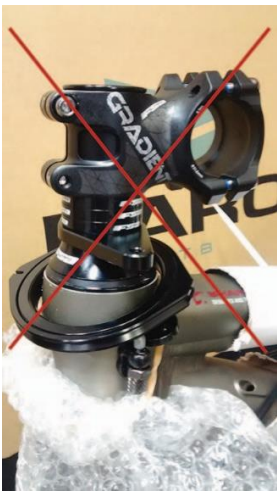
#1: Wrong rotor plate position Inside the box

The original position (as packed inside the box) below the 3 x 5mm spacer on the headset stack (as shown below on picture #1) is not correct and the rotor plate needs to be positioned properly.

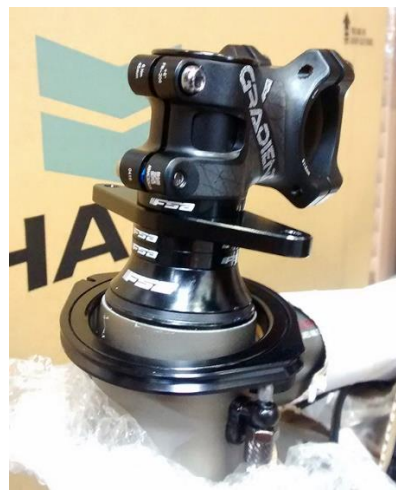
#2: Correct rotor plate position between 2nd and 3rd 5mm spacer

The correct position for the rotor plate is shown below (picture #2) in between the second and third spacer from the bottom cone. This prevents the rotor from bottoming out against the plate while braking, which could dangerously reduce braking power.

- Remove the headset's top cap with an 8mm Allen wrench,
- Loosen the two stem bolts and remove the stem from the steerer tube,
- Remove the three FSA spacers and the rotor plate,
- Place these 4 items back in the proper order shown in picture #2 above,
- The correct rotor plate position is between the 2nd and 3rd 5mm spacer.

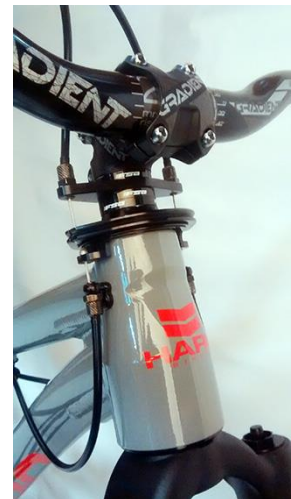
#3: Proper lower and upper cables assembly:

The 2021 Thread Two and Thread Slope are spec'd with a custom-designed Haro rotor, which uses a plate to affix the upper cables and assemble the upper barrel adjusters.
