VW GOLF MK.I GTI

FRONT SEAT SUPPLEMENTARY FOAM REPAIR KIT

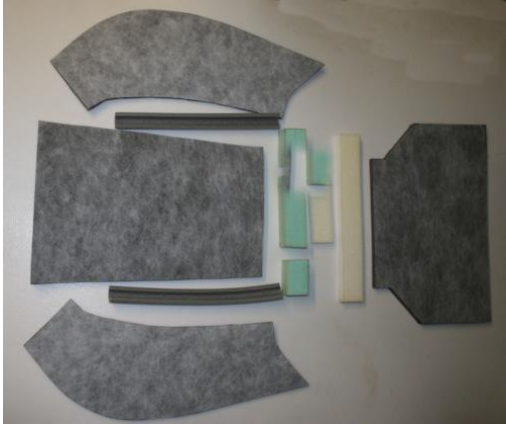
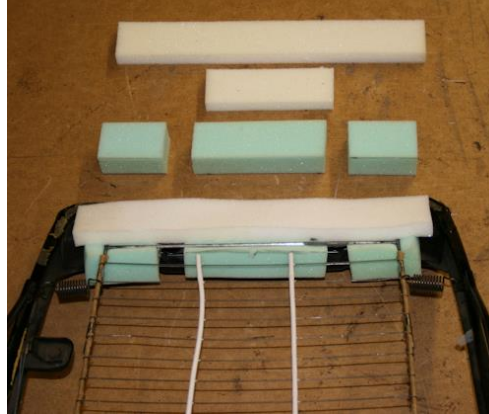
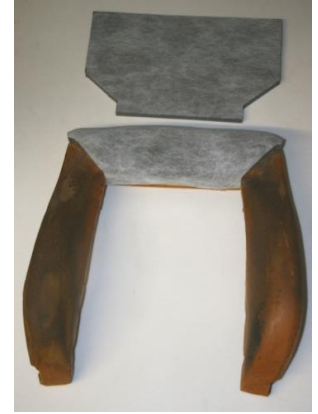
We have found from experience that seat foams over 20 years old go soft and can get easily damaged. In particular the side bolsters on the seat base split open on the side you get in and out of the car. This kit is designed to wrap over the original foam cushions to create once more a smooth surface and a very good base for your new seat covers. From the pictures below you will see what is included in this kit.

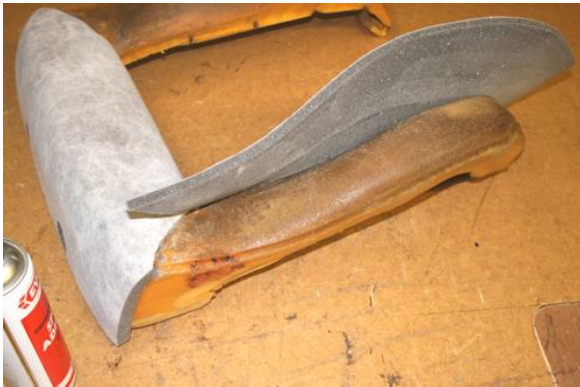
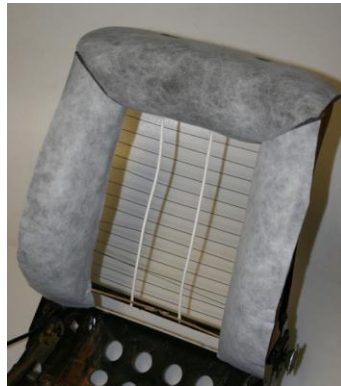
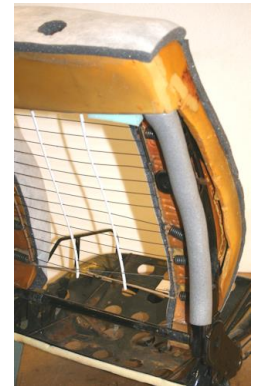
We have found that the wire diaphragm can wear out too. Even with a new diaphragm it is wise to support the top of the unit which will help support the top roll of the squab seat foam. Position as above and glue in place as shown here. Apply adhesive to underside of the new foam wrap and the old cushion. Carefully apply the top wrap over the cushion and press into place. Also included in the kit are pieces to cover the tube on the rear of the squab frame. By renewing this piece, the seat cover will fit much better.

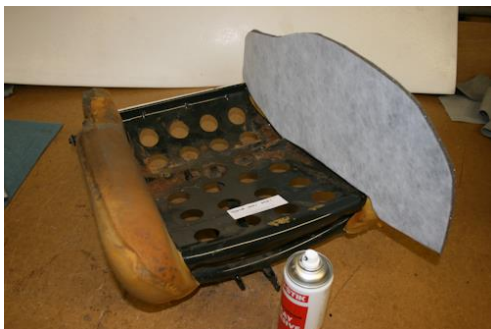
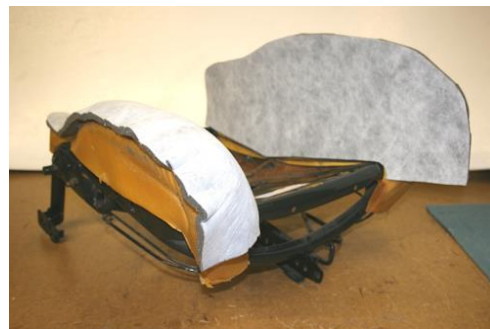
The bolsters on the base usually need repairing as the metal support bar damages the bolster itself. Once repaired apply the foam wrap to these bolsters as described above.
