1902-051E

EMI TEST REPORT 1902-051E REV. B

TEST STANDARDS: MIL-STD-188-125-1, MIL-STD-461G & MIL-STD-464C

EMP SHIELD, LLC
2010 6TH ST
BURLINGTON, KS 66839

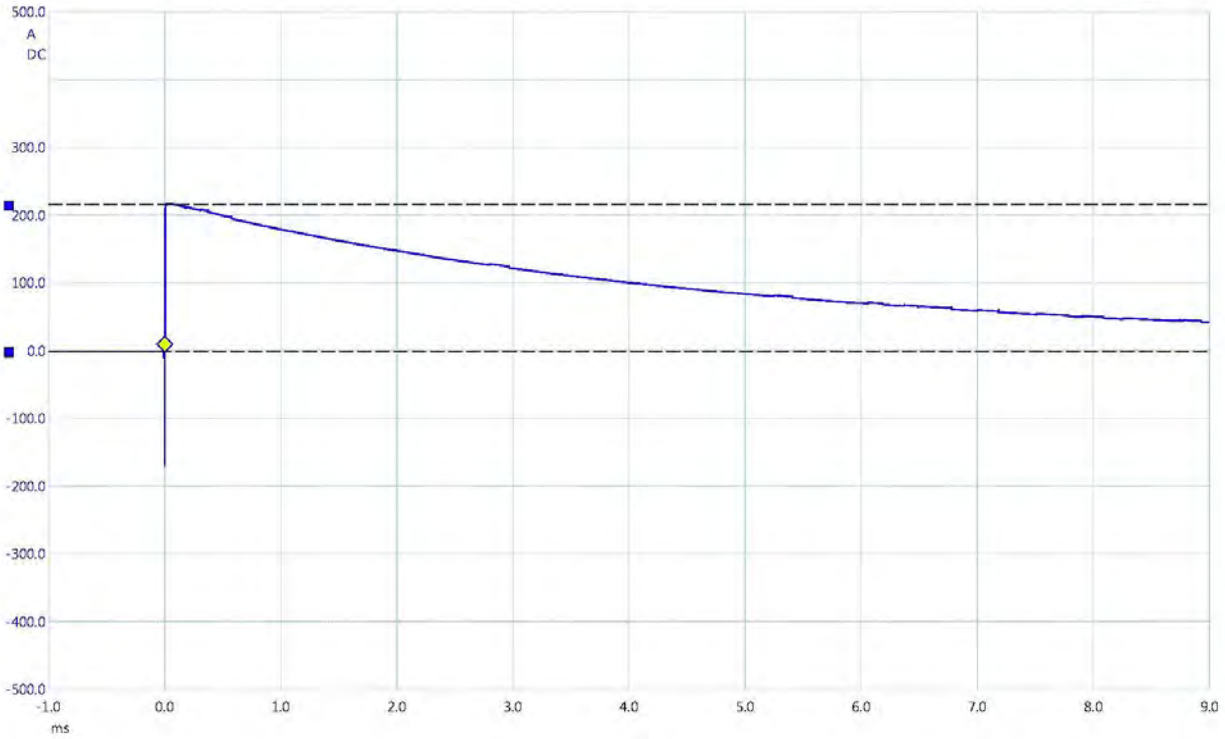
L-G 80% Plot

1 2 Δ
Channel A 0.0 A 215.6 A 215.6 A

DC Breakdown Voltage				
Test Level (A)	Line Configuration	L-G Pre-Test (VDC)	Test Current (A)	L-G Post-Test (VDC)
50	L-G	243	49.91	244
100	L-G	244	106.4	244
150	L-G	244	162.9	243
200	L-G	243	215.6	243
250	L-G	243	264.6	243

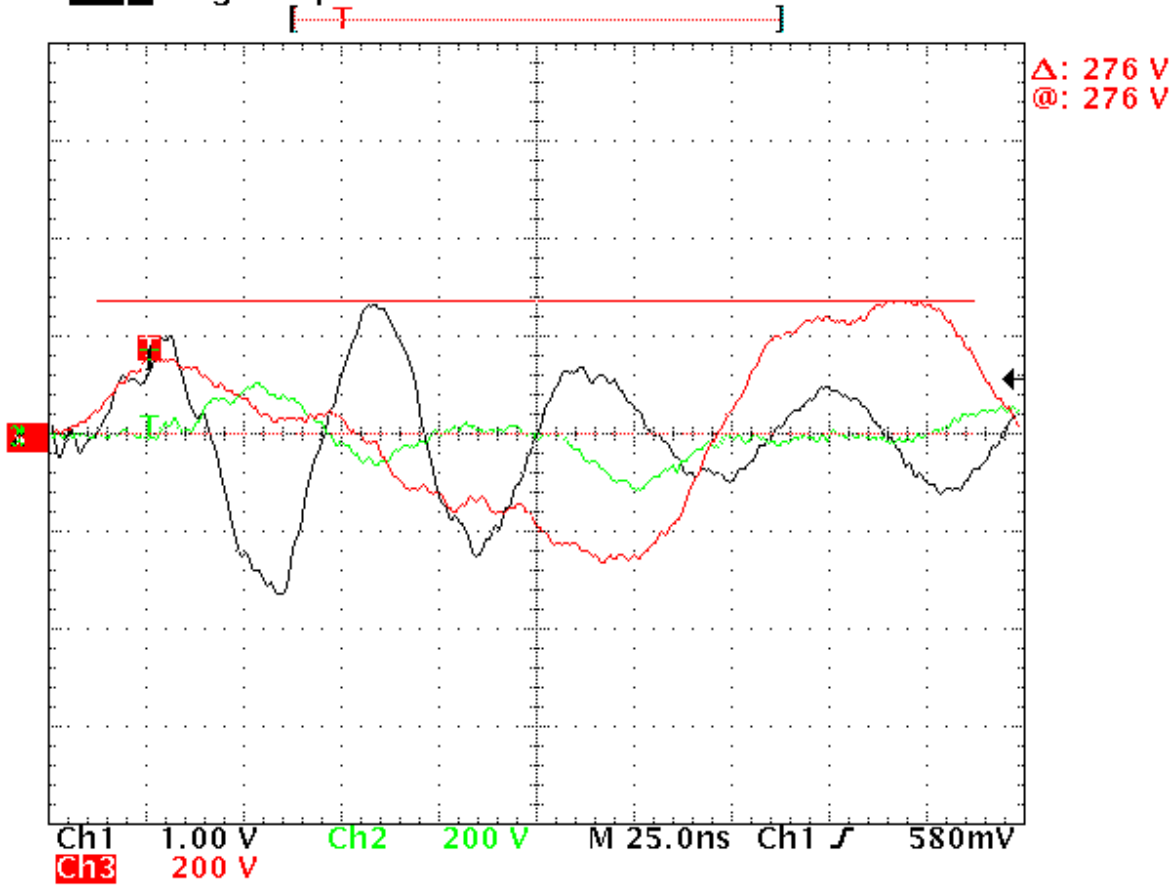
Measurement at End Of 250 Feet Of Romex Plot

Tek Stop: Single Seq 1.00GS/s
