SERVICE BULLETIN

May 27, 1999

SAFETY RECALL CODE 0812 - 1999 X1 REAR BRAKE LINE AND POSITIVE BATTERY CABLE

B-020

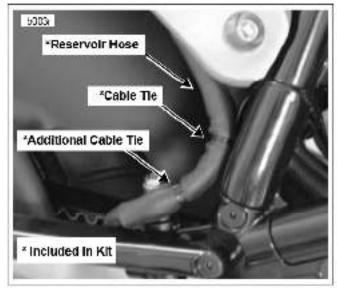
Figure 1. Rear Brake Line - Right Side

- See Figure 1. Cut cable tie holding rear brake reservoir hose to rear brake line above rear master cylinder on right side of motorcycle.
- See Figure 4. Disconnect two wires from rear brake light switch.
- Remove rear master cylinder banjo bolt and two banjo washers. Discard banjo washers.
- Remove rear brake caliper banjo bolt and two banjo washers. Discard banjo washers.
- Carefully push up on bottom of oil tank to allow rear brake line tangs to be freed from stude on the bottom of the oil tank.
- See Figure 2. Cut cable tie on wiring harness and cable tie on vent tube on left side of bike.
- Slide rear brake line into area where battery usually sits and then off of bike through left side of frame.
- See Figure 4. Remove rear brake light switch from original brake line.

- See Figure 1. Inspect rear brake reservoir hose on right side of motorcycle for damage. Replace as required by Installing new replacement hose provided in kit. If hose is undamaged, proceed to step 23.

- See Figure 1. Install two cable ties (thick) to reservoir
 hose and rear brake line in two locations as shown in figure. Use care to avoid pinching hose.

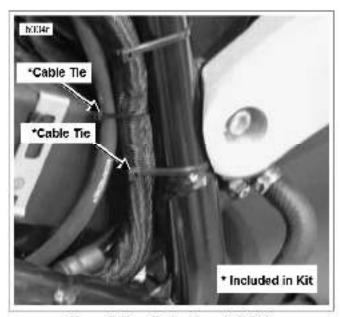
Figure 2. Rear Brake Line - Left Side

- See Figure 6. Inspect positive battery cable and vent lines (transmission vent and cam cover vent) for damage. Replace as required.
- 26. See Figure 2. Cable tie vent hose and wire harness to frame on left side of motorcycle. NOTE: Use thick cable tie on wire harness and thin cable tie on vent hose. Use care to avoid pinching hose.

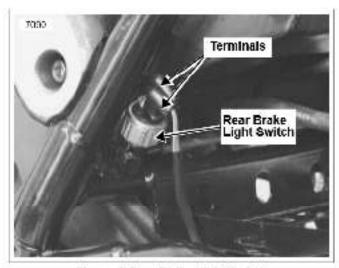
Figure 4. Rear Brake Light Switch

- Attach oxygen sensor connector to battery strap with new thin cable tie on left hand side of motorcycle.
- See Figure 4. Connect rear brake light switch wires to rear brake light switch.

- Cost threads of rear brake lamp switch with LOCTITE PIPE SEALANT WITH TEFLON and install to new brake line. Tighten switch to 84-96 in-lbs (9.5-10.8 Nm). Tighten as required to orient terminals perpendicular to brake line.

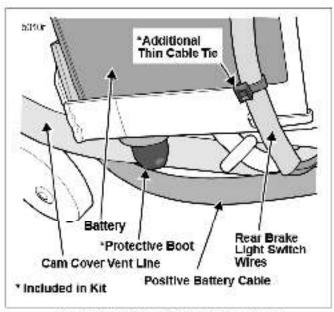
Figure 6. Positive Battery Cable Routing

- See Figure 6. Install protective boot, included in kit, over stud and nut on bottom of battery tray on right hand side of motorcycle.
- Install bettery with strep and nut. Tighten nut to 40 in-lbs. (4.5 Nm)

- 36. See Figure 6. Attach rear brake light switch wires to bettery strap with new thin cable tie on right hand side of motorcycle. NOTE: HDI (all except Canada, Japan and New Zealand) models do not require this cable tie as the brake light switch wire routing is different.

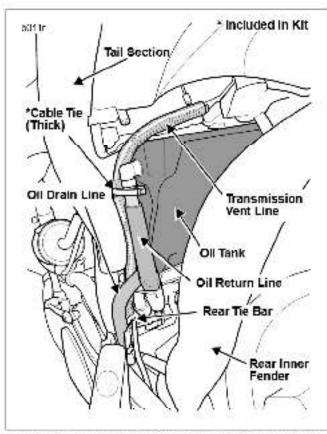
Figure 7. Transmission Vent Line Routing (Rear View)

- 28. See Figure 7. Renoute transmission vent line to left side of motorcycle, under battery tray, over rear tie bar, above rear brake line, between oil drain line and tail section, above oil return fitting (on oil tank), and over the top of the oil tank. Use care to avoid kinking hose after tie bar.

- See Figure 7. Attach transmission vent line to oil return line as shown with new (thick) cable tie.
- See Figure 8. Reroute positive battery cable from starter solenoid post under rear brake light switch wires and under cam cover vent line then behind and over battery to positive terminal.
