SERVICE BULLETIN

B-021A

SAFETY RECALL CODE 0814 - FUEL TANK RETENTION SYSTEM

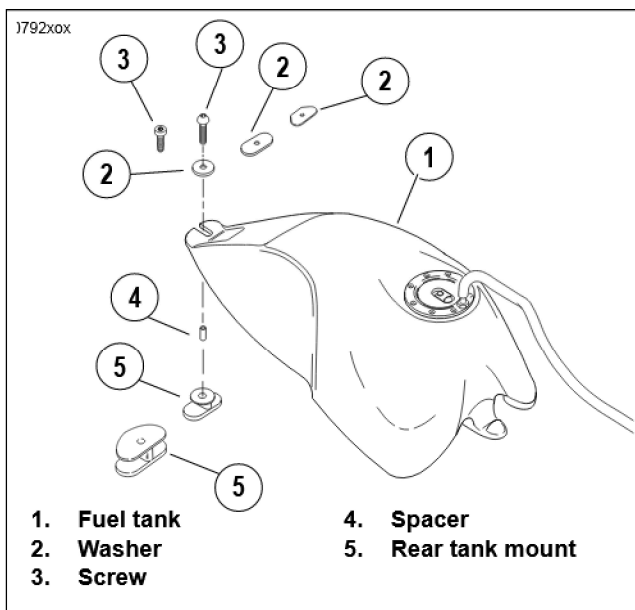
Figure 1. Original Fuel Tank Mounting Arrangement

See Figure 1. Vehicles being serviced will have varying combinations of tank mounting parts. Once removed, Items 2, 3, 4 and 5 are to be discarded.

- See Figure 1. Remove and discard fuel tank mounting screw (3) and washer (2).
- While securely holding fuel tank, carefully slide rear tank mount (5), with spacer (4), to the rear of the vehicle and away from the tank. Discard mount and spacer.

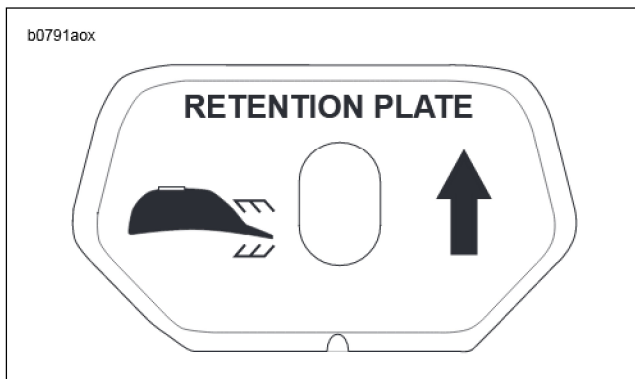
Figure 2. Retention Plate with Decal

See Figure 2. The retention plates have decals on them showing the position and direction that they are to be mounted. Also, they have a V-shaped notch on the shorter straight side which must face to the rear of the vehicle.

It is important that the prongs on the retention plate face toward the rear of the vehicle and be in direct contact with the fuel tank. All vehicles require two retention plates, one above and one below the fuel tank.

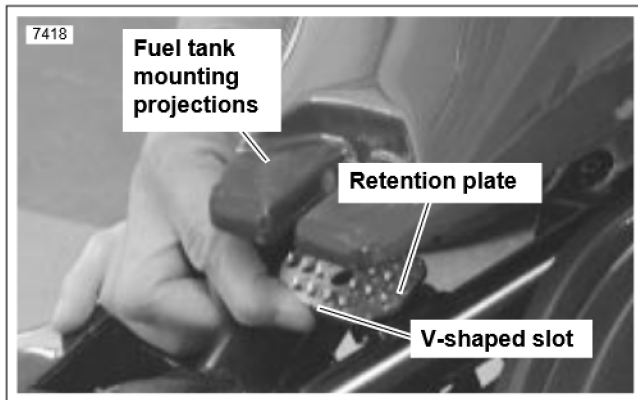
Figure 3. Bottom Plate

- S1/S1W/S3/S3T Models:** See Figure 3. Carefully raise the back of the fuel tank and place a mounting plate and a retention plate in position on the frame. Make sure shorter straight side of both retention plate and mounting plate face to rear of vehicle.
- M2/S2/S2T Models:** See Figure 3. Carefully raise the back of the fuel tank and place a retention plate in position on the frame. Make sure shorter straight side of retention plate faces to rear of vehicle.
- Carefully place the fuel tank onto the lower retention plate.

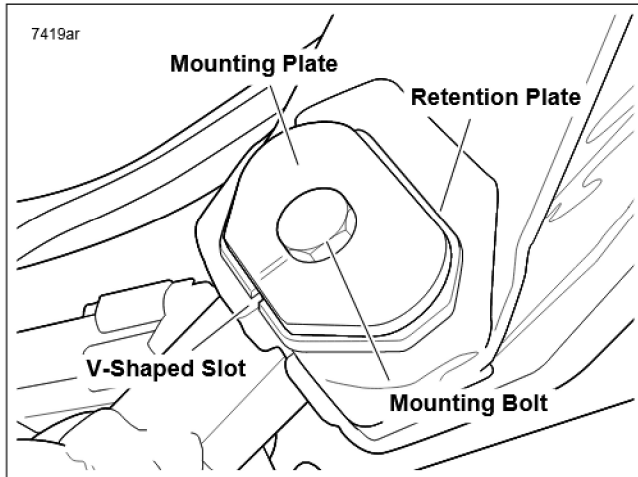
Figure 4. Final Assembly

- See Figures 4 and 5. Place the remaining retention plate and mounting plate in position on top of the fuel tank rear mounting projections. Make sure shorter straight side of both retention plate and mounting plate face to rear of vehicle.
- See Figure 5. Install new mounting bolt (4) and tighten to 18-23 ft-lbs. (24.4-31.2 Nm).
- Wait five minutes and tighten bolt again to 18-23 ft-lbs (24.4-31.2 Nm).
