# SERVICE BULLETIN BUG

B-019 May 17, 1999

### SAFETY RECALL CODE 0811 - S1 AND S1W NEGATIVE BATTERY CABLE

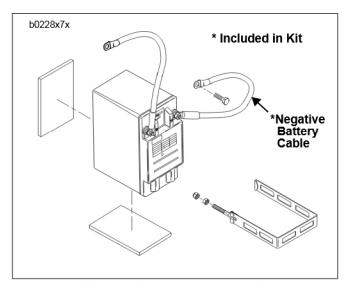
Figure 2. Negative Battery Cable

Buell Motorcycle Company has learned that certain 1996-1998 Buell motorcycles were built with a negative battery cable that could break. This condition could cause the engine to stall/quit when riding. Accordingly, Buell Motorcycle Company is conducting a voluntary recall campaign to formally recall all potentially affected motorcycles.

- Visually inspect the negative battery cable coming from the left (-) side of the battery. Inspect for the following:
  - HD Part Number 70461-67B and lot number printed on cable.
  - · Shiny heat shrink on both ends
  - Silver-colored soldered wires visible at the terminals

- See Figure 2. Disconnect negative (-) battery cable from battery terminal.
- Disconnect negative (-) battery cable from frame.
  Remove and discard original negative (-) battery cable.
- 12. Install **new** negative battery cable supplied with kit to frame with existing hardware. Tighten bolt to 10 ft-lbs (13.6 Nm). Use care when routing cable to avoid contact between cable and circuit breaker.
- Install **new** negative battery cable supplied with kit to negative (-) battery terminal with existing hardware Tighten battery cable bolt to 30-40 **in-lbs** (40.7-54.2 Nm).
- Install tail section with two TORX bolts and nylon washers. Tighten TORX bolts to 72-96 in-lbs (8.1-10.8 Nm).
- 15. See Figure 1. Install **new** hose clamp to fuel hose and fuel supply valve.
- Install vent hose to fuel tank vent with cable tie supplied in kit
- 17. Install fuel tank.
