April 8, 2009

PC45 Air Pump Flow Reduction

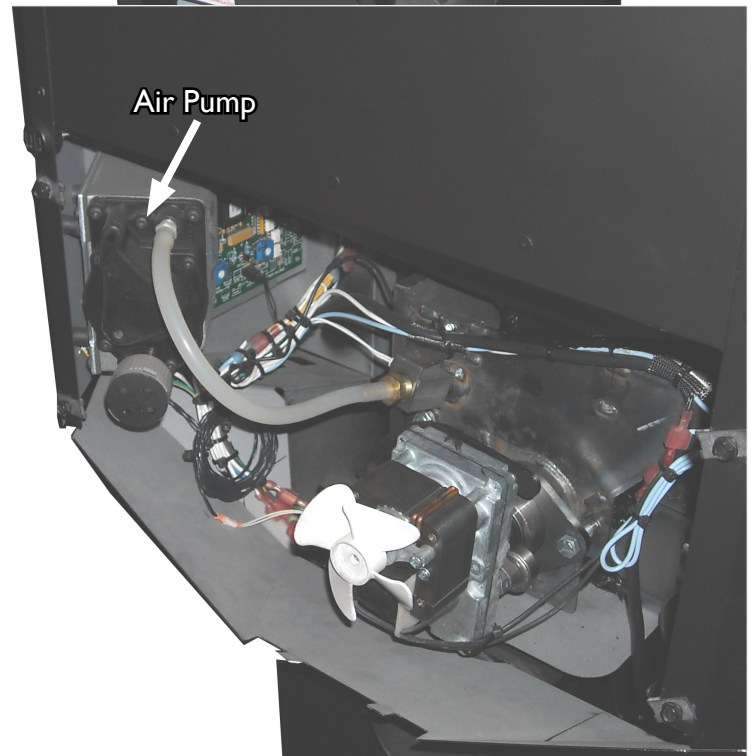
Identification: As of 1/26/09, pumps being sent out as replacements are updated. The updated pumps have an X on the label.

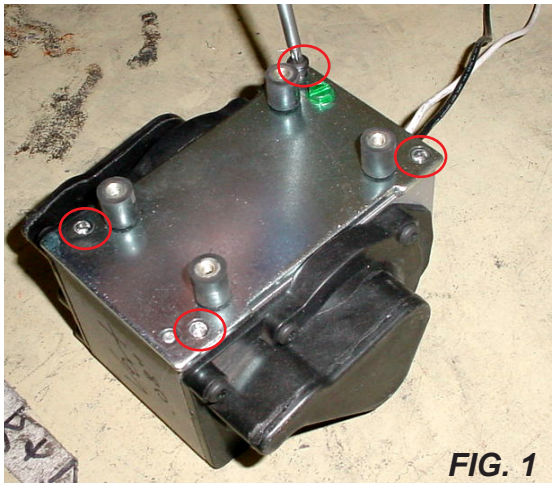
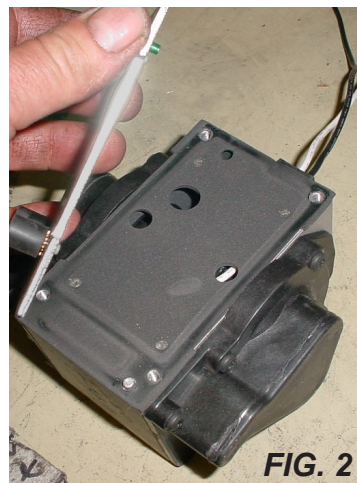
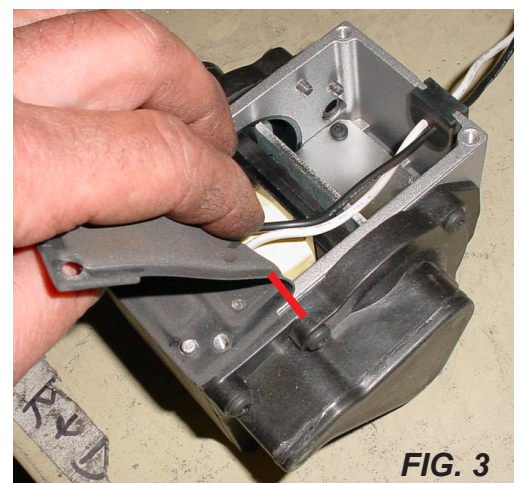
If the air pump sounds like it is working, but there is no ignition, the igniter may have burned out due to low air pump flow. The likely cause is from parts rubbing together inside the pump. This condition can be corrected using a teflon spacer between these rubbing parts. Remove the rear covers and disconnect the wiring and the silicone tubing from the air pump. Using the 3/32" Hex key wrench, remove the mounting screws that hold the pump to the stove. Sometimes these screws are so tight that you must damage the rubber mounts to remove. Replace with the mounts supplied, as needed.

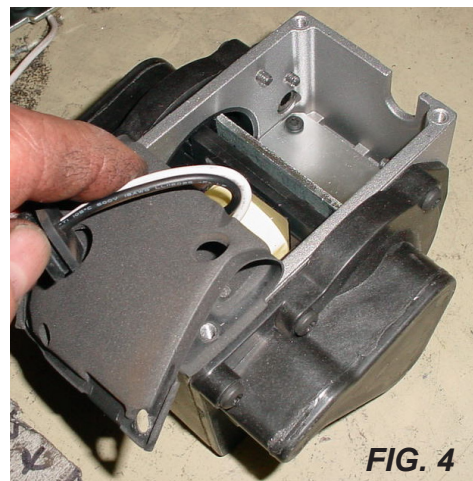
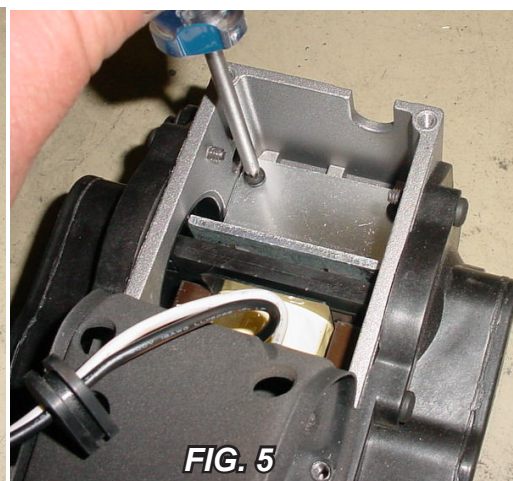
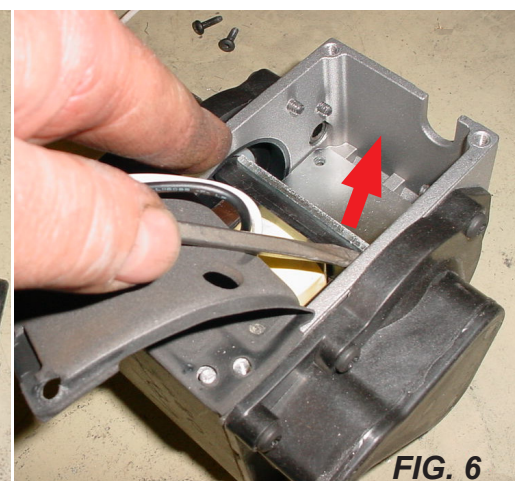
With the pump out of the stove, apply power to it and check the air flow by putting your finger over the outlet. (make a mental note of the volume of air movement). Remove the four # 20 Torx screws from the corners of the bottom plate. Take notice that the position of the green ground screw is on the same end that the wires come out of the pump housing (FIG 1). Carefully remove the bottom cover from the air pump and lay it aside (FIG 2). Gently pull the rubber gasket back starting at the wire end of the pump and stop at the screw shown above (FIG 3). Remove the wire and strain relief from the housing and lay the wires back over the rubber gasket (FIG 4). Remove the two #15 Torx screws that hold the steel pole piece to the pump body (FIG 5). Gently pry the steel pole piece from the housing (FIG 6). The plastic armature it is against contains two magnets which are holding it in. Once the magnets release, the steel piece will come out more freely.

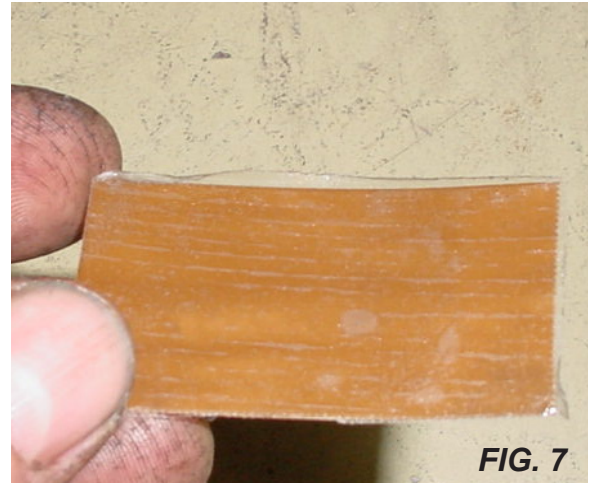
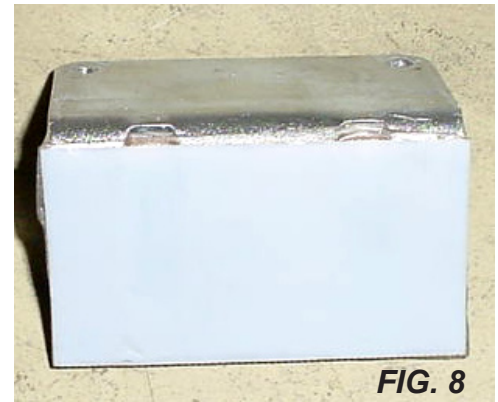
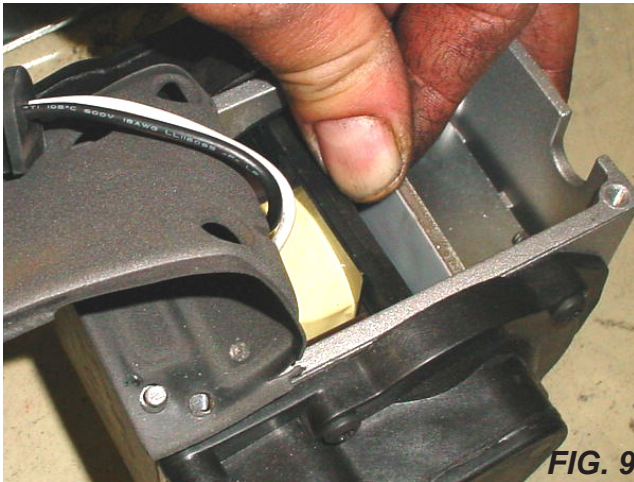
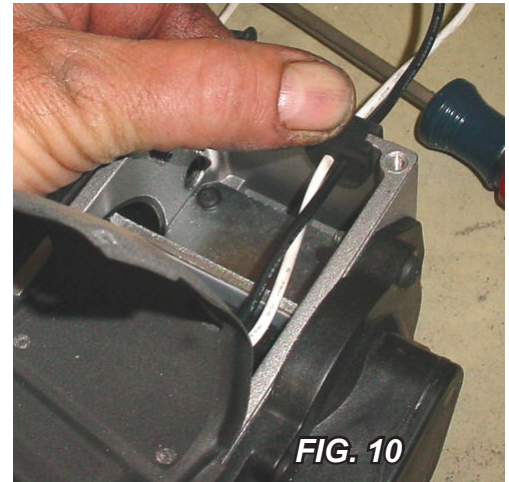
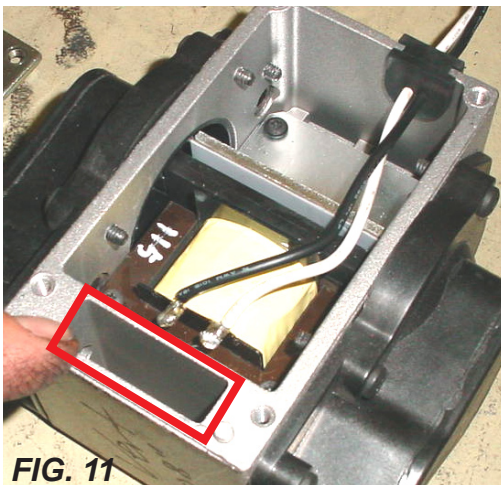
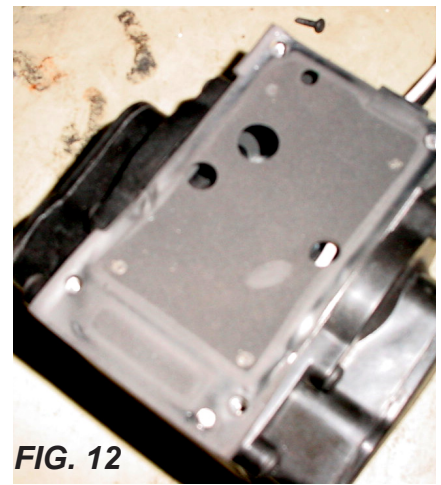
Using a clean cloth, wipe off the pole piece and the plastic magnetic armature of the air pump. Remove the paper backing from the adhesive on the Teflon sheet (FIG 7), and apply it to the slotted side of the steel pole piece (FIG 8), keeping it evenly spaced between the edges, while covering the slotted surface. Install the pole piece back into the pump housing with the Teflon facing the plastic magnetic armature. (FIG 9) It is easier to start the screws while the pole piece is held in an angled position and then allow it to sit down onto the pump housing. Install the wire and strain relief back into the notch in the air pump body (FIG 10). If the gasket was completely removed from the housing, be sure there is no damage to the gasket in the area shown (FIG 11). This area is the outlet passage to both pump diaphragms. Leakage here will reduce pump output. Lay the gasket back into place on the bottom and install the bottom cover. Apply power to the pump and check the outlet air flow in the same manner as when it was first removed. You should be able to feel a significant increase in the flow. Install the pump into the stove, and re-connect the hose and wiring. Ty-wrap the wiring to the original configuration and re-check the operation of the pump.
