## Case Study

**application** Reinforced Retaining Wall  
**location** Eagan, MN  
**product** Miragrid® 7XT

**job owner** Dino Xykis  
**engineer** Civil Solutions Group  
**contractor** Structures Hardscapes Specialists

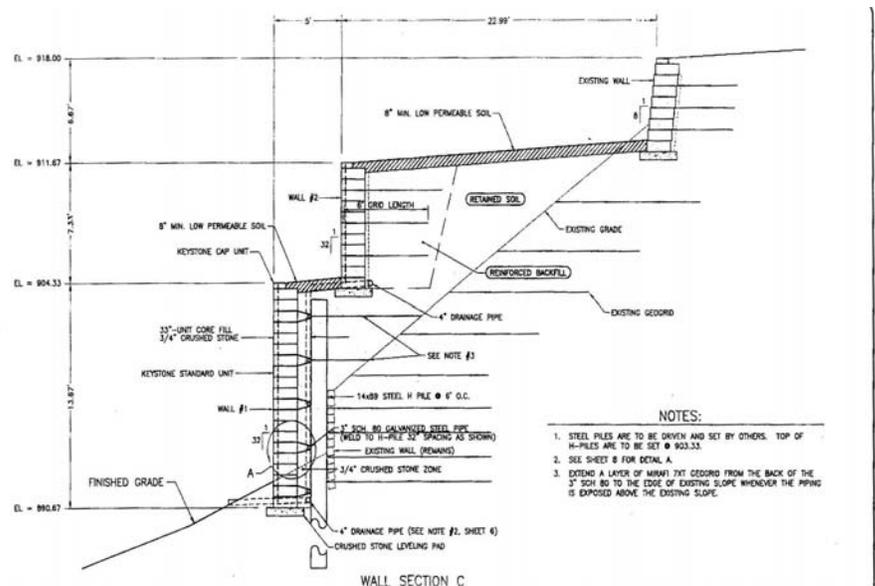
Five layers of Mirafi® BXG geogrid were installed to create a stabilized geogrid reinforced platform.

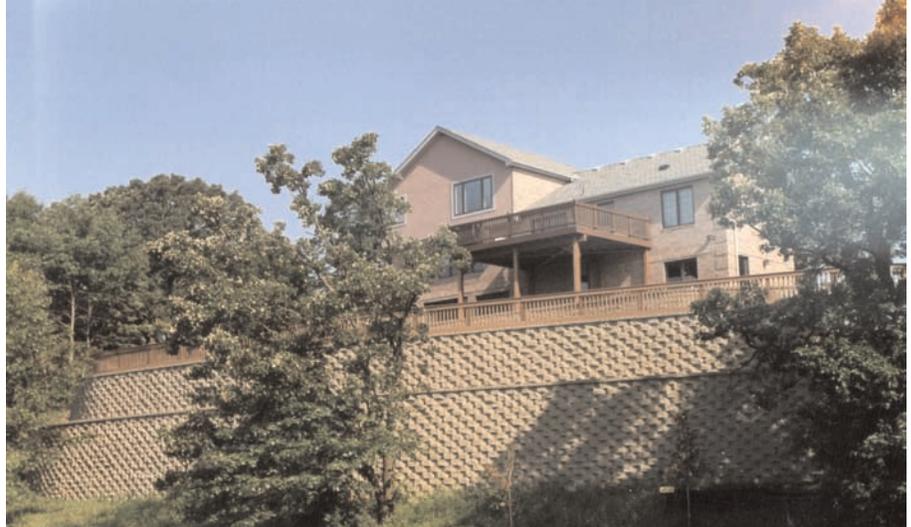
Miragrid® 7XT was used to reinforce this Keystone® retaining wall.
