Case Study

application | **Railway Reinforcement**
location | **Edmonton, Alberta**
product | **Mirafi® RS580i and H2Ri**

job owner | **Canadian Pacific (CP)**
engineer | **Clifton Associates**
date of installation | **2016**

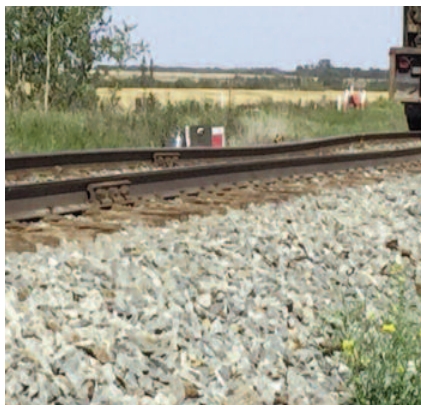
Unrepared track section with cross level variation due to settlement issues.

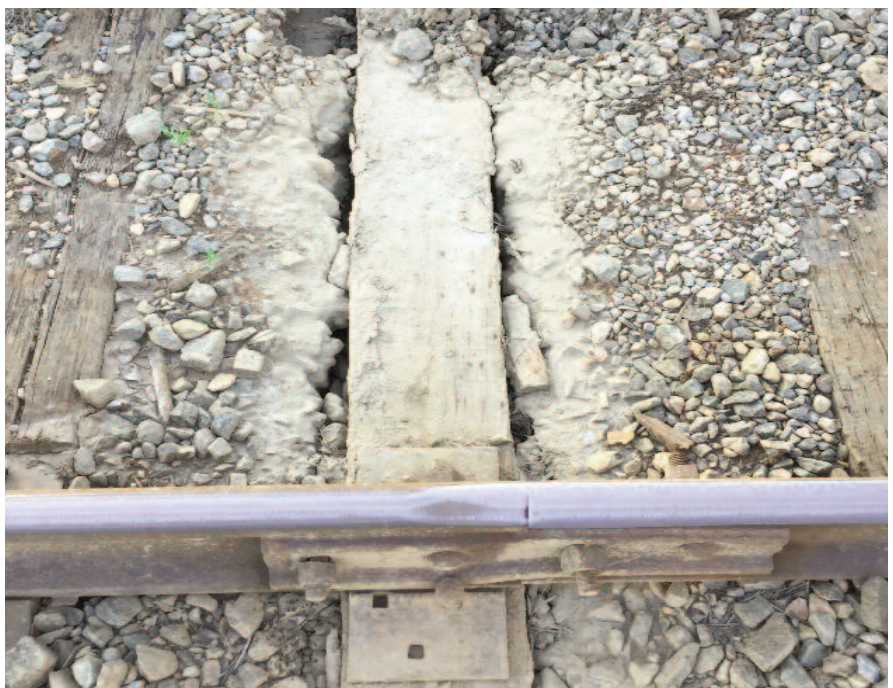
Evidence of mud pumping and ballast contamination prior to repair.

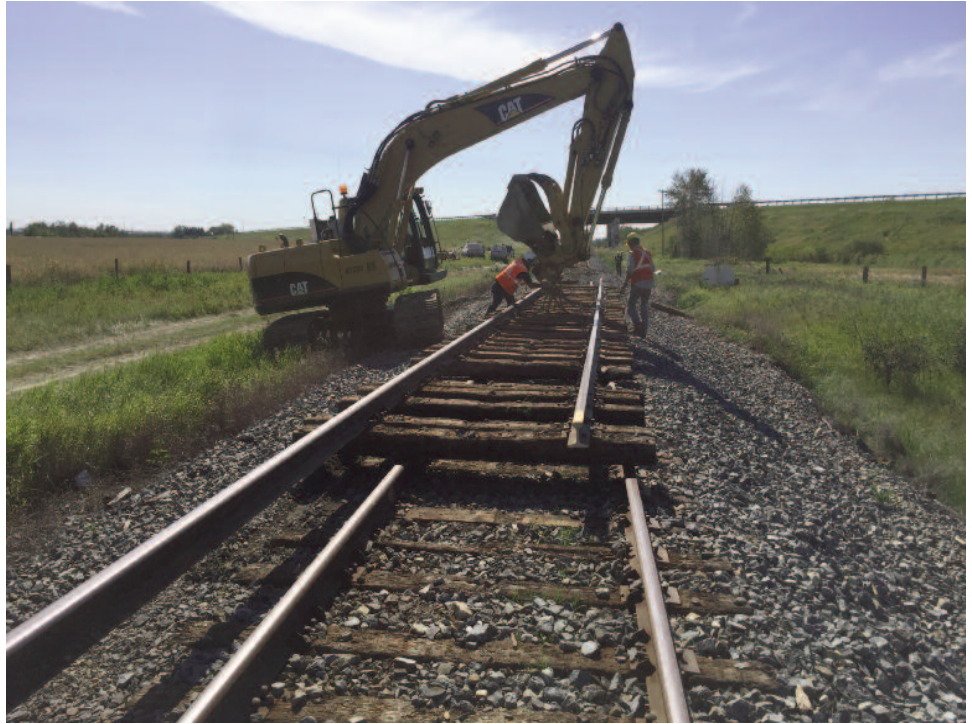
Track panel is removed.

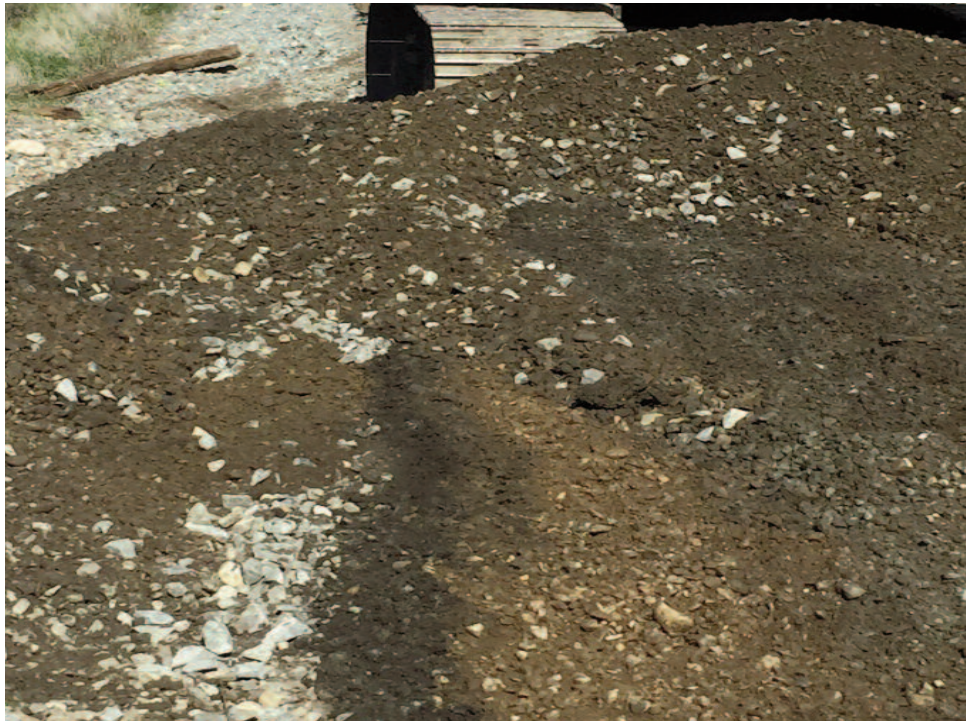
Contaminated rail ballast: The dark material is topsoil that has migrated into ballast. The lighter area is sub-ballast, which has migrated into ballast.

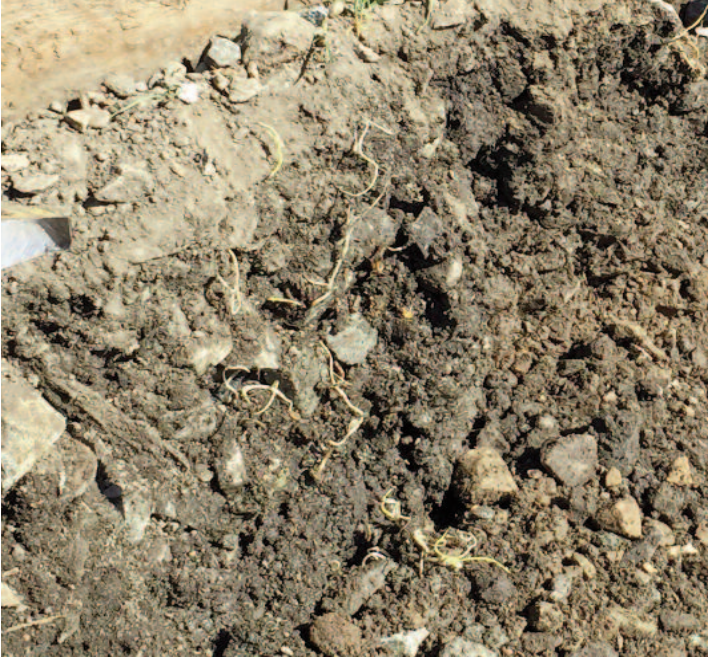
Ballast contamination and moisture enough to support plants and root systems.

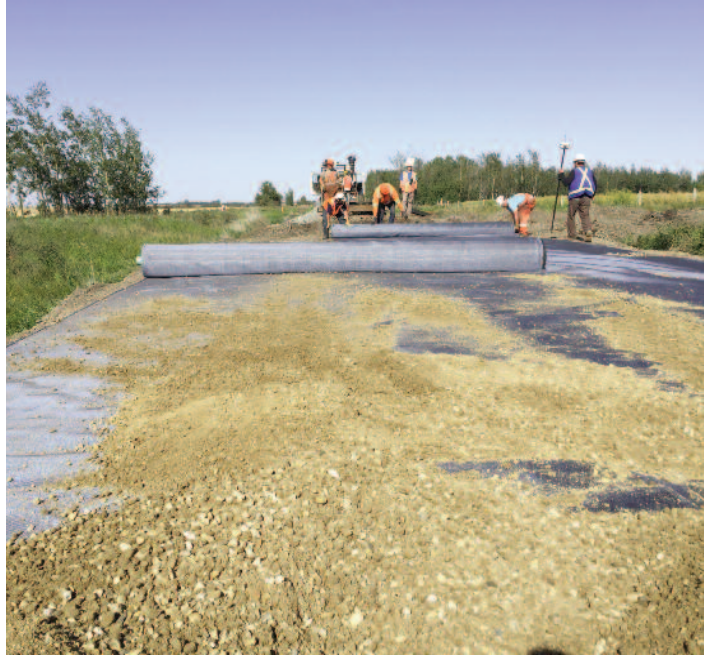
Mirafi® H2Ri installed at the subgrade/subballast interface.

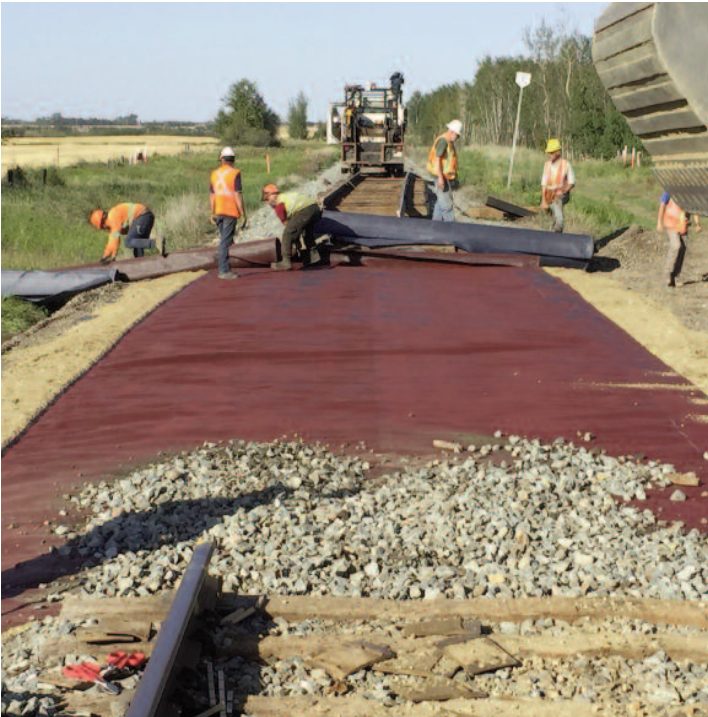
Mirafi® RS580i installed at the ballast/sub-ballast interface.

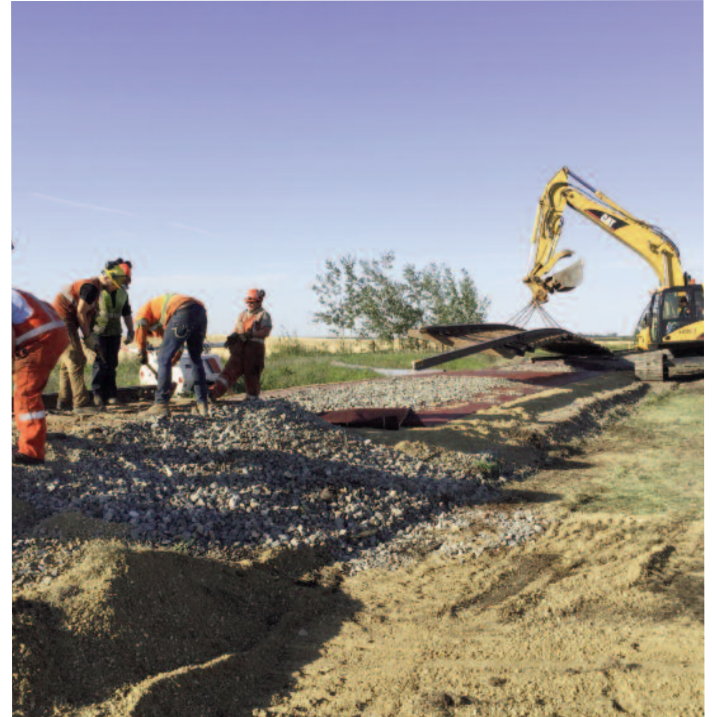
Reconnecting the track panel.

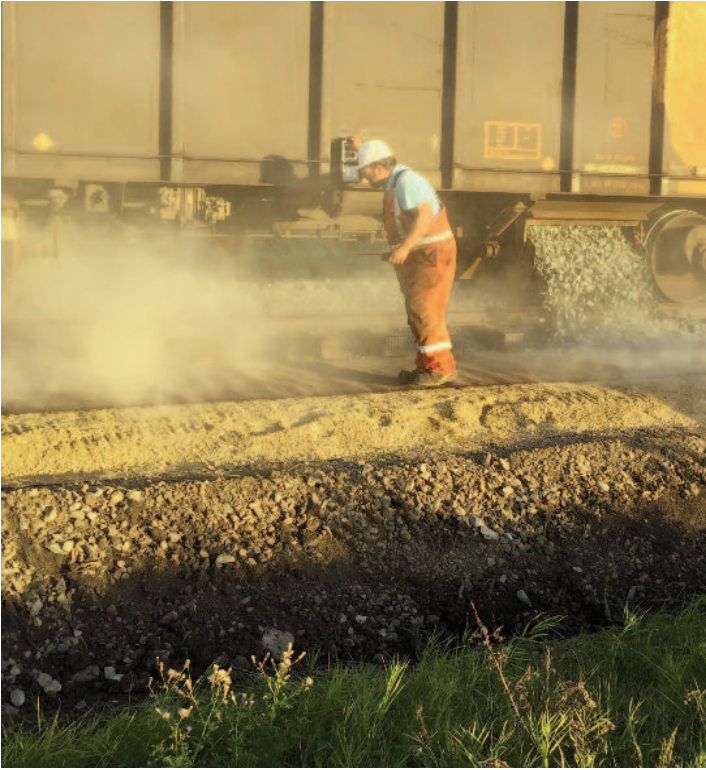
Placing new ballast.

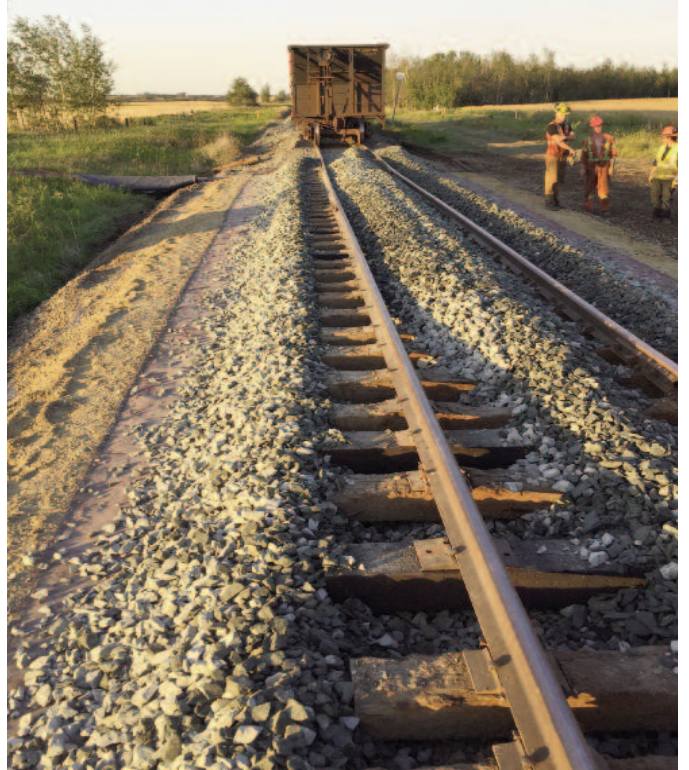
Placing new ballast.

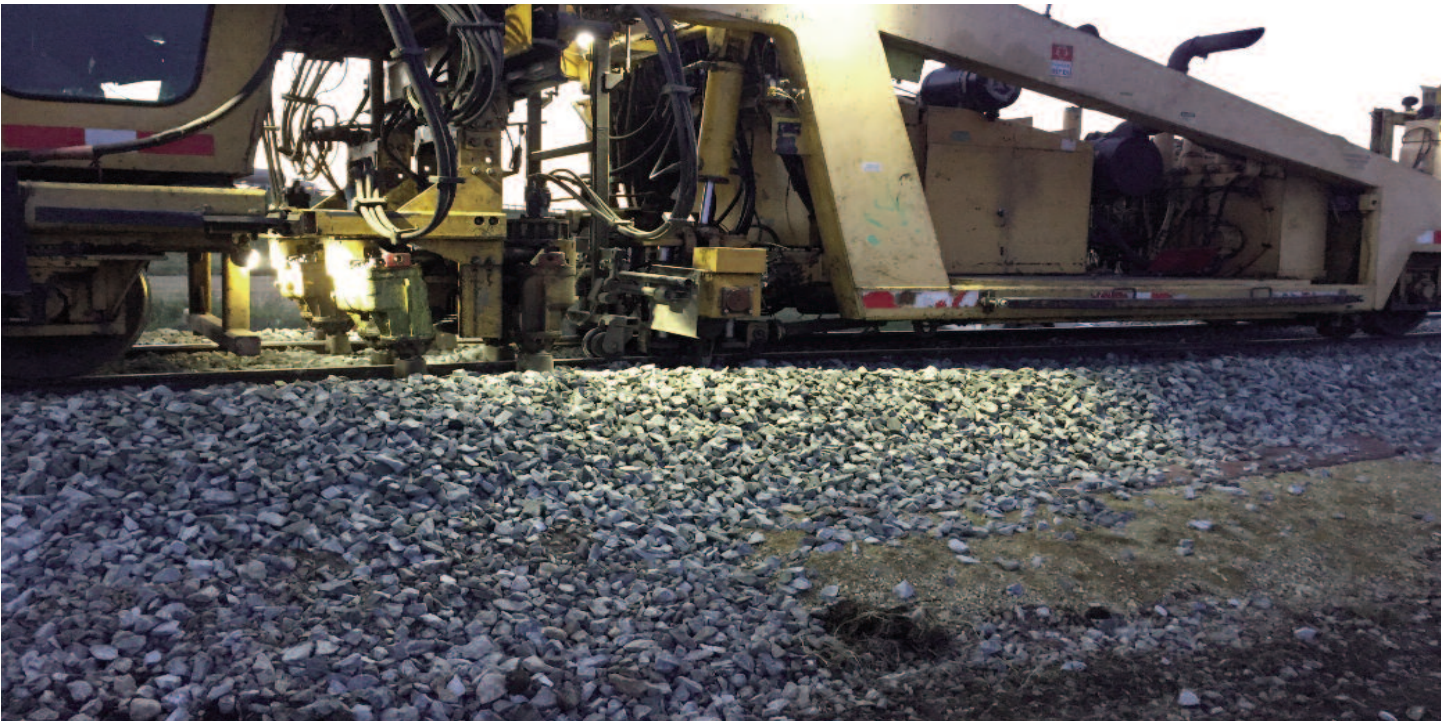
Lifting rail and compaction of ballast under rail ties.

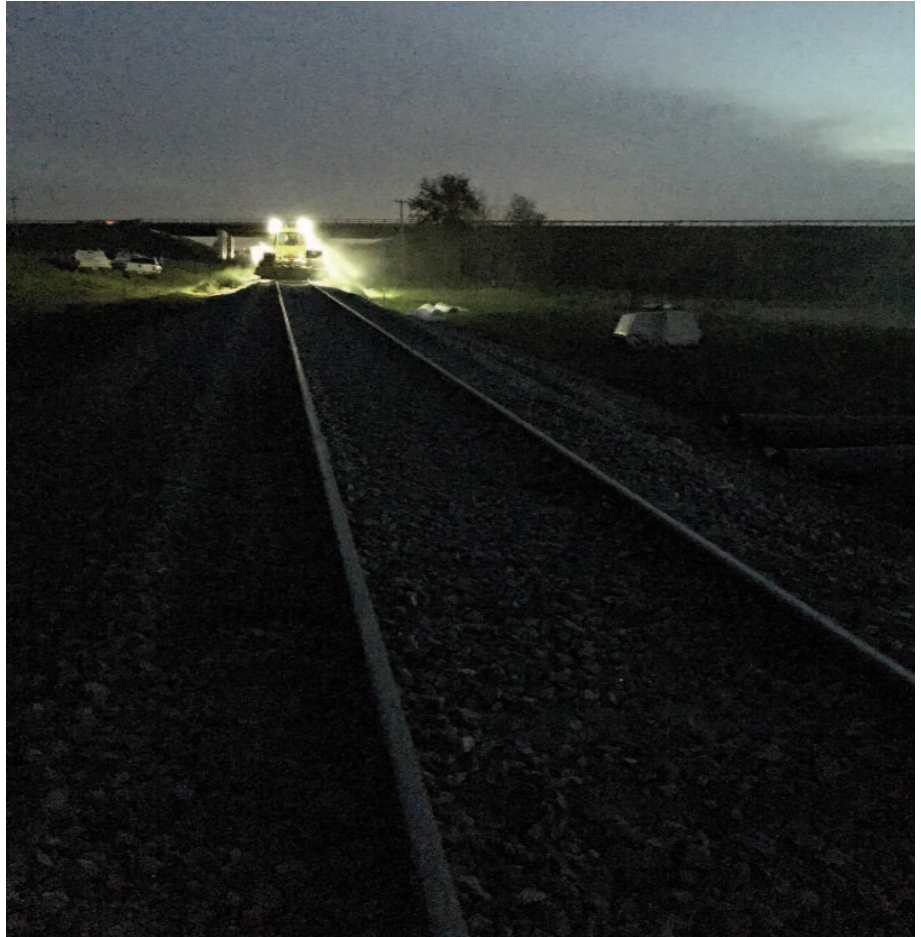
Installation complete.
