Platen Refurbishment & Teflon Coating

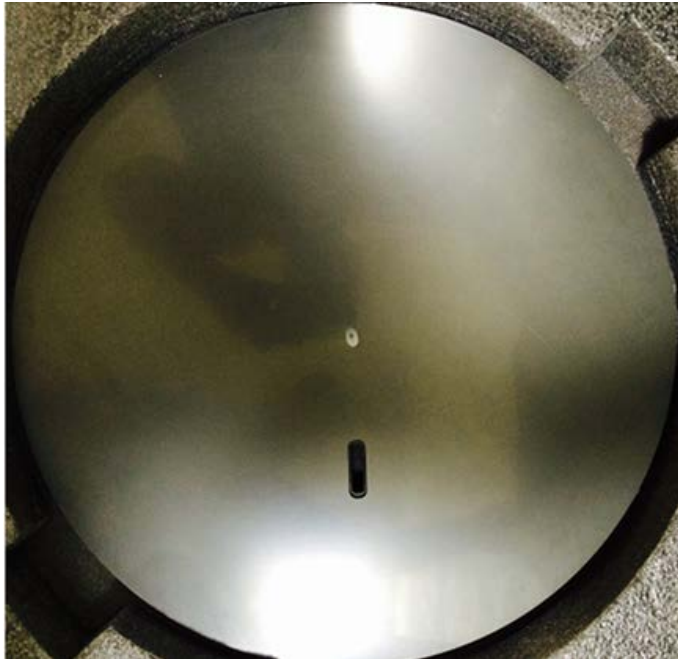
The Mirra Platen assembly is subjected to chemical and process waste material and will wear over time. During maintenance activity and tool failures the platen can become scratched and form imperfections on its surface. These imperfections, over time, can effect the polishing process.

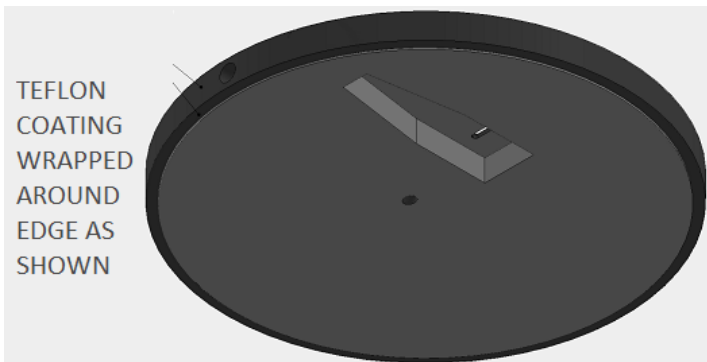
The customer provides core platen. Entrepix will have the part stripped of hardware and remove any OEM grey paint. The surface of the platen will be lapped to a Super Finish of .0005 micro inches Ra (roughness) of All surfaces will be masked then coated with chemical resistive primer and super slick black Teflon.
