9 Flush Valve Troubleshooting Tips

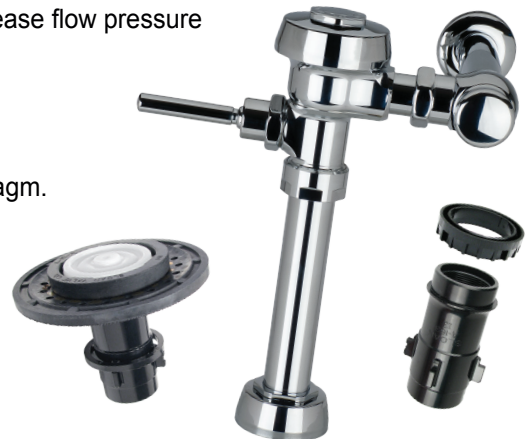
Other causes of no evacuation:

Cause: Low pressure (>25 psi / 1.7 bar)

Solution: Address plumbing system deficiencies or adjust control stop to increase flow pressure

Cause: Low consumption or urinal diaphragm installed in older closet.

Solution: Install correct GPF diaphragm

Cause: Cover not properly tightened for unit using dual filtered bypass diaphragm.

Solution: Tighten cover

Cause: Incorrect piston installed (in piston type flushometers.)

Solution: Match piston GPF to fixture GPF

Cause: Piston lip seal degraded (in piston type flushometers)

Solution: Replace piston assembly

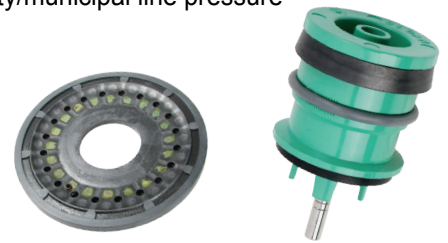
There are a couple of different reasons the unit could continuously run with no shut-off. First, understand that the potential causes and solutions are dependent on whether the unit is diaphragm or piston type.

For Diaphragm Type Flushometers:

For Piston Type Flushometers:

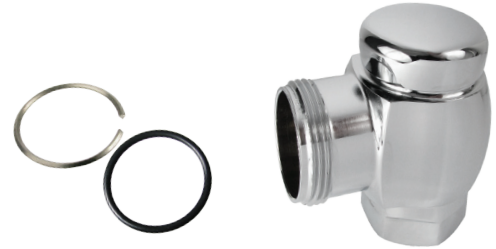
Piston type flushometers: If you hear a 'thump' or 'bang' upon valve shut off then there are three possible causes and solutions:

Cause: High flow pressure

Solution: Adjust control stop to decrease flow pressure. Decrease plumbing system flow pressure.

Cause: Piston lip seal degraded

Solution: Replace piston assembly

Cause: Loose plumbing

Solution: Secure piping properly and/or check hammer arrestors
