## 335D/X5D ASV Elbow Instructions

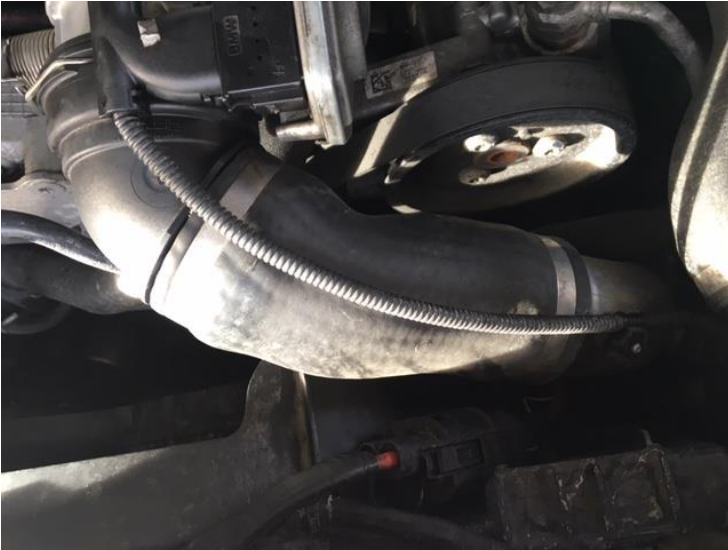
- 1) Remove engine cover over top of ASV. (On X5 models move the aluminum crossbar out of the way by removing 4 bolts, unclipping cable and sliding away from ASV area.)

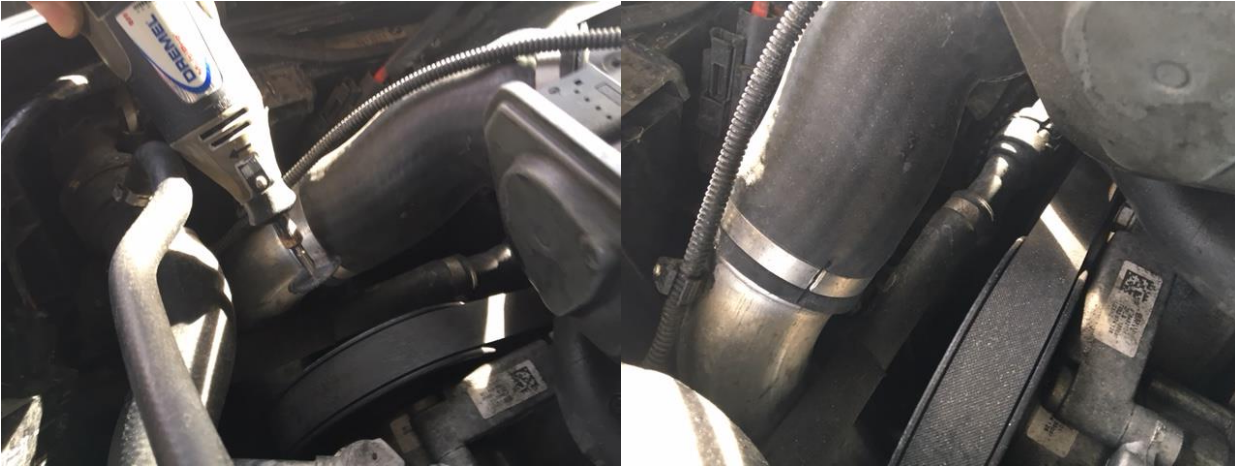
- 2) Using Dremel or cutoff wheel, carefully cut factory clamp that holds boot cold side charge pipe

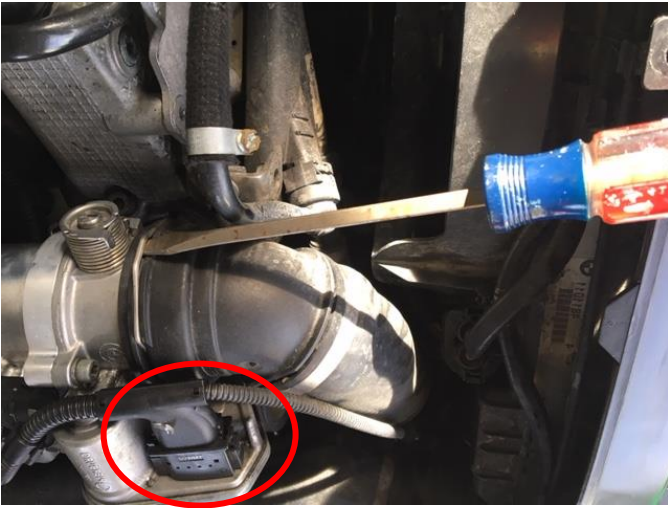
- 3) Unclip ASV electrical connector (circled). Pull quick-release clip outwards from hose and slide factory connector off of ASV. Push clip back in to pull off completely. Remove elbow from cold-side pipe as well.

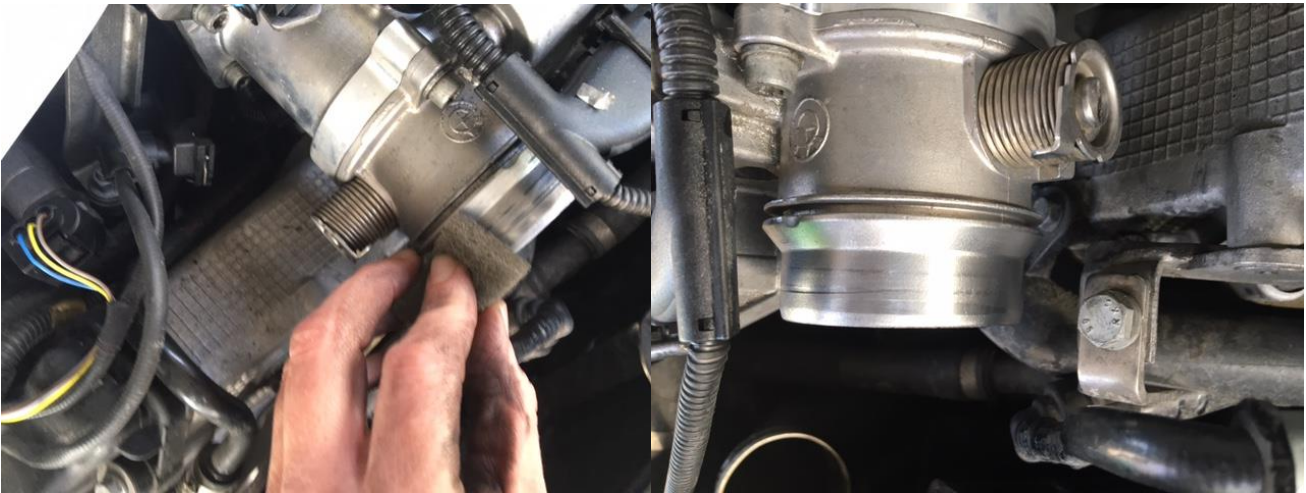
- 4) Using brake-clean, carb cleaner or similar, clean off any oil from cold-side pipe end and ASV end.
- 5) Use included scotchbrite pad to prep ASV end for installation. After surface is clean, wipe off any remaining residue with cleaner.

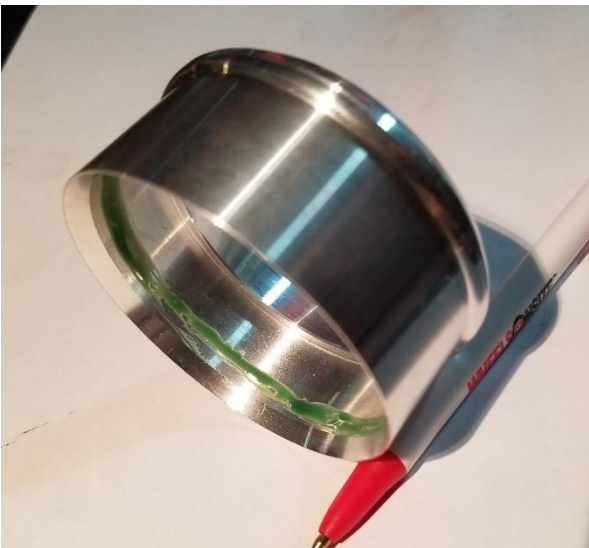
- 6) Apply Loctite to leading edge of ASV fitting completely around as pictured (the tube may require some persuasion to get Loctite out but it contains enough for the application).

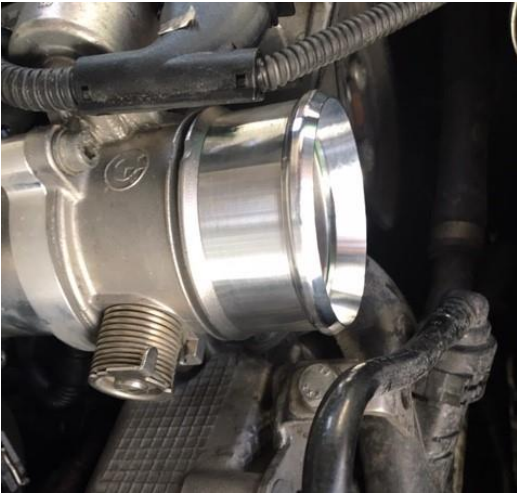
- 7) Slide ASV fitting onto ASV while twisting, this will insure good coverage/bonding. Be careful to keep the fitting straight. Slide fitting on until the angled section fully seats as shown.

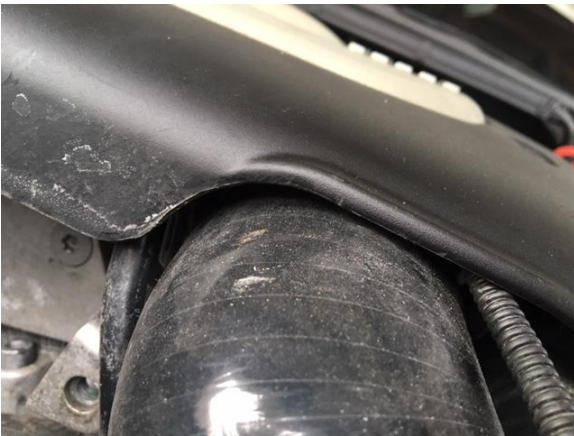
- 11) Push ASV elbow so that it is fully square on the fitting and the fitting is no longer visible. As clamp is tightened make sure that there is not any interference with the clamp body and surrounding areas. Do the same for the cold-side end.

- 12) Replace engine cover (and brace on X5 models) and make sure there is no contact between the engine cover and the silicone elbow. If there is contact plastic may need to slight trimming/sanding.
