Journal of Architectural Conservation

Windowcraft - Part One

SONJA ALLBÄCK AND BERTIL FREDLUND

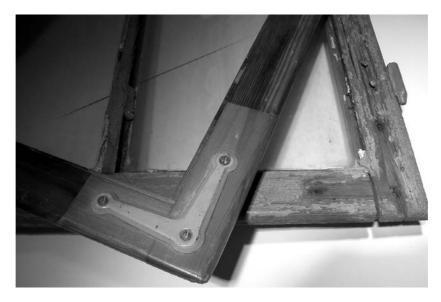
Figure 1 Windows from 1880, showing small-scale repairs.

We started our training school in Sweden in 1985. Since the Windowcraft artisan is a carpenter, glazier, painter, blacksmith, and bricklayer, all rolled into one, he or she will thus be an expert on the interactions between the various materials of a window – wood, glass, paint, putty, fittings, and plaster – and will assume responsibility for the end result. This new organizational form removes earlier technical and financial limitations on the renovation and maintenance of windows. The individual parts create the whole (Figure 1).

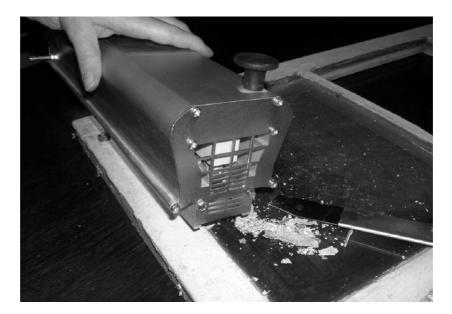
Figure 2 The putty lamp – an innovation by Sonja and Hans Allbäck.

Another difficult problem that we encountered was how to soften hard linseed-oil putty in order to remove glass. The putty needs to be heated to more than 100°C to soften (depending on the quality of the putty), but glass will crack long before that temperature. As we wanted to save the old blown glass in order to recycle all parts of the window, we carried out many trials before realizing that infrared radiation with a wavelength

below $2.6 \, \mu m$ passed through the glass. At a wavelength of $2.0 \, \mu m$, only $10{\text -}15$ per cent of the energy is absorbed by the glass, depending on its thickness and iron oxide content. We knew that if we could regulate power to the lamp at a level where the infrared radiation was very high ($\sim 2.0 \, \mu m$) and focus this energy, we might heat the surface without affecting the glass. This was the basis for the development of a new tool to soften hard putty without cracking the glass – the 'putty lamp' was born (Figure 2).² Infrared radiation passes through the glass, and softens the putty over and under it. Once the putty and pins are removed, the valuable, original glass can be lifted from the casement and recycled.

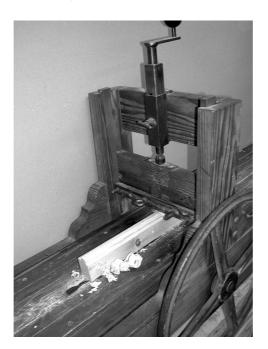
Figure 3 Modified copy of a planer from the early eighteenth century.

We also found many useful hand tools and quality materials, including a hand-driven profile planer from the early eighteenth century. Even today we use this 'machine' to complement the work of modern machinery in renewing windows from that period (Figure 3).

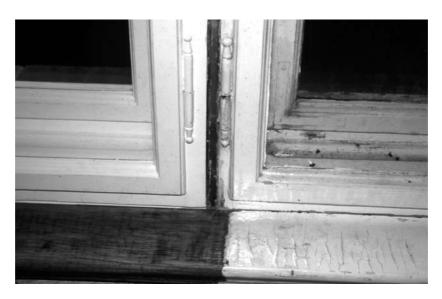
Figure 5 Window from 'Kastenfenster' in Leipzig dating from 1880.

The window from August Bebel-Strasse consisted of an inner and outer frame with three inward-opening inner casements and three-inward opening outer casements (Figure 5). The casements did not have cross bars, nor were there any fittings on the outside.

All the frames and casements were of very good quality and well worth preserving. The timber was healthy and there was no fungal damage. In spite of neglected maintenance, the windows were in good condition.

The casements and frames were dismantled and transported to our workshop in Ystad, Sweden. First, all the glass was removed with a putty lamp. Rusty fittings were removed for cleaning and all paint was

completely removed. The outer and inner frames were fitted together and minor damage caused during transportation was repaired. After impregnation with raw linseed oil, the windows were re-glazed using linseed-oil putty of our own manufacture. Our goal was to keep the milled glass in the outer casements. As an experiment, we used 3 mm Pilkington Kappa Energy glass (K-Glass) in one of three inner casements, in order to show the differences in colour and light. Nobody noticed the difference.
