TEST REPORT EVALUATION OF STRUCTURAL WALL BRACING CAPACITY (MAXIMUM HEIGHT 2.7M) USING WILMAPLEX HOOP IRON WITH TENSIONER

WILMAPLEX PTY LTD. 57 LATHAMS ROAD, CARRUM DOWNS, VIC 3201

MONASH UNIVERSITY DEPARTMENT OF CIVIL ENGINEERING WELLINGTON ROAD CLAYTON, VIC. 3800

14 NOVEMBER 2014

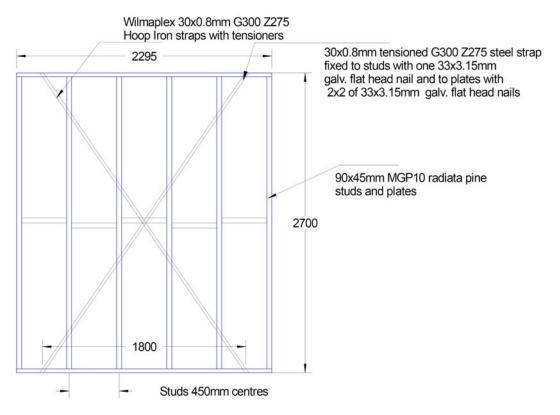
Figure 1 Wall frame specimen for 450mm stud spacing

Monash University was commissioned by Wilmaplex Pty. Ltd. to evaluate the structural bracing wall capacity (horizontal racking resistance) for of timber walls braced with 30x0.8mmWilmaplex Hoop Iron straps, with studs spaced at 450 and 600mm centre to centre, as shown in Figures 1 and 2. The wall frames comprised of 90x45mm MGP10 Radiata pine frames with the straps nailed to the frame using 33mmx3.15mm flat head galvanized nails. Three replicates of each stud spacing specimens were tested at the structures laboratory at Monash University, Clayton Campus.

Six MGP10 wall frames fitted with Wilmaplex Hoop iron straps and tensioner were delivered at Monash University for testing. All wall frames comprised of 90x45mm MGP radiata pine components with the first three having a 450mm stud spacing, and the second three with a 450mm stud spacing, see Figures 1 and 2. All wall frames were braced using Wilmaplex 30x0.8mm G300 Z275 steel straps, the braces were tensioned using Wilmaplex galvanized steel tensioners. The straps were connected to the top and bottom plates with 2x33mmx3.15mm nails, one on the top face and the second on the side, straps were connected to the studs with one similar nail where the strap intersected with the studs. The straps cover the following Wilmaplex codes as given in the wilmaplex 2013 catalogue, 3086M, 30815M, 30830M and 30850M. The tensioner is identified as TEN in the same catalogue.

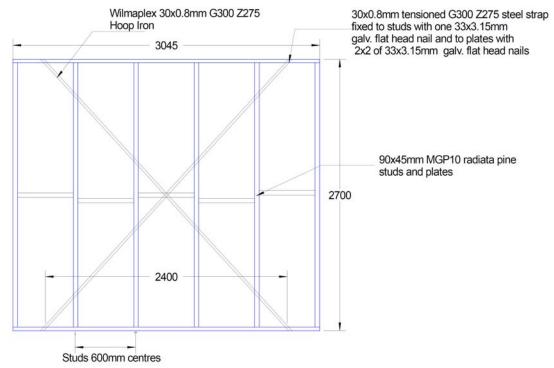
Figure 2 Racking specimen for 600mm stud spacing

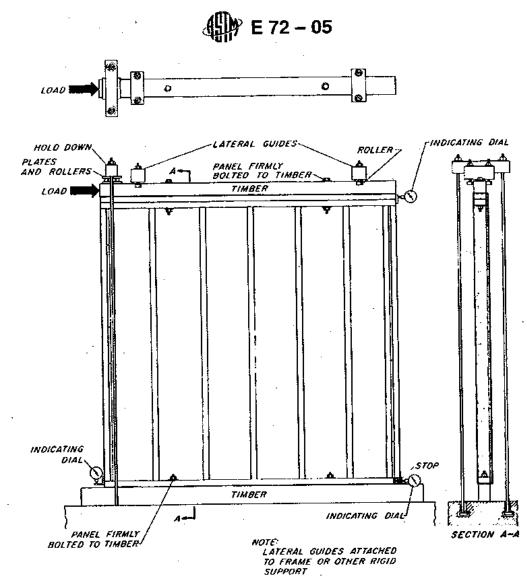
Figure 3 Racking load test setup taken from ASTM E72

The test set-up used was similar to the method used in ASTM E72, Section 14. The test set up is shown in Figure 4, which was extracted from ASTM E72. The load was applied using a hydraulic cylinder fitted with a 50kN calibrated load cell. Four transducers were fitted onto the assembly; the first two ($D_{1a\&b}$) were located on the lower left of the wall to measure the rotation; the rotation was measured averaging the two readings. The third transducer (D_2) was located on the lower right end to measure the slippage and the forth transducer (D_3) located on the upper right end measured the total of the first three transducers plus the deformation of the panel. The net horizontal deflection of the panel at any given load, in accordance with ASTM E72, was the reading of D_3 less the sum of the readings of the average of $D_{1a\&b}$ and D_2 . Test data from all transducers and load sensors were electronically recorded.

Net deflection= D_3 - (D_1+D_2)

Note that $D_{la\&b}$ represents the average of 2 transducers that were fitted to measure the rotation of the panel.

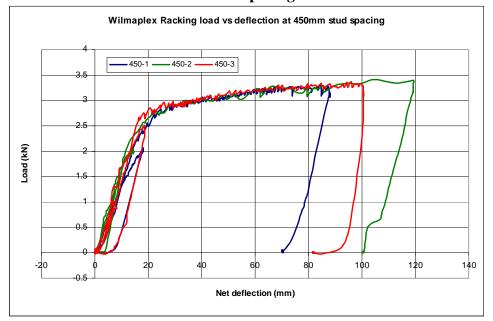
Figure 5 Racking load versus net deflection D3 for 450mm stud spacing

Specimen 450-1, 2 and 3: Frame distorting diagonally, strap buckling on the compression side.

Tables 2 and 3 give all the calculated test data for the 450 and 600mm stud spacing consecutively.

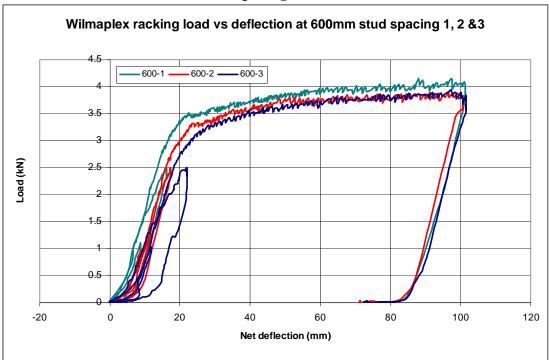
Figure 6 Racking load versus net deflection D3 for 600mm stud

Specimen 600-1, 2 and 3: Frame distorting diagonally, strap buckling on the compression side.

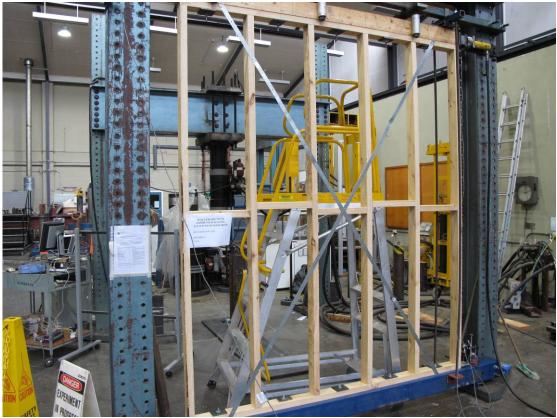
Figure A1 Test set-up for the 450mm studs wall

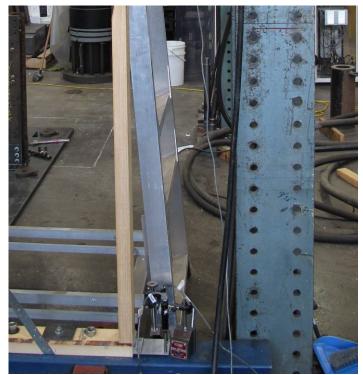
Figure A2 Transducers measuring the uplift.

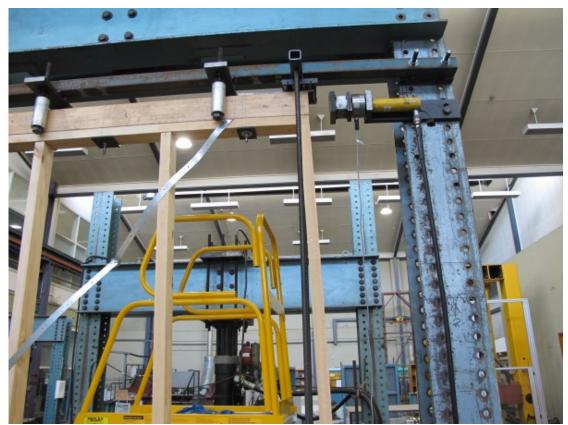
Figure A3 Hydraulic cylinder and a load cell fitted to apply the racking load.

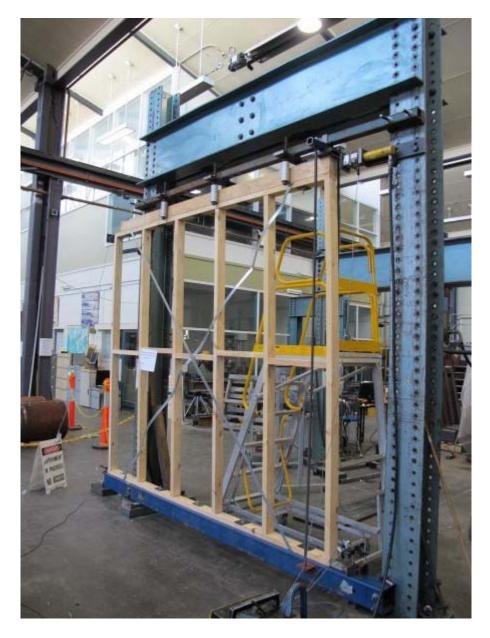
Figure A4 Typical mode of failure, diagonal distortion and buckling of strap in the compression side.
