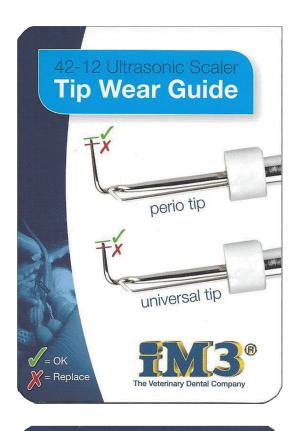
- Tip wear will significantly reduce scaler performance as it will alter the ultrasonic frequency.
- The ferrite rod must be tight a loose or broken rod will cause poor or no vibration.
- 3. A correctly functioning tip used on a power setting of 3-4 lights will produce a coolant mist (no dribble) around the tip.
