PILOT TESTING THE EFFICACY OF USING A LOW-POWER ULTRASOUND EMITTER TO DECREASE BAT ACTIVITY

This is an EPRI Technical Update report. A Technical Update report is intended as an informal report of continuing research, a meeting, or a topical study. It is not a final EPRI technical report.

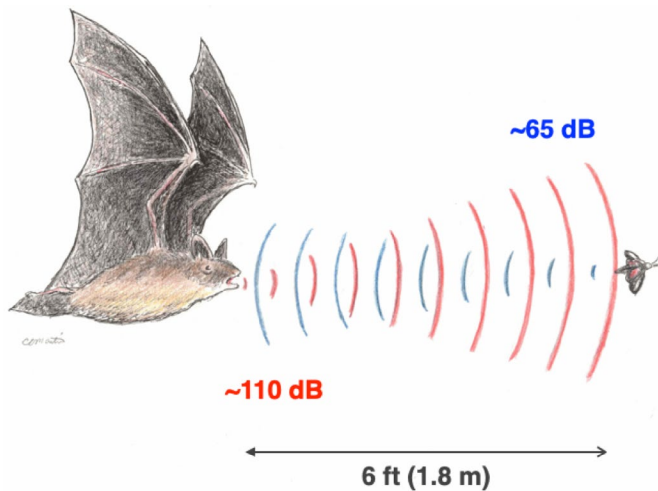
Figure 1-2: Diagram of a bat echolocating a target 6 ft (1.8 m) away with an echo return of 45 dB fainter (blue) than original sound level pressure (red)

While echolocating, bats can vary the duration, frequency, intensity, and pulse repetition rate of the sound they make during a sequence of pulses in order to perform precise movements, localize targets, and generate important target detail such as texture (Jones 1999). According to Surlykke and Kalko (2008) and Jakobsen et al. (2013), bats echolocate at intensities between 110-135 dB SPL at 3.9 inches (in) [10 centimeters (cm)], depending on species. The echoes from objects six feet (ft) [3.3 meters (m)] away are nearly 45 dB fainter due to the amplitude of the sound wave decreasing exponentially over distance traveled. As a result, bat calls must be very loud with a high SPL to be effective over any distance since sound attenuates rapidly (Figure 1-2).

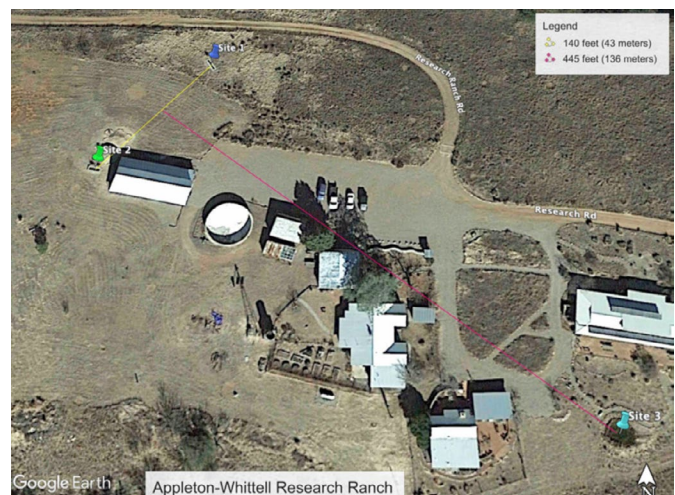
Figure 2-2: Distance between sites at Research Ranch Headquarters

The Headquarters sites included two concrete water troughs (Sites 1 and 2) and a constructed pond (Site 3). The dimensions of the concrete troughs were approximately 14 ft x 4 ft x 18 in (4.3 m x 1.2 m x 46 cm) with an open water surface of approximately 10 ft x 2 ft (3 m x 0.6 m) (Appendix B, Photo B-1, and B-2). Site 1 was located approximately 140 ft (43 m) northeast of Site 2 (Figure 2-2). Site 3 exhibited natural characteristics, including ground-level topography, fringe vegetation, and sediment substrate (Appendix B, Photo B-3, and B-4). The size of Site 3 was approximately 10 ft x 10 ft (3 m x 3 m). Site 3 was approximately 445 ft (136 m) southeast of Site 2 (Figure 2-2).

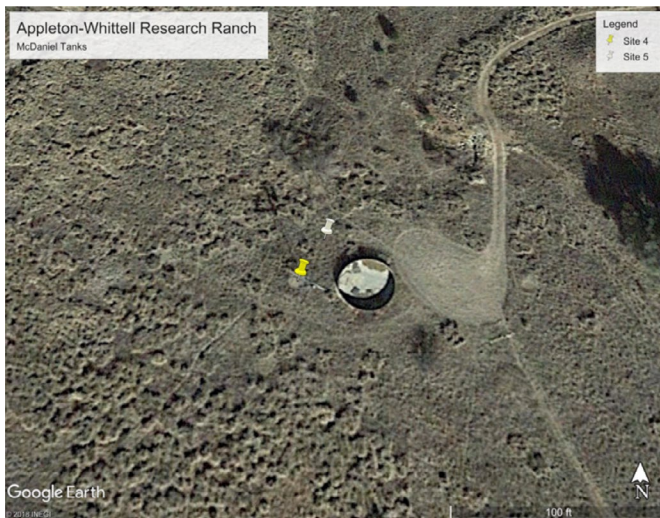
Figure 2-3: Location of McDaniel Tanks, Site 4, and Site 5. These ponds were not yet constructed at the time of this aerial photograph.

The McDaniel tanks (Sites 4 and 5) were constructed ponds approximately 1.1 mi (2 km) southeast of the Headquarters sites. The ponds were created in 2017 and exhibited natural characteristics, including ground-level topography, fringe vegetation, and sediment substrate, and contained submerged or partially submerged organic debris such as branches and logs (Figure 2-3; Appendix B, Photo B-5). Sites 4 and 5 were approximately 25 ft (8 m) apart and approximately 75 ft (23 m) and 35 ft (11 m) in diameter, respectively.

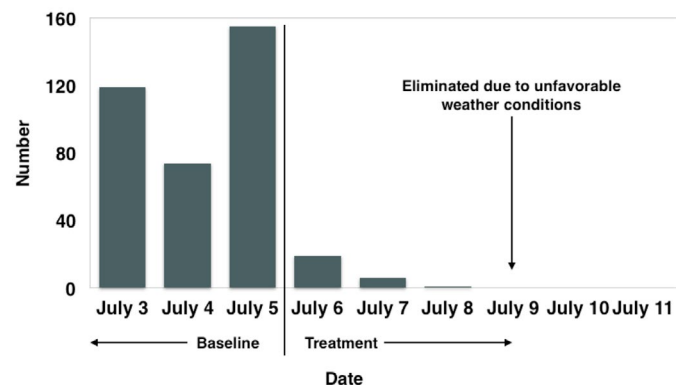
Figure 2-5: Site 1 video review, sips per night, July 3-11, 2018. Baseline data were collected prior to operation of the ultrasound emitter and treatment data were collected during the operation of the ultrasound emitter.

At the AVRR Headquarters sites (Sites 1-3), while bat activity, measured by total number of sips, decreased at treatment Site 1 and Site 3, the total number of sips increased at Site 2 where no ultrasound emitter was operating (Figure 2-8). Similarly, total number of sips at treatment Site 5 decreased during ultrasound emitter operation while the total number of sips at Site 4 increased during the same time frame (Figure 2-9). An exception to this was on July 3 at Site 4. Bat activity during baseline data collection on July 3 at Site 4 was comparable to bat activity while ultrasound emitters were operating at Site 5.

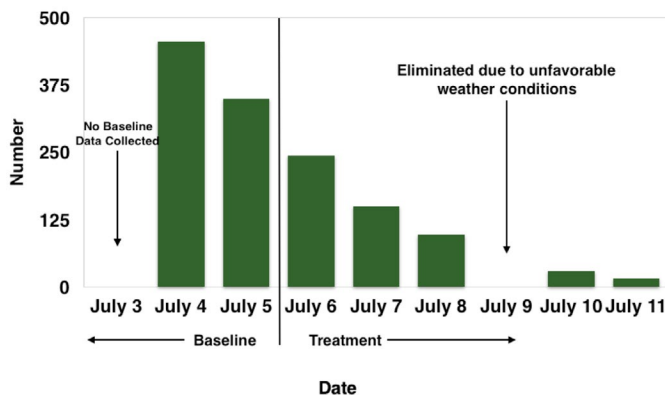
Figure 2-6: Site 3 video review, sips per night, July 3-11, 2018. Baseline data were collected prior to operation of the ultrasound emitter, and treatment data were collected during the operation of the ultrasound emitter.

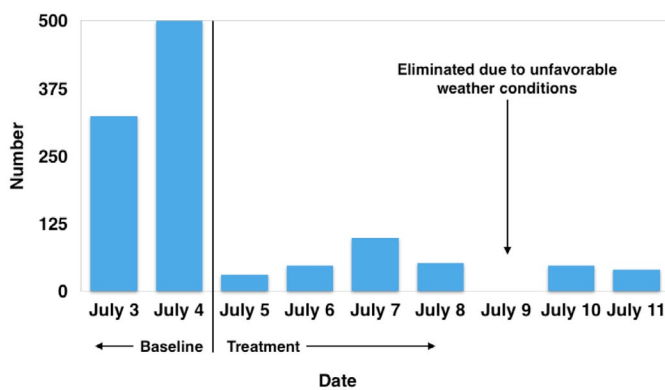
Figure 2-7: Site 5 video review, sips per night, July 3-11, 2018. Baseline data were collected prior to operation of the ultrasound emitter, and treatment data were collected during the operation of the ultrasound emitter.

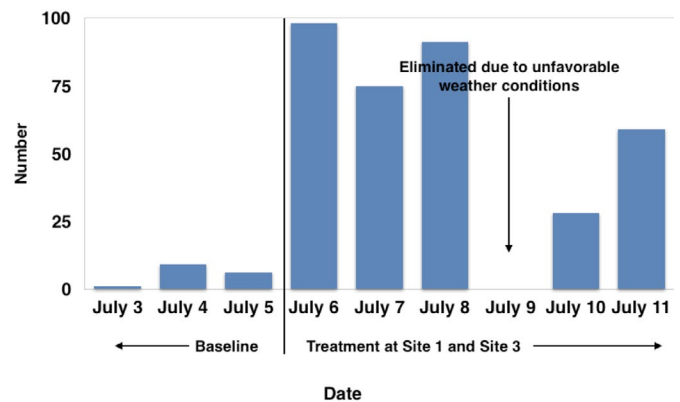
Figure 2-8: Site 2 (no treatment) video review, sips per night, July 3-11, 2018. Baseline data were collected prior to operation of the ultrasound emitters at Site 1 and 3. Data collection continued at Site 2 while ultrasound emitters were operating at Site 1 and 3.

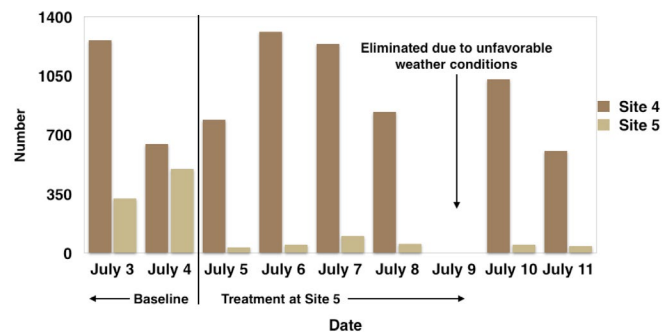
Figure 2-9: Site 4 (no treatment) and Site 5 (treatment) video review comparison, sips per night, July 3-11, 2018. Baseline data were collected at both Site 4 and 5 prior to operation of the ultrasound emitters at Site 5. Data collection continued at Site 4 while ultrasound emitters were operating at Site 5.

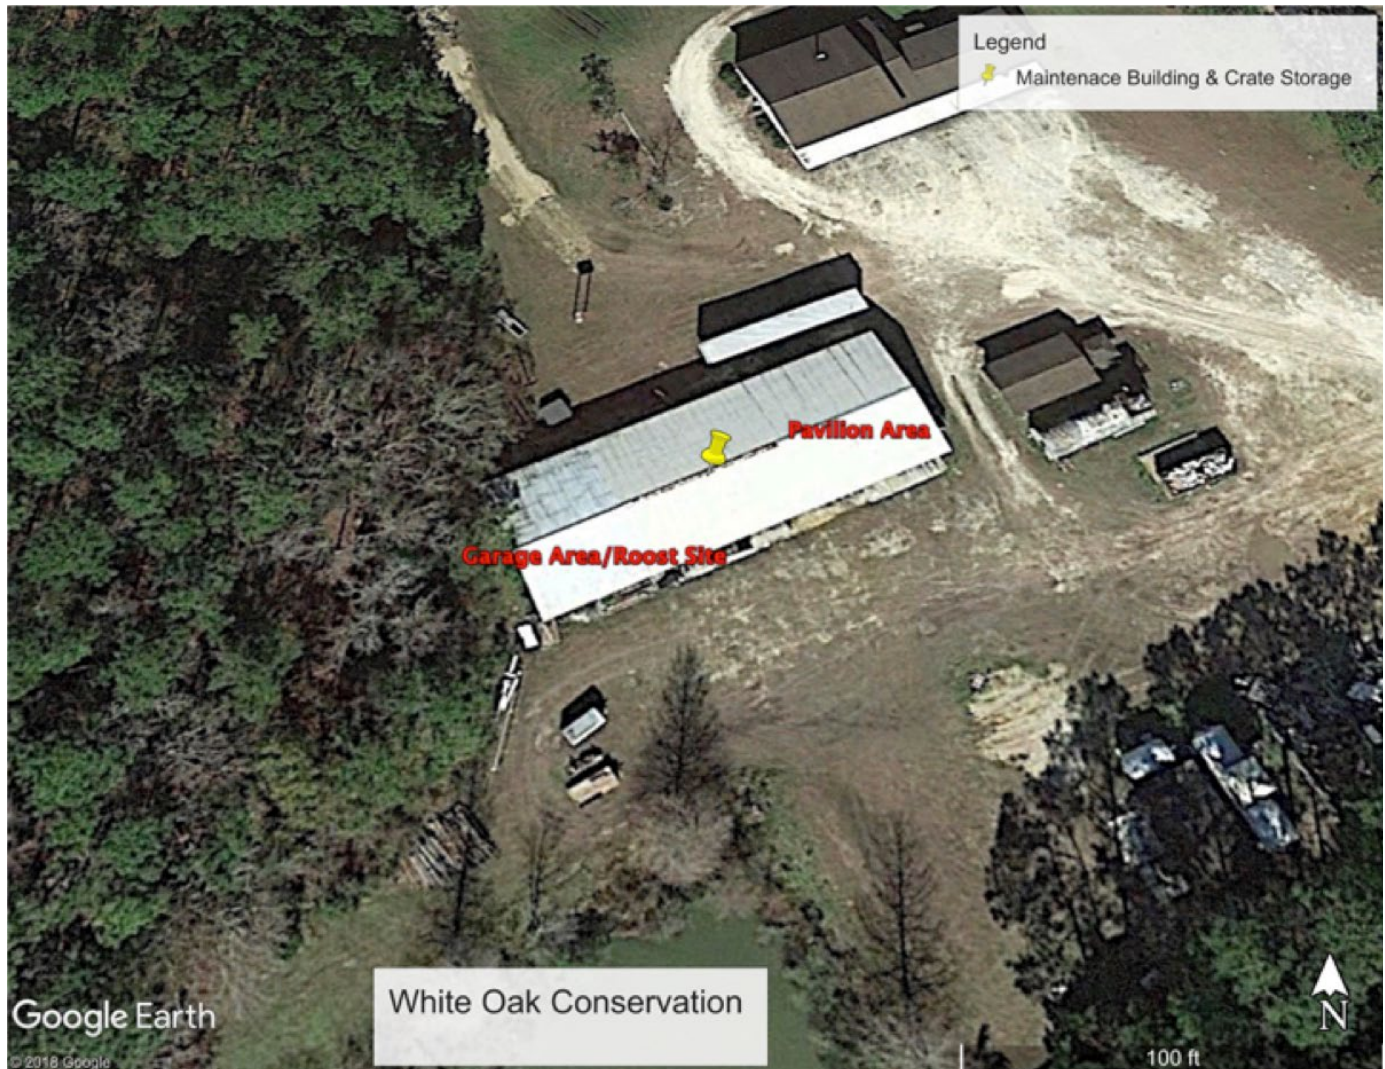
Figure 3-2: Bat roost site within the garage area of the maintenance building. This area is used for storage.

White Oak Conservation is an exotic animal conservation facility with diverse habitat features including forest interior, streams, lakes, and ponds (Figure 3-1). A ten-mile (16-km) stretch of St. Mary's River bisects the property. The property also includes numerous buildings and structures. The research site was a concrete block maintenance building

attached to an open-sided, concrete, roofed crate storage area (Figure 3-2) (Appendix E, Photo E-1). The building consisted of a large colony of southeastern myotis (*Myotis austroriparius*) and Brazilian free-tailed bat (*Tadarida brasiliensis*) (Appendix E, Photo E-2). The combined colony is likely limited by available roost space and numbers peak at approximately 4,000 individuals.

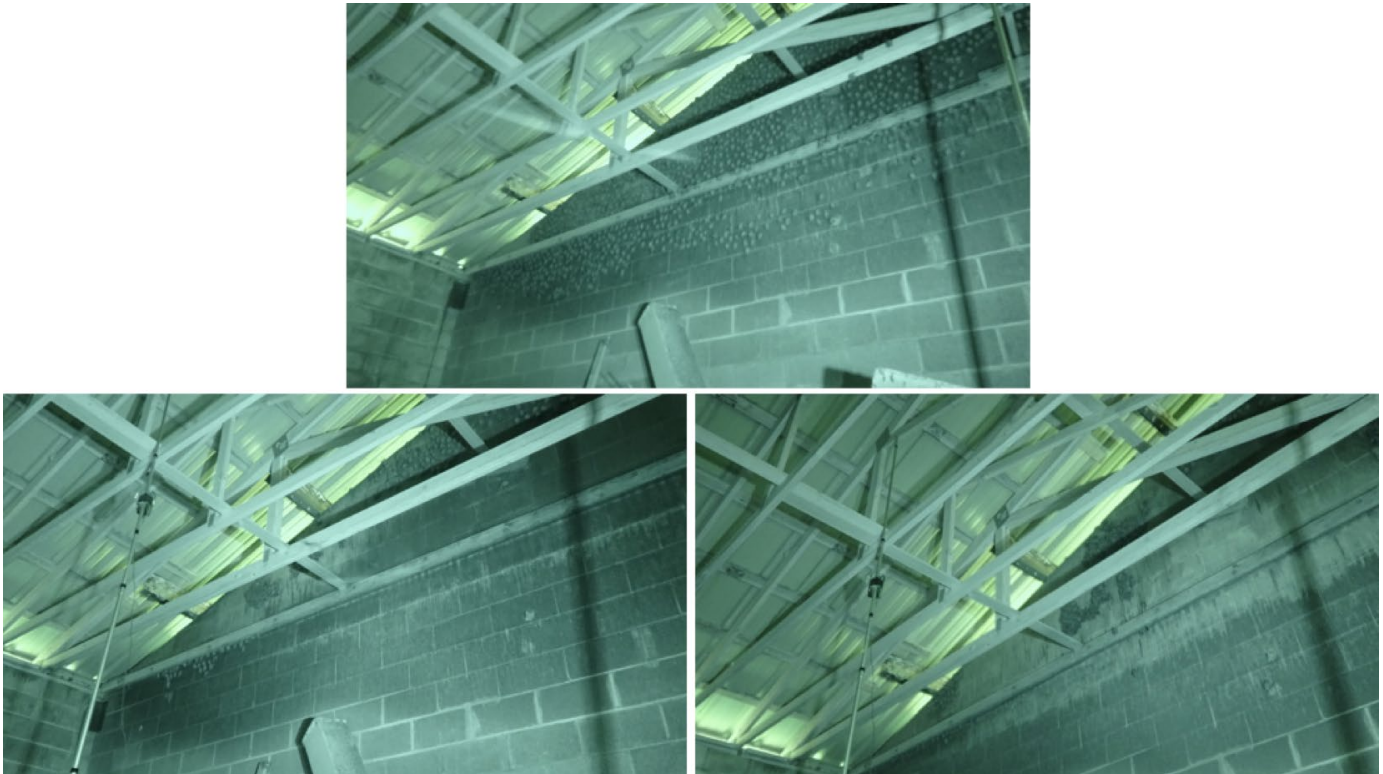
Figure 3-5: Bats roosting at 09:00 on east wall at north end of roost post-treatment. From top, left to right: October 9 (no treatment), October 23 and October 26 (post-treatment).

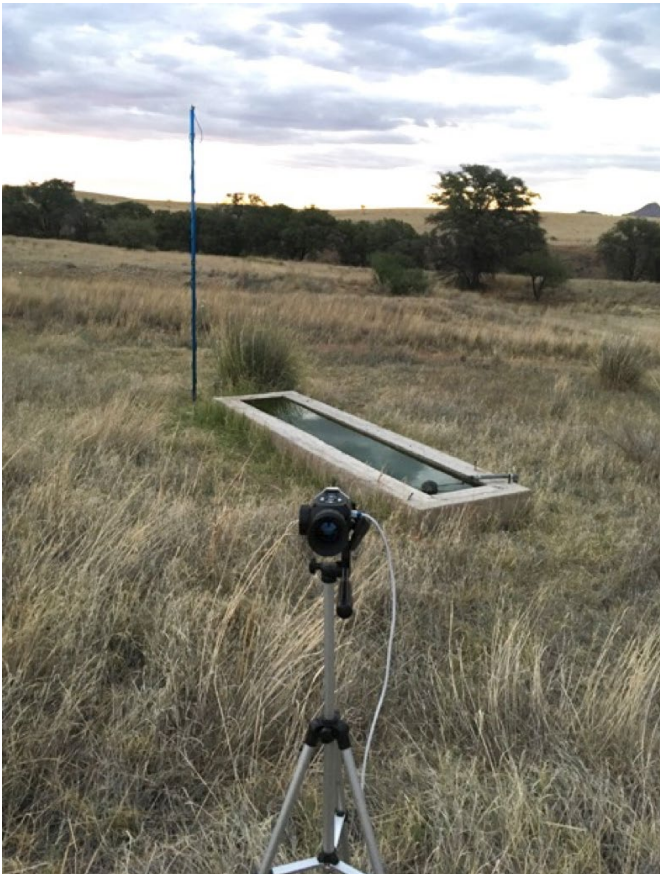
Photo B-1
Site 1 with thermal imager (foreground) and pole with bat detector microphone (background)

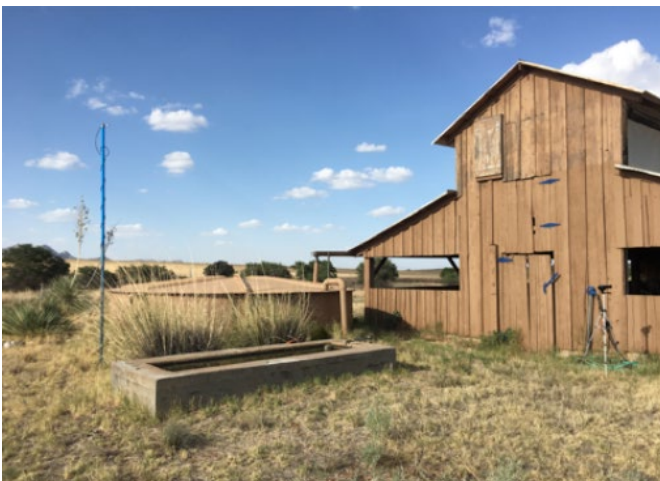
Photo B-2
Site 2 with thermal imager and pole with bat detector microphone

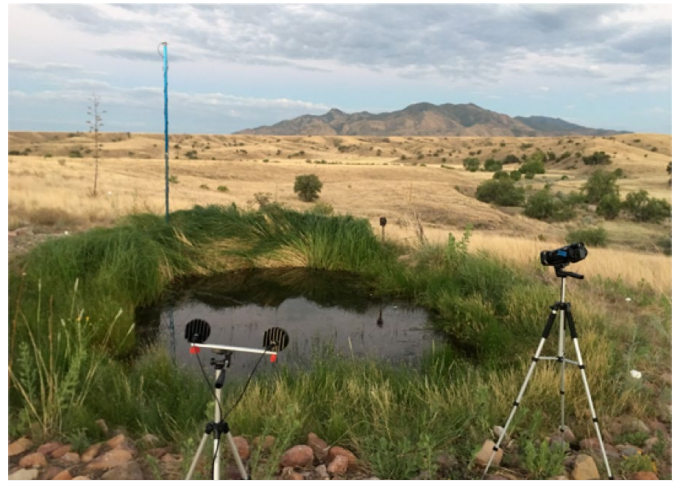
Photo B-3
Site 3 with infrared camcorder and external infrared lights (foreground) and pole for bat detector microphone (background); AWRR trail camera (background)

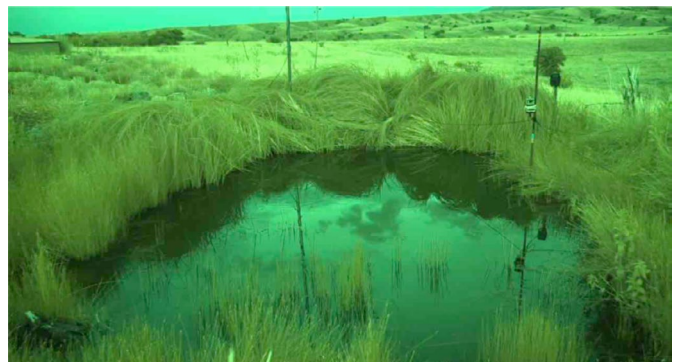
Photo B-4
Site 3 infrared video, ultrasound emitter on right edge of pond; AWRR trail camera visible behind ultrasound emitter

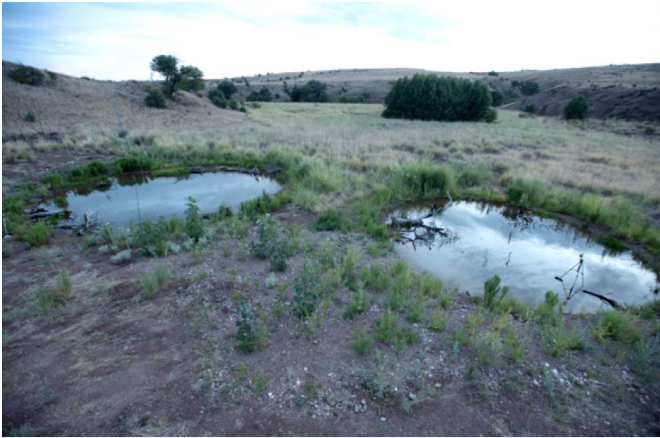
Photo B-5
Site 4 (left) including pole with bat detector microphone and Site 5 (right) with three ultrasound emitters deployed in water

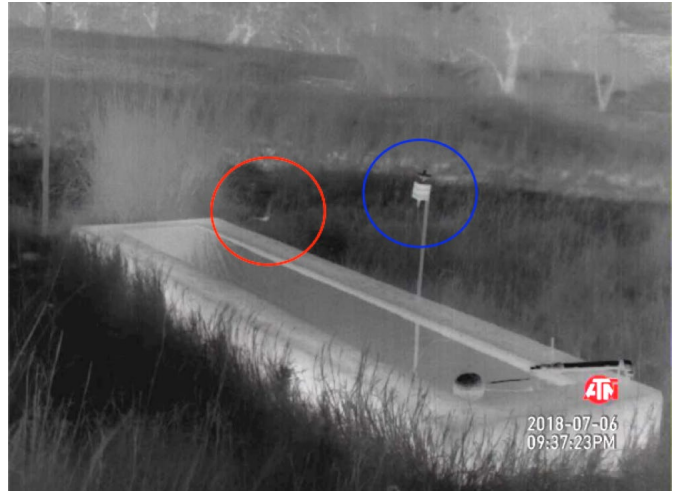
Photo B-8
Site 1 thermal imagery, treatment data collection; ultrasound emitter circled in blue, bat fly-by circled in red; bat appeared to approach water for a sip then turned away

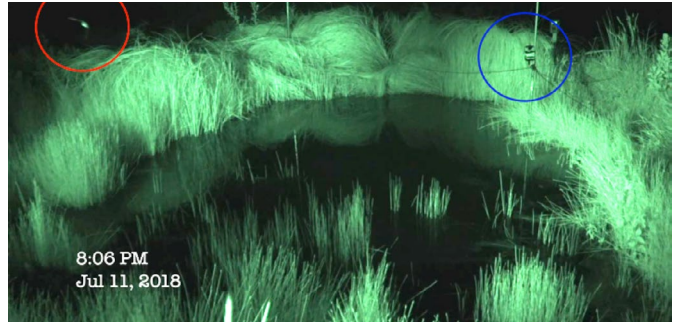
Photo B-9
Site 3 infrared video, treatment data collection; ultrasound emitter circled in blue, bat fly-by circled in red

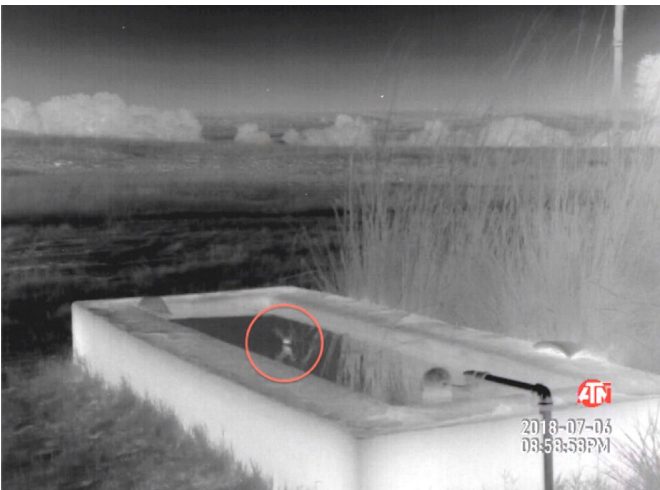
Photo B-7
Site 2 thermal imagery, no treatment; bat sip circled in red

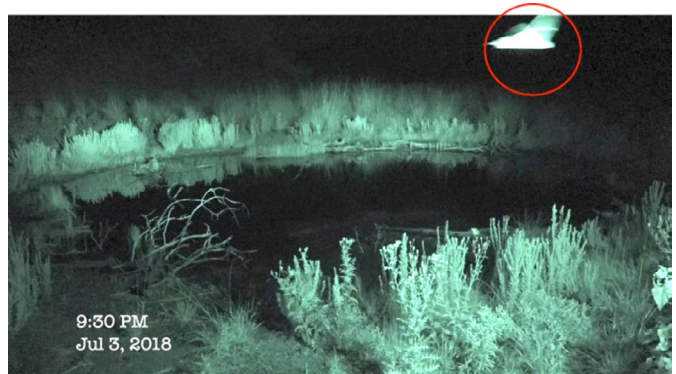
Photo B-10
Site 4 infrared video, no treatment; bat fly-by circled in red

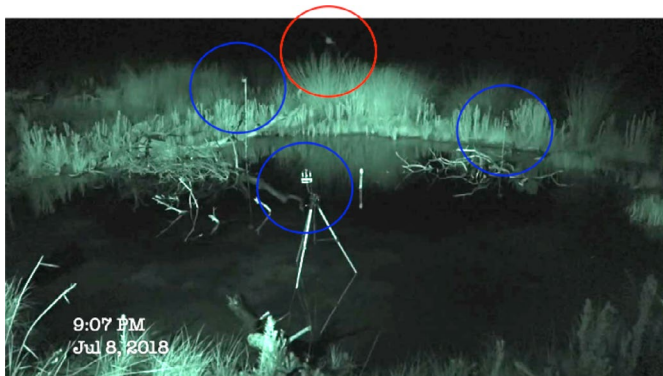
Photo B-11
Site 5 infrared video, treatment data collection; ultrasound emitters circled in blue, bat fly-by circled in red

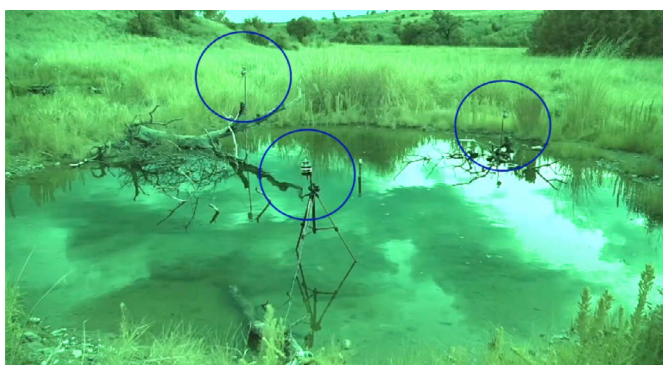
Photo B-12
Site 5 infrared video, treatment data collection; ultrasound emitters circled in blue

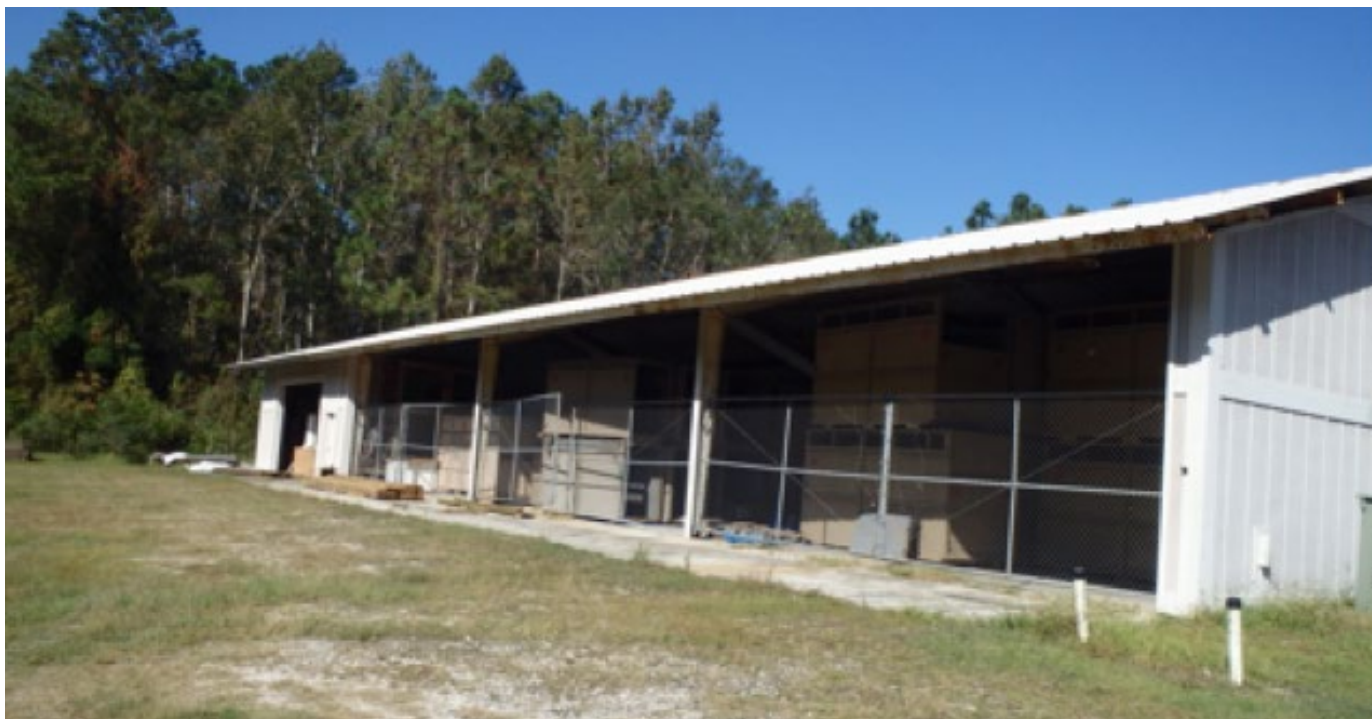
*Photo E-1
Maintenance building and crate storage; Garage (far end) used for storage and was location of roosting bats*

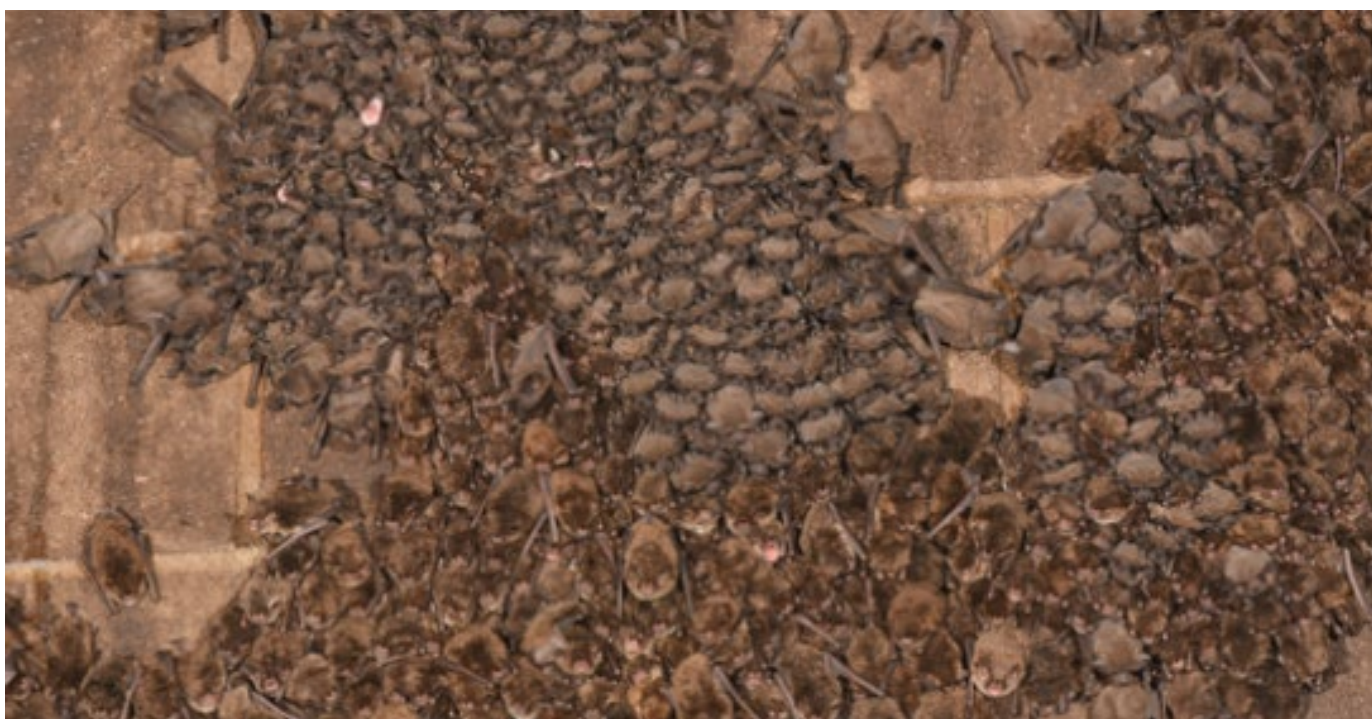
*Photo E-2
Bats roosting on east wall at south end of roost; Bottom half (darker pelage): southeastern myotis (*Myotis austroriparius*); Top half (lighter pelage): Brazilian free-tailed bat (*Tadarida brasiliensis*)*

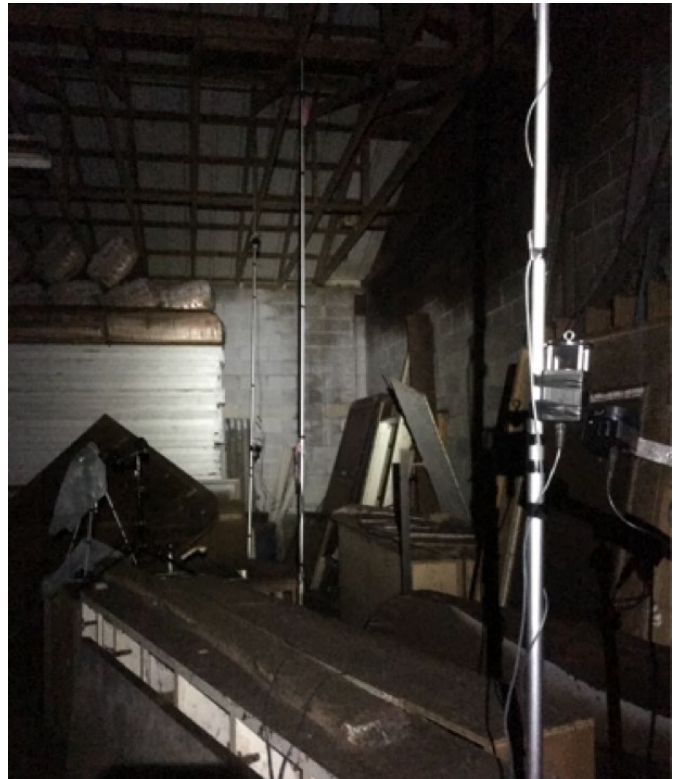
Photo E-5
North end ultrasound emitter pole (background), data logger pole (middle), south end ultrasound emitter pole (foreground)

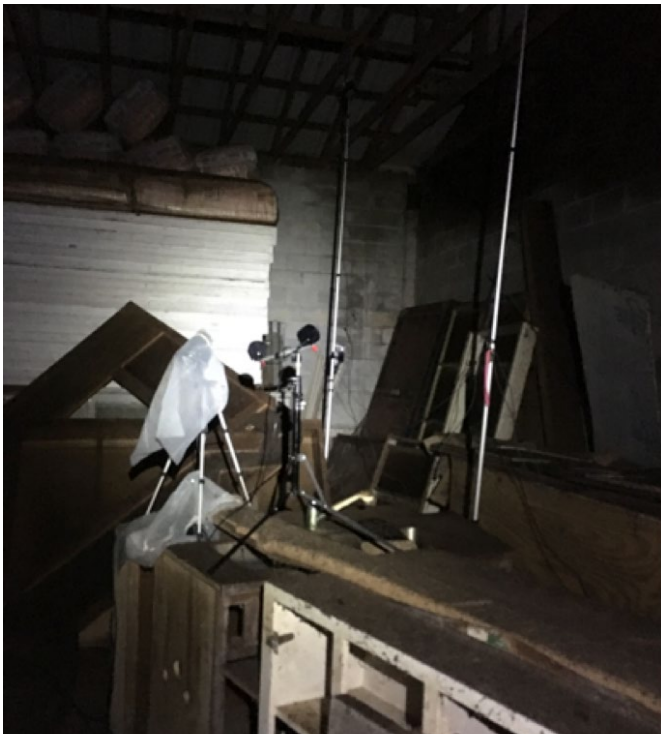
Photo E-4
North end infrared time-lapse camcorder with external infrared lights, ultrasound emitter pole (background), and data logger pole (foreground)
