KNOCKANDO  
WOOLMILL

*Conservation Plan*

*July 2006*

ANDREW PK WRIGHT  
Chartered Architect and Heritage Consultant

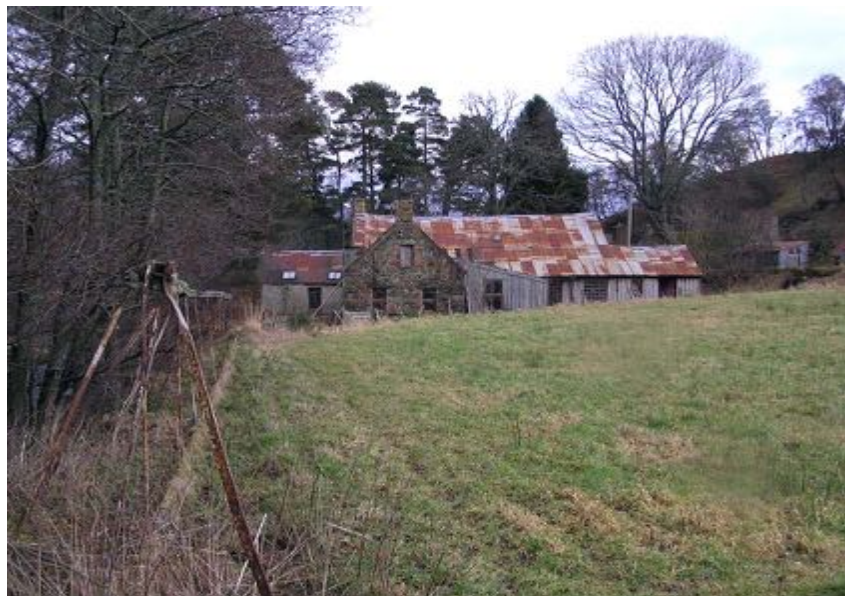
View of the woolmill from the west with the tenter frame to the left

TENTER POSTS: located in field to W of mill, allowing drying cloth to be stretched out.

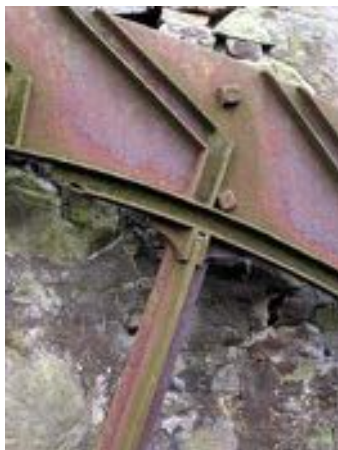
Detail of the waterwheel installed at Knockando

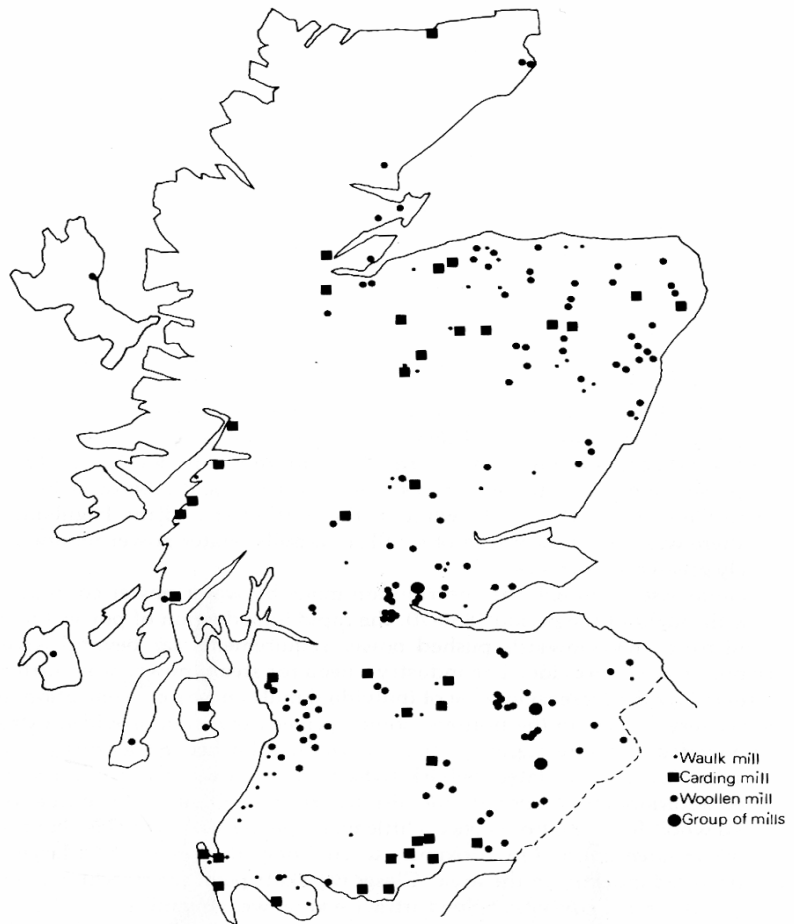
*Distribution of water-powered woollen mills c 1845-80 (Shaw) <sup>52</sup>*

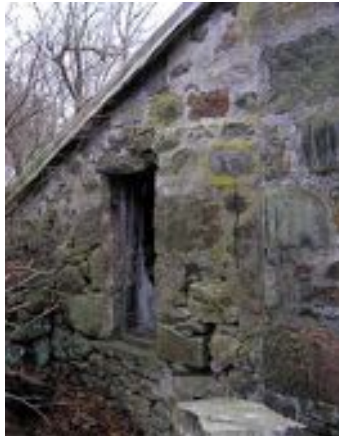
Junction of masonry between the wash house and the main mill structure

Could this have been an earlier workshop? The position of the building in relation to the line of cottages would have been logical, and indeed production of cloth could have continued while the new mill was under construction. It is possible, too, that this structure might have had a small timber waterwheel on the end gable if some mechanisation had been introduced earlier than may have been thought. The floor of this structure sits lower than that of the machine room, against the lie of the land, and it could have acted as the original wash house and dyeing room. There had been a connecting door from the beginning, bricked up no later than the early twentieth century, as the bricks are of the large Victorian face dimensions, bedded and pointed in lime mortar.

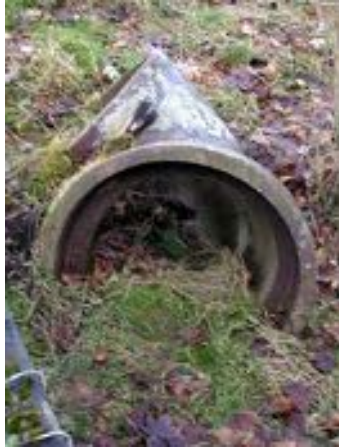
*Discarded pipe from the lade system*

It is apparent from studying the surrounding landforms that the mill foundations were set at a lower level than the natural fall in the ground. In most other respects the position of the mill defies logic and it does not appear to be where expected. Even if it had started its existence with a small waterwheel on the gable, the far gable would have been a more logical for it in terms of coping with the flow of the water and with a tailrace, although sometimes the configuration of the land in finding the easiest route for an elevated lade would override the more obvious considerations on siting. Further, it might have been more logical for a mill with a single waterwheel to have been positioned to be more or less parallel with the watercourse, once more with the waterwheel on the far side where fewer problems might be encountered in controlling the flow of water. Curiously, the arrangement where the lade crosses the path leading into the mill

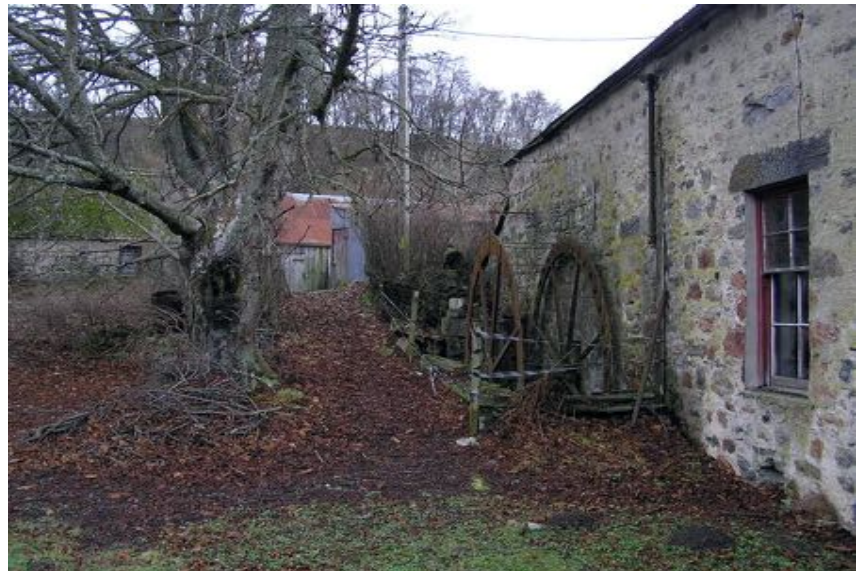
*The waterwheel with the end of the penstock visible*

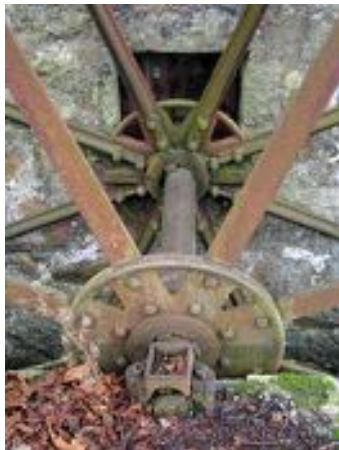
*The cast-iron sectional waterwheel*

The mid-1860s date fits with the site evidence, and with when, it is believed, the waterwheel may have been installed, brought from the former mealmill at Pitchroy (approximately three miles from the site of the woolmill). The cast-iron wheel, capable of being dismantled and transported in sections, has an overall diameter of fourteen feet with eight radial spokes; forty buckets were accommodated, and the axle shaft (or 'axle tree') is octagonal. It is difficult to see evidence of differing build periods to the masonry of the east wall, which is remarkably consistent,

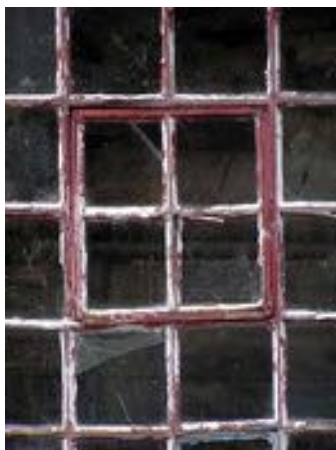
*Detail of one of the 42-pane workshop windows*

The lintols to the window openings are of large sections of dark grey schist, and to some of them the grooves where the stones have been split with the quarryman's iron rods can still be seen, left undressed. Window openings are treated in a fairly unsophisticated, but traditional way, coating the inside reveals with a thin slurry of render to regularise the face, and to save on having to dress the reveals with any degree of precision, other than to achieve a true arris on the outer face. There are no checks for the window frames – in essence, this was a continuation of the same traditions of Northeast rural construction in which the earlier cottages on the site had been built. It is possible that the large window to the right of the waterwheel (see left) had been introduced later, at around the same time that the single storey extension was built to accommodate the spinning mule, to improve the amount of light entering the workshop in an area which would have been, by then darkened, by the new extension. The original window, which must have matched those of the northwest wing, appears to have been replaced with a sash and case window, probably for improved ventilation, and this may have occurred in the early years of the twentieth century, or possibly later, even. There is evidence of a small window to this wall having been blocked up, in close proximity to the rim of the wheel and to the immediate right of it.

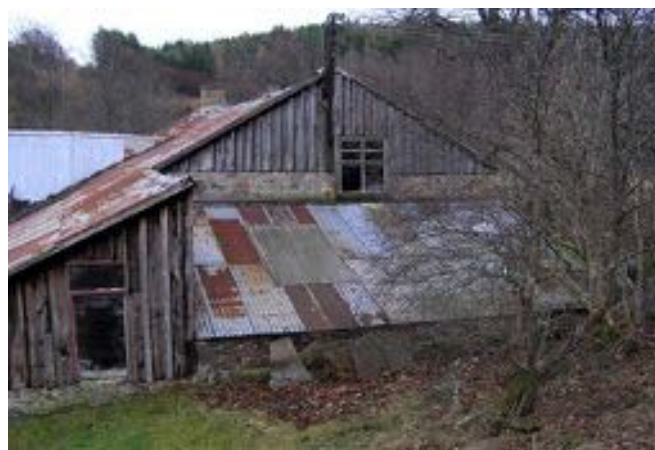
*Southwest elevation of the mill shed*

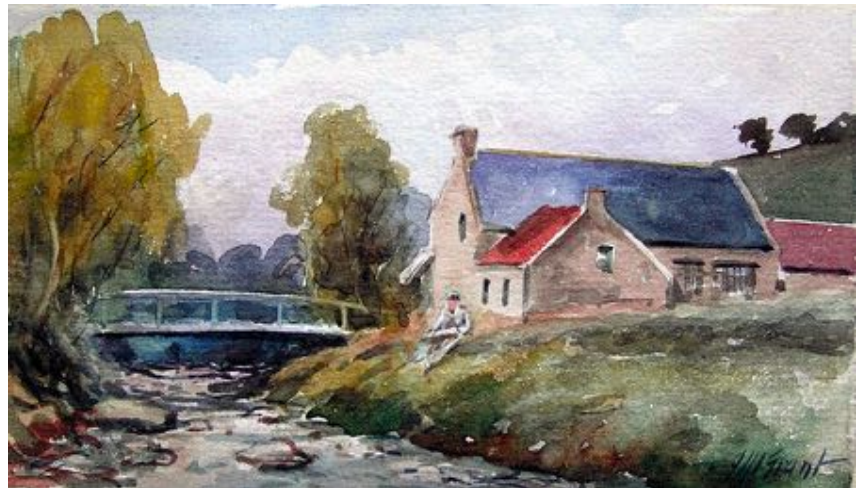
*Early watercolour by JM Grant showing the mill before the additions of the weaving shed and lean-to extensions on the re-entrant (courtesy of Graeme Stewart)*

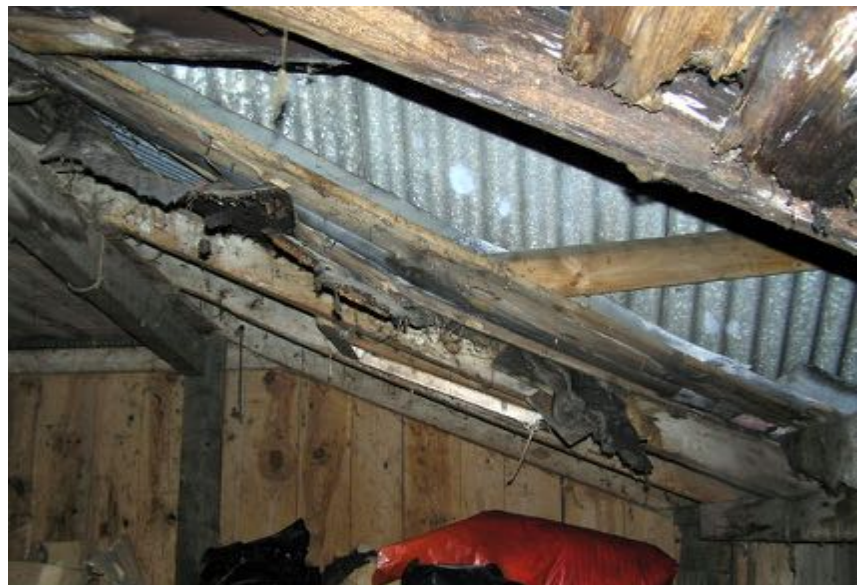
*The precarious nature of the attic roof construction, showing clearly the remnants of the original asphaltic roof covering*

In time, the impermanence of the construction led to its own problems. To save on weight and the amount of timber needed, the angle of the roof pitch is relatively low, and the timber sections are slender. Worse, they were of poor quality home-grown timber (confirmed by the findings of the timber infestation report <sup>74</sup>) and, with the levels of residual dampness throughout the building, this has had the inevitable consequence of attracting the attention of woodboring beetles, affecting what little residual strength the sections may have had. With such a low roof pitch, the more traditional finishes could not have been contemplated, and a highly

unusual, if not experimental material was introduced, of asphaltic pitch brushed hot onto the timber sarking, bound by what appears to have been oat straw as a by-product of the farming activities, and possibly even by strands of wool. The drips from this material, when it was applied to the roof, are visible on the face of the masonry of the wall housing the waterwheel. Natural rock grade mastic asphalt, a combination of limestone and bitumen, was imported from France and Switzerland, and was patented in the 1860s <sup>75</sup>. Much of this material still survives, sandwiched below an overcladding of corrugated iron sheeting on battens, from which it can be assumed that the compound, although it would have been capable of being repaired, had suffered an early failure in use. Ironically the overcladding of the iron sheets has resulted in the roof structure, already under-designed, becoming even more overloaded. Even if it had not failed to remain weathertight (the movement of the lightweight roof and sarking boards must have been a constant problem) the working conditions on hot summer's days with the sun beating down on a thin, dark coloured coating such as this must have been quite unbearable.

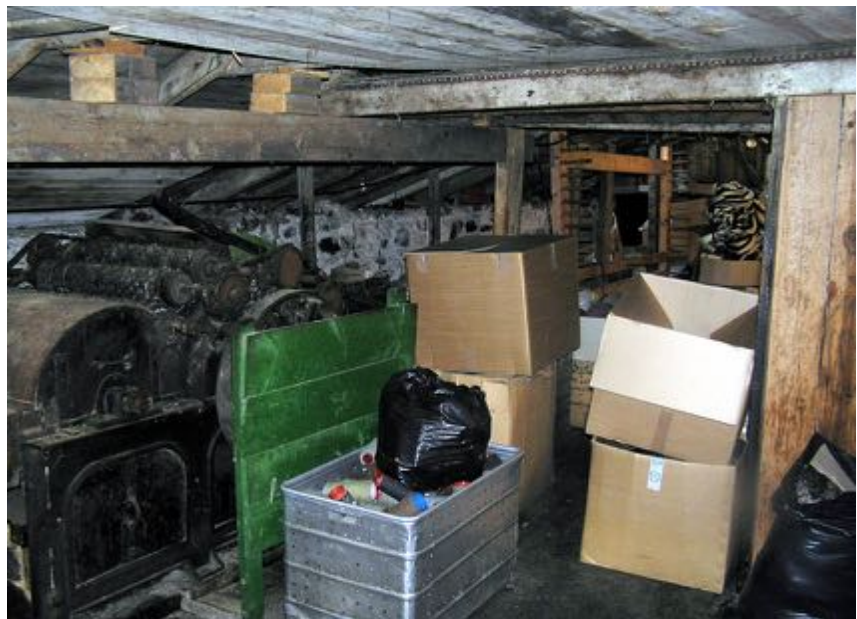
*The attic floor – the machine on the left is an early wool blender, or 'teazer'*

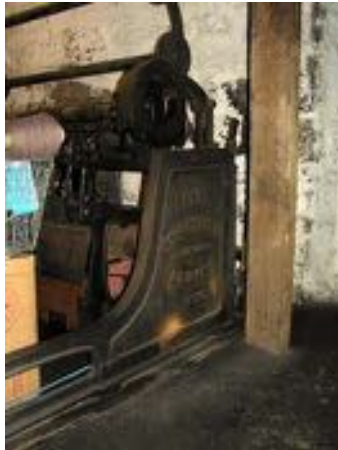
Endplate to the mule with the manufacturer's name and date stamp

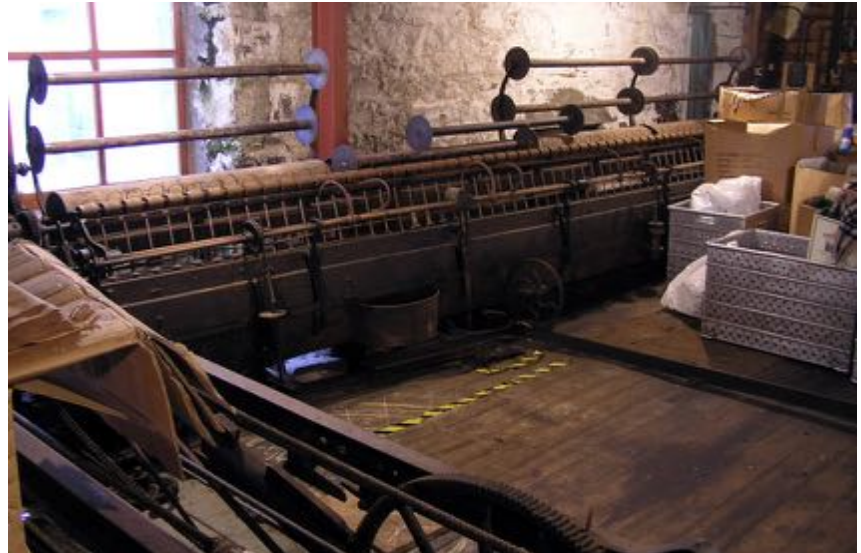
The Platt spinning mule of 1870

If the evidence points to the woolmill operations having been expanded under new management of the site in the 1860s, it could not have been long before the second phase of development began in earnest. Clearly Smith must have decided that the output could have been enhanced by the incorporation of a spinning mule and so, in 1870, he commissioned one direct from Platts of Oldham. It is understood that the old mule was acquired by the mill at Dallas, and when it closed down it was transferred in turn to Ballantynes <sup>76</sup>. The precision with which the machine sits in the space, for operating reasons mounted on a suspended timber floor (the remaining floors are all solid) all point to the fact that the single storey extension to the mill on the northwest side adjacent to the burn was created specifically for this machine. The opportunity was taken to provide a floored out loft for storage, with a high level access door at the new northwest gable. From here the bales of raw wool were introduced for feeding to the wool blender, or teaser as it was known, in the adjoining attic. The chimneyhead above the door is a mystery – with the position of the door lintol it could never have accommodated a flue line, and perhaps there had been a change of heart over introducing a further hearth here to supplement that built into the adjoining gable which, of course, must have been rendered out of use once the mule had been installed. Ultimately, but only when the weaving shed had been added, was the heating problem

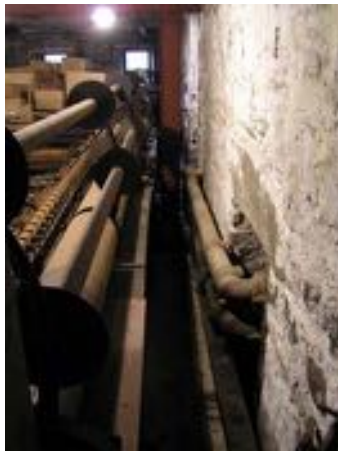
Heating pipes to the rear of the mule served by the boiler in the weaving shed through the original fireplace on the gable

to be overcome with the insertion of patented 'DESIDERATUM NO 8' solid fuel boiler which used the flue line served by the former hearth, stoked from the weaving shed, with the bank of heating pipes fitted to the base of the wall behind the mule. The extension appears on the 1st Edition map, surveyed in 1871.

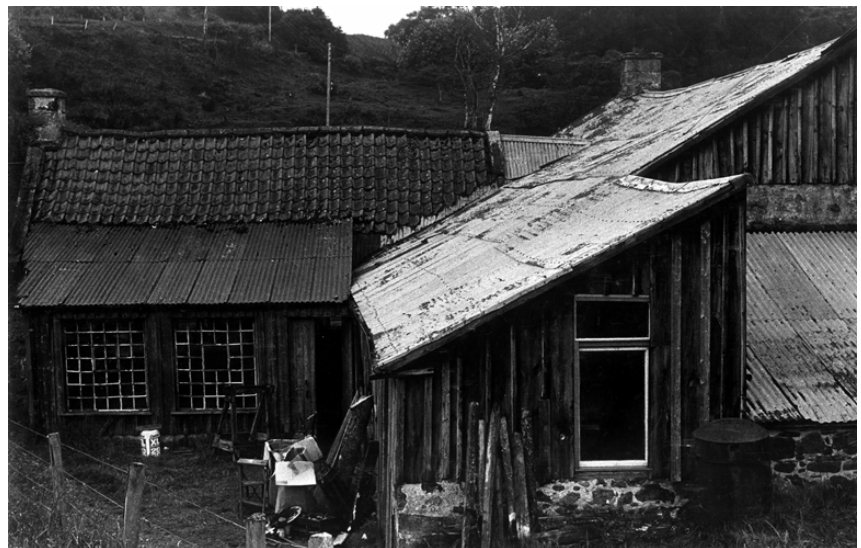
Photograph of the mill taken before the pantiled roof was removed (courtesy of Hugh Jones)

though it was not a common commodity in the area, with the continuing ease of obtaining supplies of Scottish slate, and with many of the local quarries still operating. The transaction might have related to some sort of payment in kind, for all we know. Although the pantiles have been removed from the roof, replaced in the 1970s in corrugated iron, they are still stacked neatly on the banks of the burn. The roof had no sarking boards fitted, as the tiles would have been fixed to tiling battens originally. The bottom courses of the roof were laid in roofing slates, following the established East Coast tradition of vernacular building in the villages of East Fife and the Lothians.

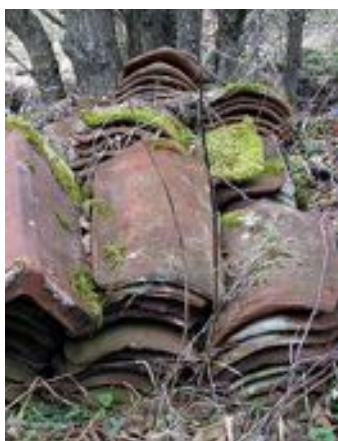
Clay pantiles stored on site

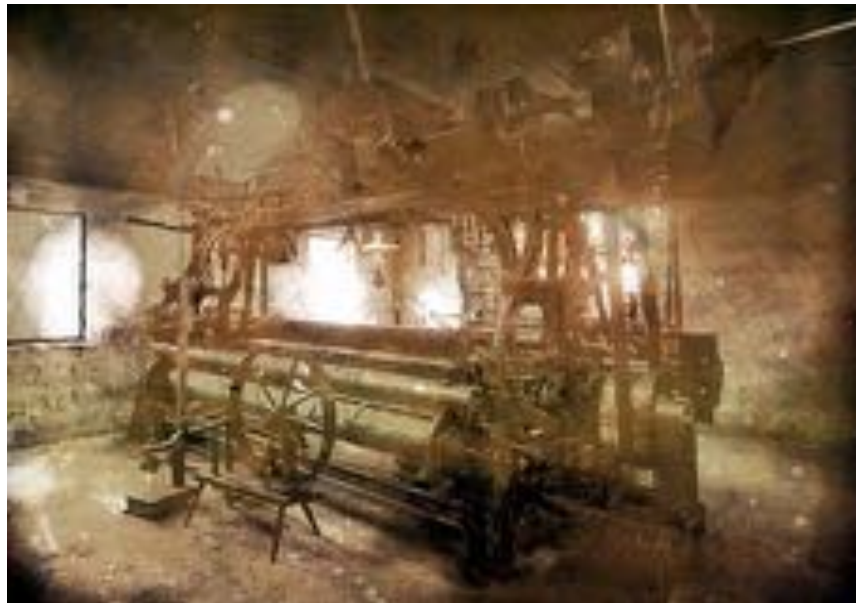
*Early photograph of the interior of the weaving shed (courtesy of Hugh Jones)*

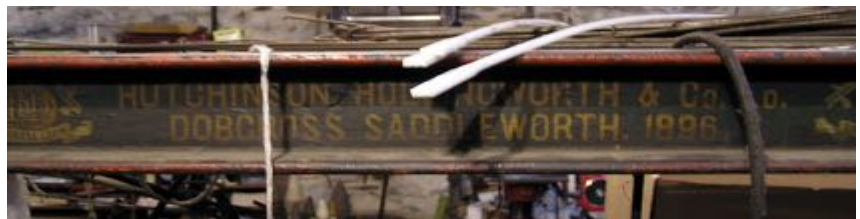
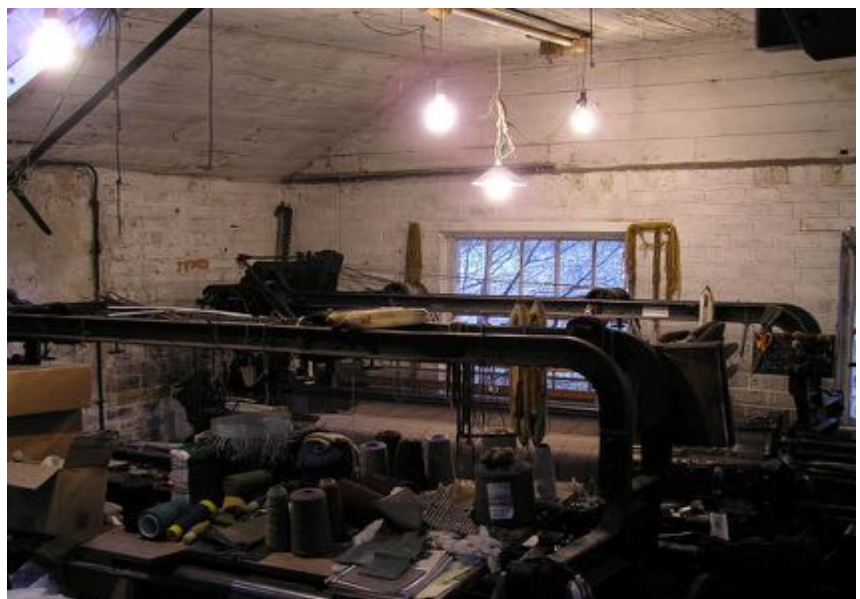
*Detail of 1896 Dobcross loom, and below, the weaving shed today*

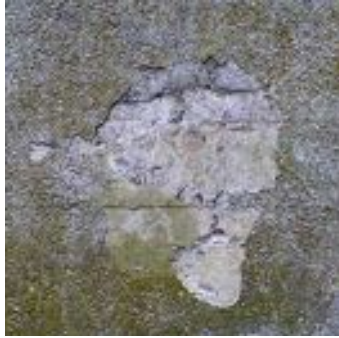
*Detail of shuttered mass concrete wall to the weaving shed*

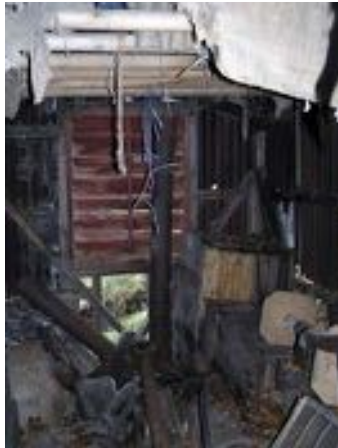
The only structure connected with textile production which is not attached to the woolmill is the winter drying shed, a small timber framed structure with sophisticated diagonal bracing at the corners, and with a monopitch roof, clad all over in corrugated iron. It is not without interest, although it has not been used for many years and is currently in a very dilapidated state. It is also one of the relatively few structures on the site that can be attributed firmly to the twentieth century, apart from the extensions to the old steading and the sheds to the rear of the mill. The shed incorporated round tenter poles at high level for hanging the cloth for drying, and at the northwest end there was space for a boiler from which a tall stove pipe passed through the roof. Air movement, to encourage the drying of the cloth, was achieved by large louvered panels, operated from a central pole.

*The winter drying shed and interior*

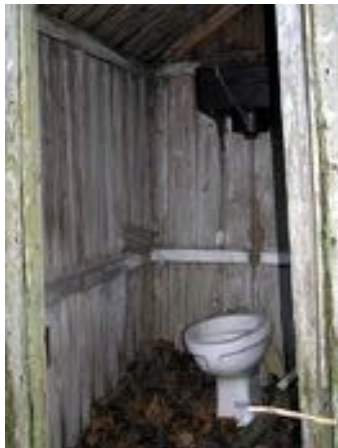
Although slightly tucked away on the path next to the waterwheel, the timber shed for the privy is an important, if vulnerable, element of the site. It seems probable that, initially at least, its use would have been reserved for the occupants of the cottage. As so many other features of the site it is an evocative survivor, built evidently with loving care. It retains much period detail, such as the basket for the toilet rolls, and the ubiquitous sanitary ware from Barrhead, here consisting of a Shanks WC bowl and a cast iron cistern by Saunders & Connor. It should not be lost in any scheme of renewal. The door is missing, but the roof is clad in a single sheet of zinc.

*The privy set within the garden and interior*

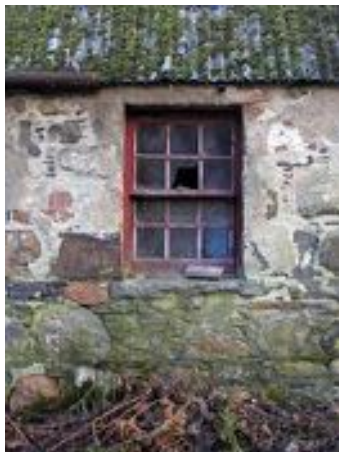
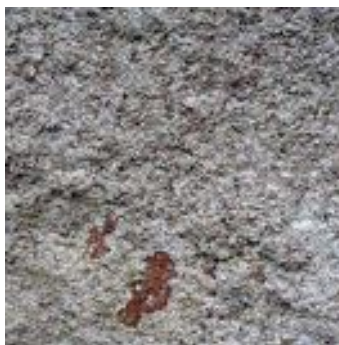
*Sash and case window and detail of harling*

The walls of this property are particularly well built, of coursed local granites, primarily black and brown in colour, with some stones of a salmon pink colour, with the occasional round field stone incorporated. The shallow lintols to the original window and door openings appear to be of a mica rich whinstone or schist, not dissimilar to the large lintols used later throughout the mill. The interstices between the stones are infilled with characteristic ladder pinnings of the main walling materials, typified by work of the early nineteenth century. The chimneyheads are neatly formed with plain blocked copes set over flagstones, and thackstones (projecting stones to cover roofing thatch) are incorporated. The walls are coated in lime harling, the constituents of which appear to be of a well graded pink aggregate which provide an attractive colour. Parts of it are not original, as the evidence of the openings to the rear wall where none existed previously suggest that the property had been reharled with a thin coat of lime after they had been introduced. A fair amount of the harling still remains on some of the walls. The gables are capped with plain skew stones supported on large, well formed skewputts. Window and door openings are treated simply, angled to the general line of the inner reveals with no rebates for the window frames, and the jambs are regularised by the application of a thin coat of smooth render. The external walls of the cottage are a good example of wall construction of the rural uplands of the Northeast of Scotland, and a very common form of construction encountered in Strathspey where the walling materials are invariably hard, and unforgiving to work.

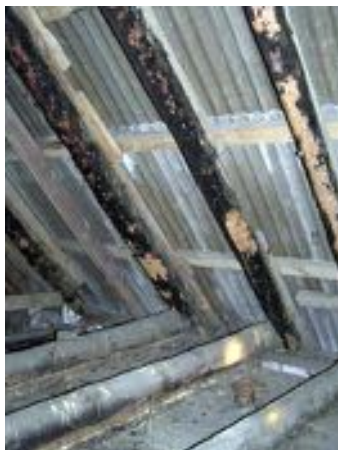
*Interior of the roofspace showing half-rounded smoke-blackened timbers*

Inspection of the roof structure confirms the suspicion that the original roof had been thatched, and this is consistent with the pictorial evidence of early photographs of the site and the watercolours of JM Grant. The rafters are set well back from the face of the wall, and are spaced out more generously than might be expected for a roof of this age designed for sarking boards to take a slated finish. There is evidence to be seen of oat straw within the roofspace, and also in the cupboard within the kitchen where it has fallen through from above. That this is the original roof is confirmed by the fact that the timbers are rough sawn, sometimes on one face only, with rounded surfaces and plenty of bark left in position. All of the joints are half checked and nailed. The roof is tied at wallhead level, but it would seem that the roofspace had been open originally as a possible throwback to the earlier tradition of open cruck-framed cottages, in which most inhabitants of the county would have lived at the time that this dwelling had been constructed. Interestingly, the remaining timbers (some must have collapsed, and were renewed when the corrugated asbestos cladding was applied) appear to have been blackened from smoke-staining, which may suggest open fires within the living area, which cuts across the clear evidence of there having been flues built into the external walls terminating in the pair of chimneyheads. A roofspace open to the living area is consistent with the evidence of a window at high level to the gable, as there is no evidence of the roofspace having been floored out otherwise for habitation, or storage, from the very limited inspection possible from looking into the roofspace where the ceiling has collapsed. It is not known exactly when the thatching was replaced but, no doubt, the regular cycle of re-thatching, and a shortage of craft skills and materials in the area as the twentieth century progressed would have been a deciding factor leading to its demise. From examining the roofspace, and the work done in renewing the roof, it is conceivable that the thatch could have limped on until after the conclusion of the Second World War, while it is

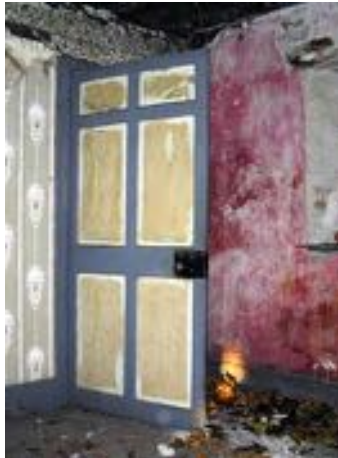
Six-panelled door to the living room

Initially, the living conditions must have been basic; more might be established by investigating the solum below the timber floors, which appear to be later additions, especially where raised throughout the middle section of the cottage. However, there is evidence of a former box bed having been located to the rear of the present kitchen in the wall recess, with a curtain rail holder at one end. The linings to the recess were refined, with beaded edges to the boards. Although on stylistic grounds it is tempting to state that the fielded six-panelled doors are in their original locations within the house, this is questionable, as the evidence of the fabric suggests that they may have been moved around and re-hung. At 28mm (barely more than one inch thick) they are remarkably slender, and that they are stable, and devoid of cracks, confirms how well they had been fabricated. They retain the early patterns of ironmongery with iron rimlocks and simple brass knobs, and it is entirely plausible that they came from the original cottage. The front door is yet another example of recycling features brought onto the site from different properties, and adapted to suit new purposes. This pair of doors could well have come out of a single lined door of a type that might have sat comfortably in a church vestry in a previous incarnation. Typically, the lock is fitted upside down.

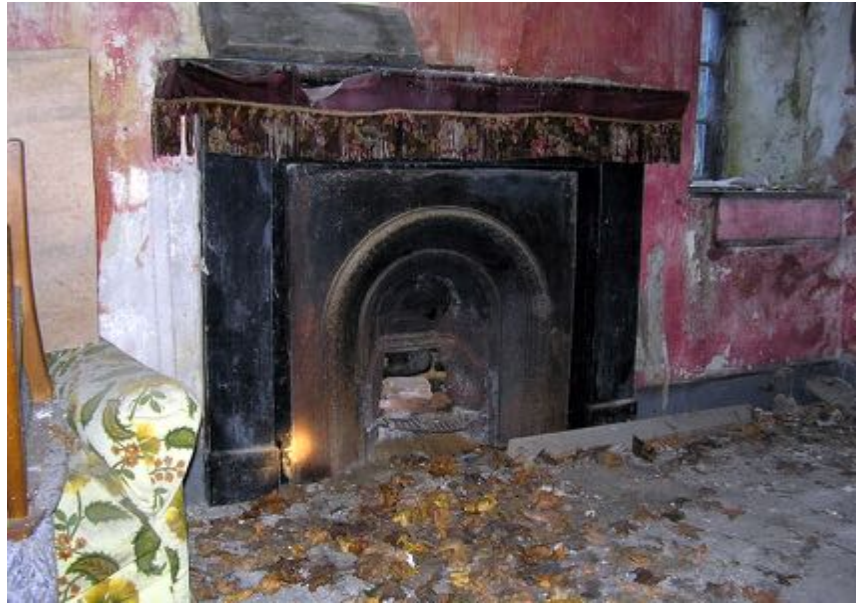
*Fireplace to the living room at the east end*

The plaster treatment was applied direct to the masonry to the three external walls of the living room, while the boarded partition to the rear of the room received the same wallpaper treatment as the other rooms. The plaster was given a distinctive pink distemper finish, not unlike the colour applied sparingly to the interior of the mill. As part of the scheme of improvements the window in the gable was widened, and a six-paned casement window inserted. The cast-iron fireplace and grate and the plain fire surround mirror the standard introduced later to the Woolmill House, while the tasselled fringe to the mantelpiece and the roller blind end holders are unexpected, and therefore important survivals. The woodwork is decorated in a neat colour scheme of dull grey and white. The patterns of successive wallpapers could, in themselves, provide an insight into the period for which the dwelling had been occupied, and perhaps even when the changes were made to the interior. In the living room one of the earlier wallpapers appears to be a William Morris print, and this, in itself, may provide the clearest indication that we have of the social aspirations of the inhabitants of the cottage at this time.

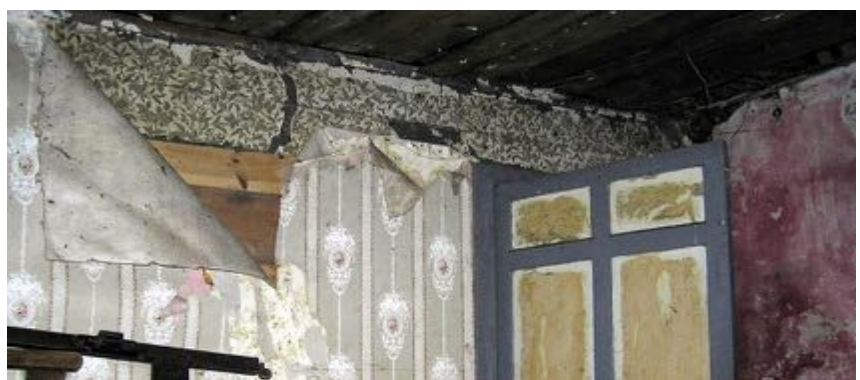
*Layers of wallpaper to the living room*

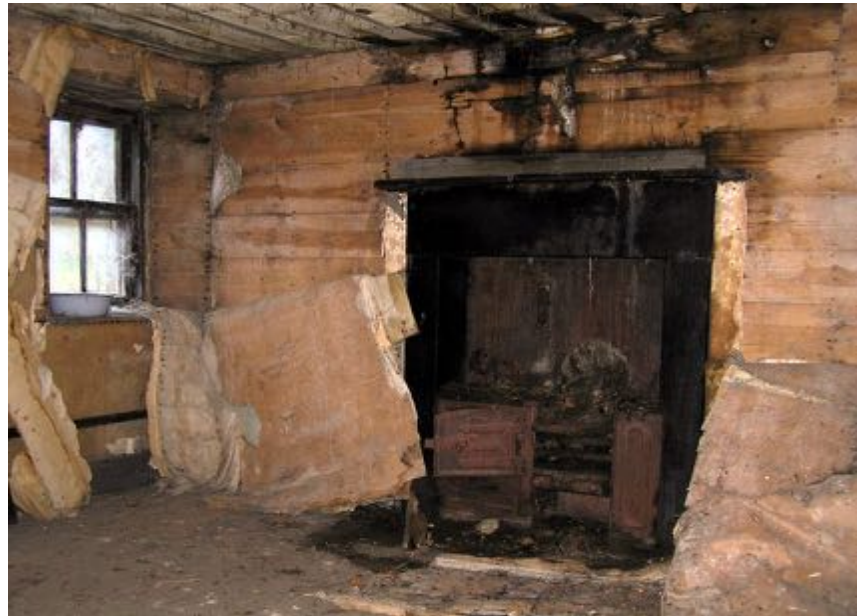
The changes made to the property seem to relate to the 1870s or 1880s. If the interior of the property had been unacceptably primitive, in the main this was overcome by lining the walls with rough sawn boarding laid butt-jointed, in preference to applying smooth plaster finishes which was reserved for the 'best room'. The primary benefit would have been improving appearance, and the insulation of the external walls. The same treatment was applied to close off the roofspaces and line the ceilings and walls, which were then covered in successive layers of wallpaper, a treatment that was not uncommon in lowly dwellings where living standards had to be improved, but where funds were restricted to make major improvements.

*Boarded wall linings to the kitchen and cast-iron grate*

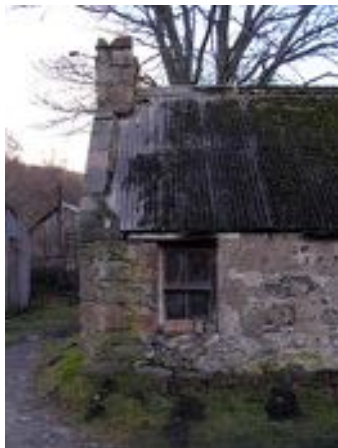
which is more likely to have been installed at this stage, rather than having been an original feature of the cottage. The window added to the rear wall of this room relates to the last round of changes to the fabric, and the fact that it is a four-paned sash and case window of a later pattern confirms this, as does the fact that the timber linings to the window do not match exactly with the wall linings. The Belfast sink, and draining board, within the old window recess on the front wall of the property, look barely used.

*Window introduced to the kitchen*

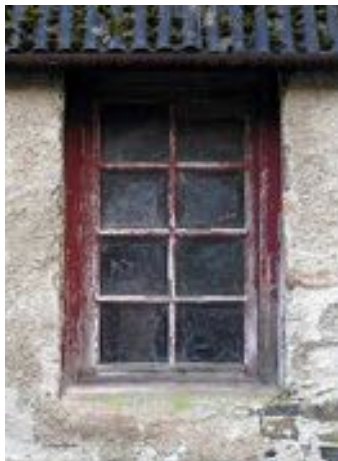
At some stage the road into the site was relocated to the rear of the properties. This would have been done for two reasons primarily – to provide privacy to the fronts of the houses to permit the gardens to be enjoyed, and to provide a more direct access to the steadings and mill, for which an increase in traffic must have resulted with the additions to the structures and the continuing diversification in agricultural activity. It seems that some further alterations were made to the cottage in response to this, and a central lobby was incorporated within the plan, or an existing space adapted, to provide access direct to a new door opening, slapped into the outside wall. The ceiling to the lobby is lap-boarded, unlike elsewhere. This alteration might have followed a change in the use of the building, perhaps for general storage, following on from the death of the last elderly occupant, Mrs Smith. The lintols of the door to the kitchen, and of the new door into the lobby are of timber, and the wall opening formed for the new door has been made good in brick, intended to be disguised by harling over the whole of the wall surface. Both of the windows inserted into the rear wall have rudimentary cills made up in cement.

*Window to the middle room*

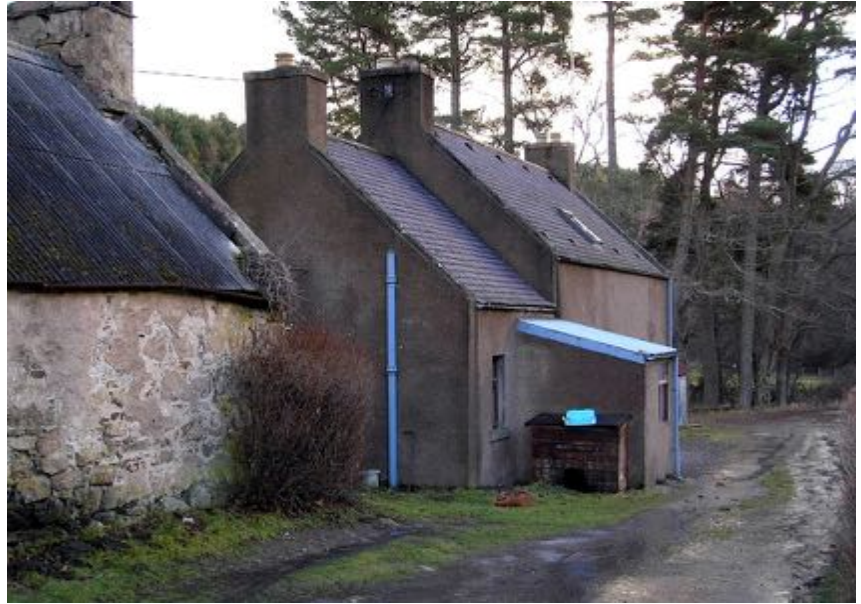
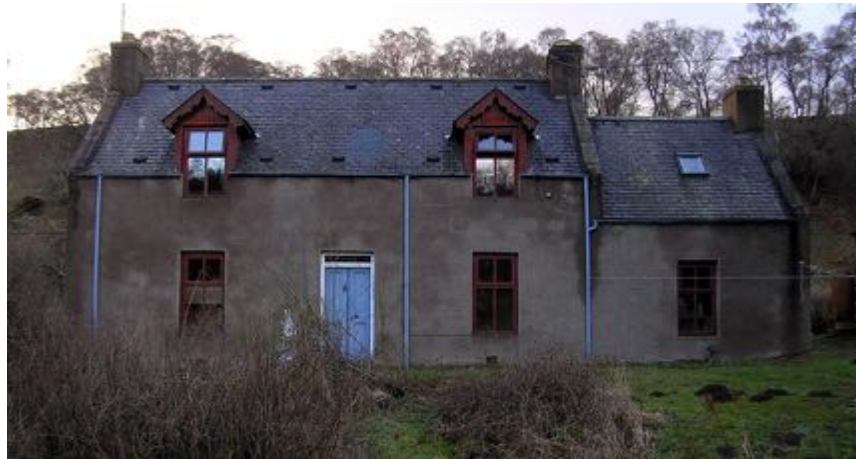
*Front and rear elevations of the Woolmill House*

elevation is, unusually, not quite symmetrical around the door to allow for increased area for the living room at the east end of the house, and for the principal bedroom. The internal layout is orthodox, with a central staircase leading to two rooms at each of the floors. A small store is positioned off the staircase set below the coomb ceiling, and each of the bedrooms has the characteristic wall press against the gables.

buildings, picked up by the same alignment in the agricultural steadings. But, more than this, the new house replicates exactly, and with subtlety, the pitch of the roof of the existing cottage, which results in a pitch closer to 50 degrees, whereas most new houses would be built with a pitch of 45 degrees at this time. It had the added advantage of making the rooms within the attic more useable. The single storey section had accommodation at first floor for a maid, but latterly it came to be used by the 'loon', a young helping hand for the farm and the woolmill and, occasionally, this would be a member of the family as Graeme Stewart recalls.

Although the wall surfaces are smeared with a modern dry-dashed cement render, the walls appeared well built, of local stone, probably not dissimilar to that found at the mill. A regional development of the older tradition of sneck harling can be seen on the early photographs, of lining out the masonry coursing and perpends (vertical joints) but the pointing is clearly still lime-based. Window and door openings are formed and treated in exactly the same way as the older properties on the site. Other developments can be witnessed, modifying the earlier traditions of building, and where the roof ridging might have been stone, lead or zinc just ten years previously, here it is of extruded clay tiles. Machine dressed Welsh slates, purplish in colour, but chosen to be more craggy in appearance to be more characteristic of Scots slating, have been laid in regular courses to standardised face widths, whereas before they would have been laid in diminishing courses to reflect the variable nature of the material delivered from the local quarries, or from West Highland sources. To a large extent these changes reflect the ready availability of a wider range of building materials than hitherto, through improvements in transportation, and the widespread adoption of mass production.

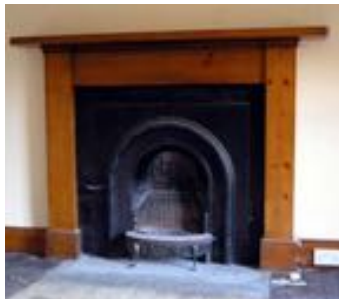
Interior details of the Woolmill House

Internally, while there is much that can be regarded as being standard throughout the house, with the exception of the kitchen and bathroom which have been refurbished, all of the rooms are close to their original condition, with characteristic features of plain moulded cornices run *in situ*, plain vertical linings to window reveals, four panelled varnished doors and plain moulded skirtings. The features that lift the quality of the interior are the cast-iron fireplace inserts, grates and fenders, and the range of period ceramic tiles and bricks and hearths. There are good plain fireplace surrounds to the bedrooms, while the fireplace to the living room, at the east end of the house, has elaborate beaded pilasters and attractive ceramic tiles to the fire surround and hearth. The staircase is of generous proportions, with barley-twist balusters interspersed with the more usual decorative castings. Varnished woodwork at first floor and throughout the stair enclosure has survived without change.

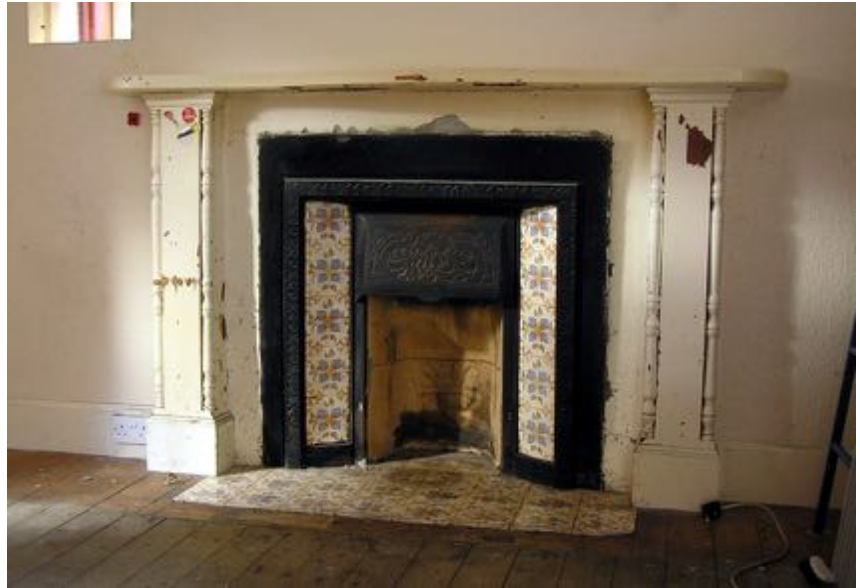
*Living room fireplace*

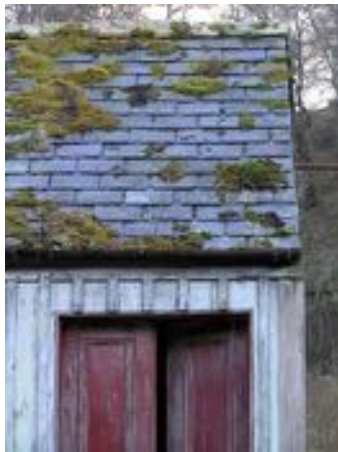
shop may have been less of an opportunity to display the ranges of material produced at the mill, as much as it had been an office for despatching orders, in addition to welcoming those onto the site. A large painted signboard carrying the name of the business had been fixed prominently above the shop window (see page 48). It was intended to be read at a distance from the elevated public roads to the north of the site, at a time when the vegetation was controlled, and when the site was much more exposed to view compared with how it appears now. It would have replaced the hanging sign fixed to the timber cladding on the approach to the mill entrance door, of which only the bracket remains.

*Detail of the shopfront*

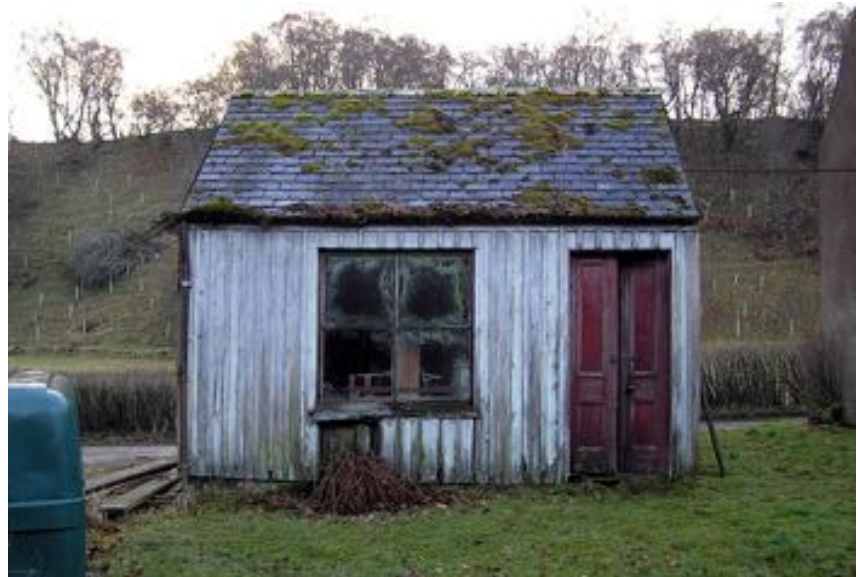
*Elevation of the shop facing the former road*

From later photographs it might be assumed that the shop was used for finishing off cloth by hand with some of the more portable machinery on the site, for which the large shop window (fitted with roller blinds) would have been appropriate to provide good natural lighting. An additional window was provided on the southeast wall, fashionably of sashes of unequal sizes, each with two panes of glass, which would have allowed a view of the road from the position of the desk and to gauge who, exactly, might be approaching. We cannot know if the shop was staffed permanently, whether it fulfilled the occasional uses referred to above, or whether it had been set up primarily for casual customers. By all accounts trade would have been busier when the owners of the local estates arrived in the area, when they would have been resident mostly for the months of August and September. Contemporary photographs of the mill show the effects of the industrialisation of the process, with the mill workers in dirty overalls, and fitters standing by with engineering hammers (page 22). It could not have been an environment conducive to conducting business.

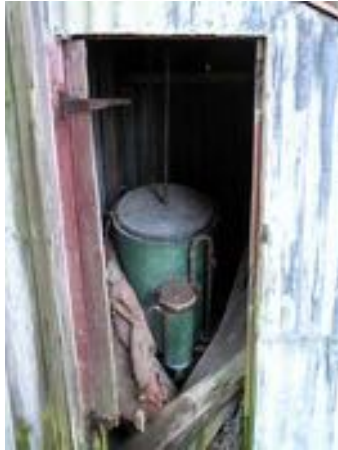
The carbide gas shed to the rear of the shop

With the exception of the lean-to sulphur shed, added to the northeast wall of the single storey wing facing the burn, and a gas carbide shed added onto the same elevation, both of which seem to have appeared in the first decades of the twentieth century, the constant round of extending the woolmill ceased. It appears that some of the textile machinery might have been replaced with other second-hand items, and the collection added to. The increase in production for blankets during World War I would have highlighted the need to rationalise some of the processes, while already others which had been central to the operations of a fully integrated vertical mill were being carried out elsewhere. The last of the machines to be installed within the mill, based fundamentally on Victorian engineering patterns and practice, was the automatic feed set purchased new in 1919 from The Automatic Feeding Machine Co Ltd of Rochdale.

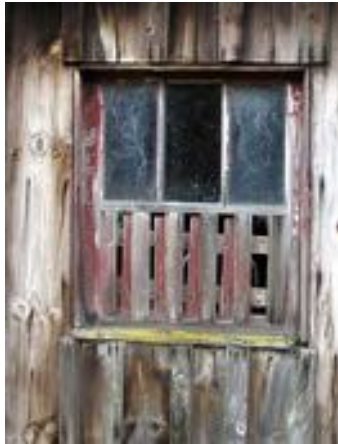
*Detail of window and ventilator to the steading*

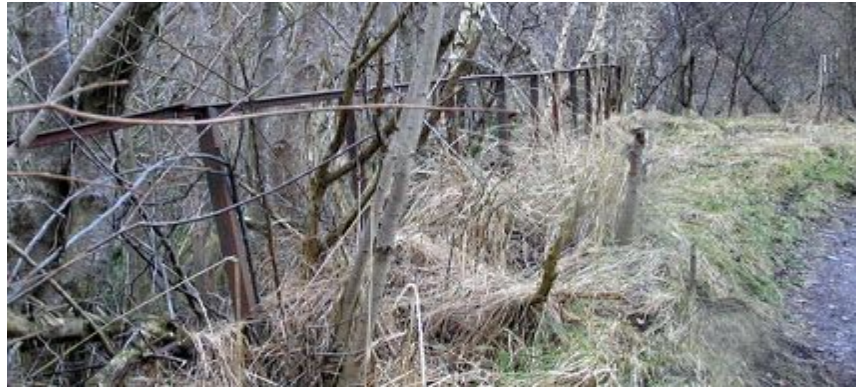
*The single bar fence on the driveway into the site*

From the early twentieth century the road to the front of the cottages was fenced off, initially with chestnut paling or similar fencing, and later with more elaborate fencing and gates made out of angle iron, bent into shape over a former, with decorative white painted spears projecting above the top bars. These were commissioned of the local blacksmith. The trees planted in the early years of the twentieth century matured; the most prominent of them now are the cypress, sycamore, and the horse chestnut with its broad and dense canopy, providing a setting for the backdrop of the waterwheel. A late photograph of the site, taken in the 1970s, shows that the garden was still being enjoyed, and a garden seat painted white, is positioned below the cypress, angled to look over the garden towards the burn. The cast-iron rustic bench seen in front of the house in the photograph taken with the Laidlaws was still in position at this stage (page 73).

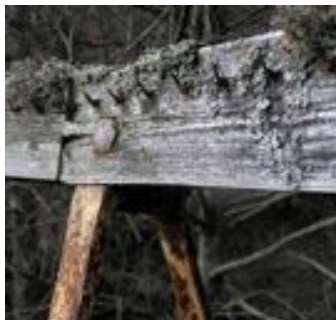
*Detail of the tenterhooks*

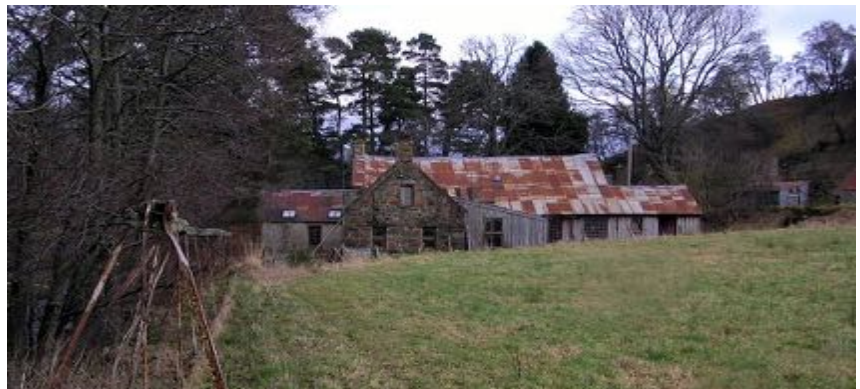
*Mill from the west with the tenter frame on the northern edge of the field*

The surviving tenter frame within the field has long been regarded as an important reminder of the production process, and of the premium that was attached within the industry to ‘summer dried’ blankets. Although the iron main frames remain, much less survives of the more vulnerable timber rails with their highly distinctive tenter hooks on which to stretch the cloth.

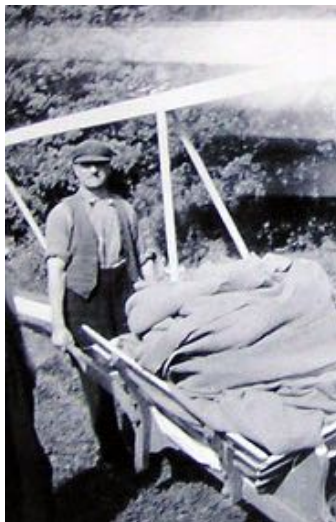
*The frame in use in the 1950s (courtesy of Graeme Stewart)*

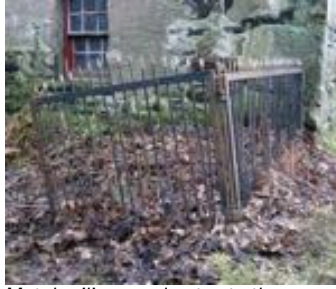
*Metal railings and gates to the private gardens*

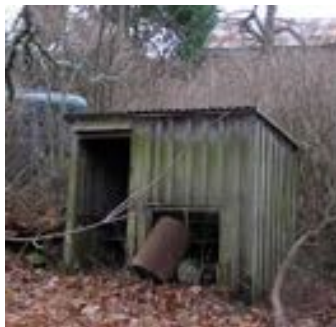
*The henhouse*

Another important feature of the site associated with the dwellings, appearing on the early photographs, is the henhouse located within the enclosure at the end of the stand of Scots pines beyond the shop. It is highly deserving of preservation in a scene that was of considerable diversity and richness in its simplicity.

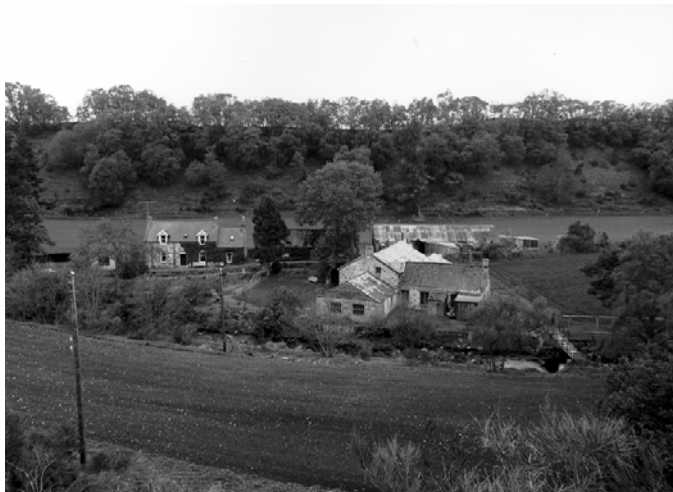
*The site in 1976 © John Hume, RCAHMS*
