No. 1446265.9

SAMPLE DESCRIPTION:
Decko SPC Hybrid Flooring – Moderno.

ISO 4760:2022(E) - LAMINATE FLOORING – TOPICAL MOISTURE RESISTANCE – ASSEMBLED JOINT (MODIFIED)

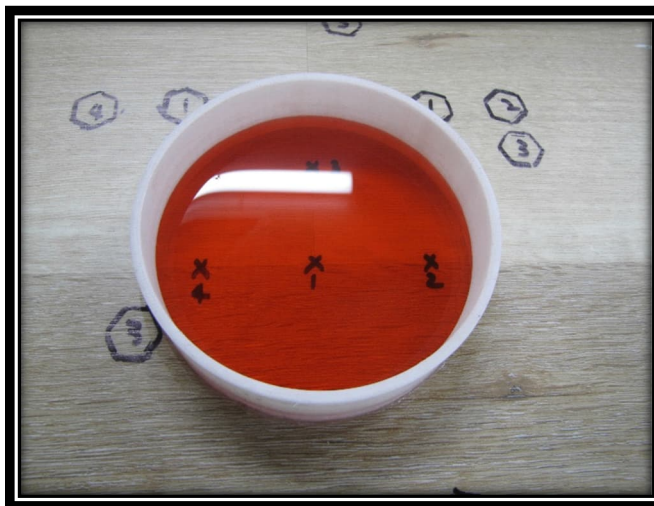
24 hrs With Water

100 mls of dye solution was applied onto the sample surface. It was poured into a cylinder 100mm diameter placed in the centre of the sample at the "T joint." Sealant was used at the plank/cylinder interface to avoid leakage.

The sample was left at 20°C, 65% Relative Humidity room conditions for 24 hours after the dye was added and then examined for dye penetration through the backing (not 23°C, 50% RH as stated in the method).

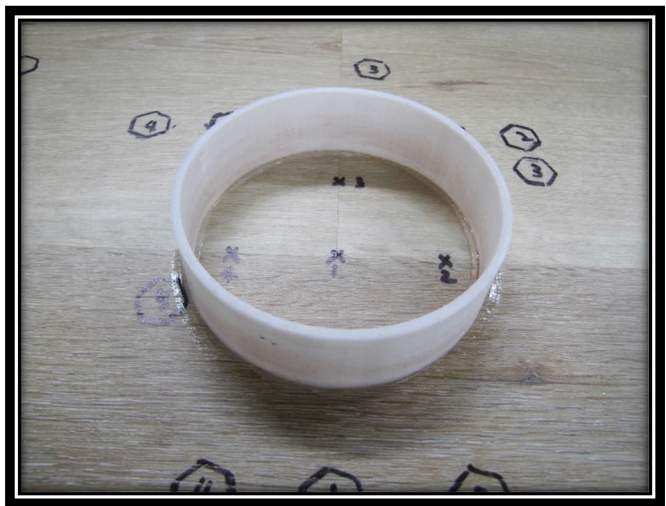
Wet Swell

Quantitative measurements are used to calculate surface swell in mm (within 15 minutes after water removal) and recovery swell (24 hours after removal of water).

Quantitative Results:	Wet Swell (mm)			Recovered Swell (mm)		
	Specimen 1	Specimen 2	Specimen 3	Specimen 1	Specimen 2	Specimen 3
Final Average (Positions 2 to 4)	0.00	0.01	0.01	0.00	0.01	0.00
Final average (Position 1)	0.01	0.00	0.07	0.00	0.00	0.04

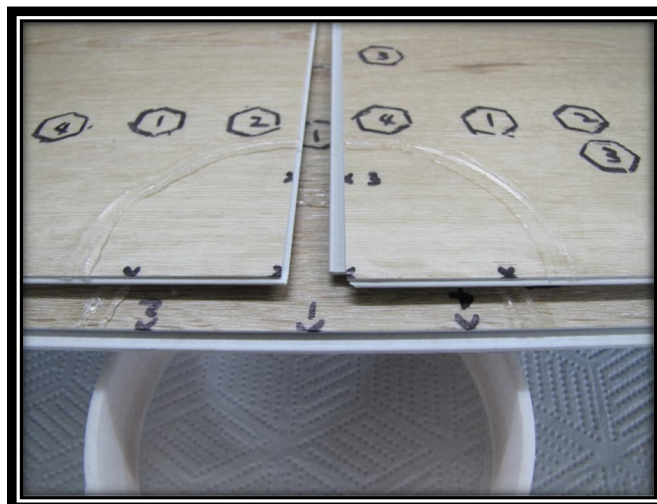
Recovered Swell (Disassembled)

Disassembly Observations:	Specimen 1	Specimen 2	Specimen 3
Migration of water along the upper surface:	No	No	No
Migration of water to the underside:	No	No	No
