Paddle Shift Retrofit Installation Guide

2004-2013 BMW 1 Series E81 E82 E87 E88 2006-2011 BMW 3 Series Sedan E90 E91 2007-2013 BMW 3 Series Coupe E92 E93 2010-2014 BMW X1 E84

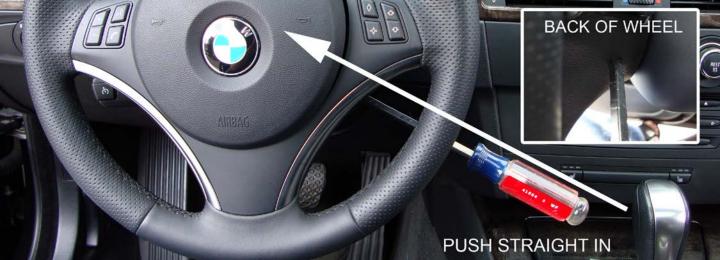
Step 3.) Airbag removal. Look and feel the lower back of the steering wheel for dimples, there is one on each side. You go through them with a thin flat head screwdriver at an angle as seen in the pictures. Then push the internal clip (operates like a safety pin) until the airbag pops out on that side. Repeat on the other side.

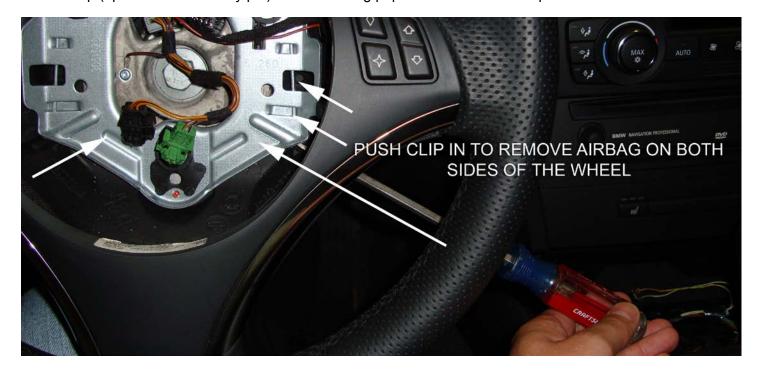
Step 4.) Disconnect the airbag. Use a phillips head screwdriver to carefully pop each clip as seen in the picture. Carefully remove the airbag and put face up in a safe place.

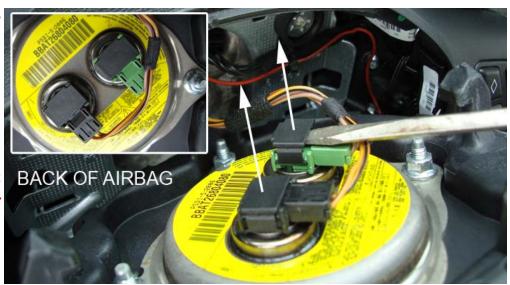
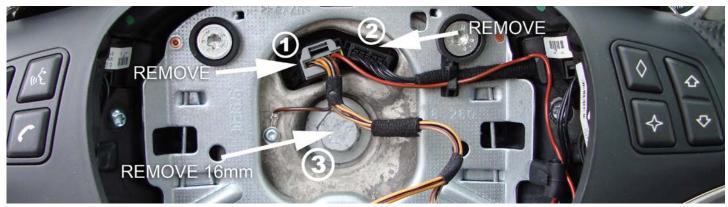
Step 5.) Remove the steering wheel. First carefully remove the (1) grey and (2) black harnesses above the bolt. Use a 16mm socket with extension to remove large (3) steering column bolt. Carefully pull the steering wheel straight off of the steering column. Please make sure the grey and black harnesses are disconnected before pulling the steering wheel off.

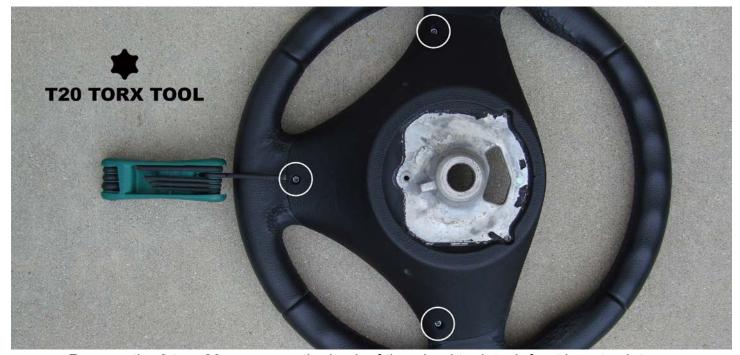
Step 6.) Remove the 3 torx 20 screws on the back of the wheel to detach front beauty plate.

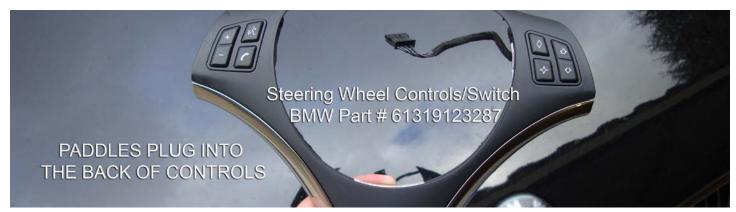
Step 7.) This is a very important step for NON-LCI paddles. If you don't have the BMW Part # 61319123287 the Sport or M3 DCT paddles will not work. Even if you have steering wheel controls that look similar, have plugs in the back or came with the used wheel you purchased. Attach the new steering wheel controls BMW Part # 61319123287 with a torx 20 tool to the back of the beauty plate. Each paddle plugs into the back of each side of the steering wheel controls/switch. Using a different part number will cause the retrofit not work unless you use modified LCI paddles.

Cause: Incorrect Steering wheel controls used. Incorrect part number used. Only <u>BMW Part #</u> 61319123287 can be used with this retrofit or the paddles will not work. Purchase the correct steering wheel controls and it will work. They all look the same. Only one will work. **LCI paddles.** Incase of LCI paddles, <u>resistors will have to be modified to work</u>. These paddles are not listed in our part numbers. If you do not have LCI DTC paddles then it is the steering wheel controls. 99% of the time it is incorrect steering wheel controls.

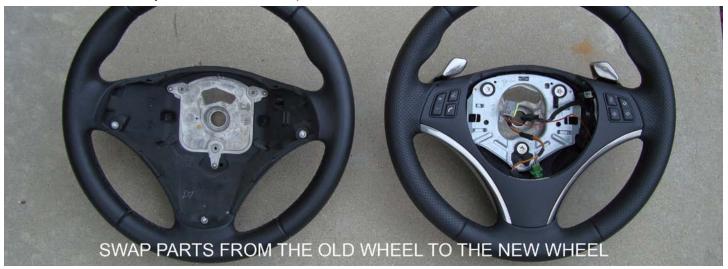
Step 8.) Remove the airbag bracket and airbag harness (If needed) from your old wheel to the new paddle shift wheel. Bolt in the right and left paddles to new wheel from the inside using (2) Paddle Torx Screws BMW Part # 32346759915. Reassemble the new wheel. Make sure everything is aligned and tight.

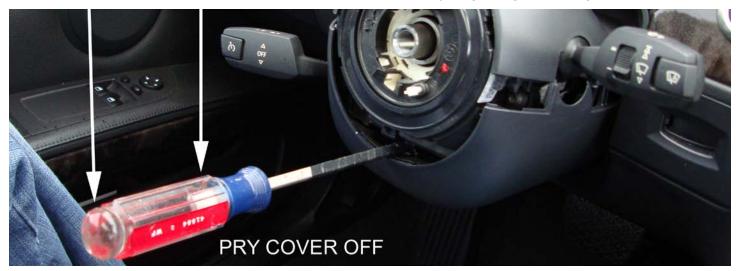
Step 9.) With the steering wheel off remove the lower steering column cover. Release the tilt steering lock on the left hand side of the lower column cover. Place your electrical tape covered large flat head screwdriver in the bottom cover from the front and carefully pry it off. Please study how this fits and aligns. It is difficult to put back on. There is a couple internal clips that need to line up on each side to reattach.

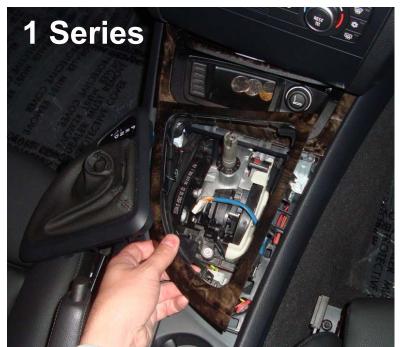
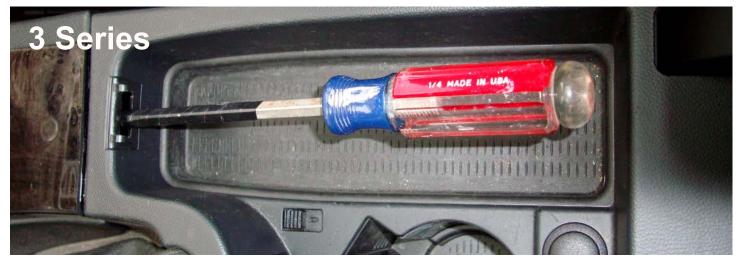
Step 11.) Remove the center console cover. 1 Series and X1 are different but wire locations are the same. Open the center console armrest lid and place your electrical tape covered flat head screwdriver in the hole for the arm rest latch as shown in the above picture and carefully pry it up. This should pop the console up.

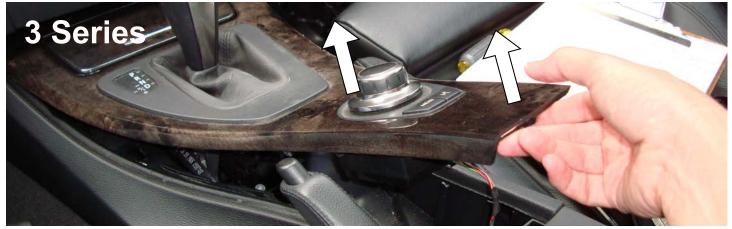
You can now grab this end of the console and carefully pull up to release the side clips. Carefully guide the leather shift boot off of the shift pole to avoid damage to the leather. Disconnect the idrive (where applicable), Disconnect the blue harness and the white harness on the bottom sides of the shifter cover. Remove the white cigarette lighter connector on the left under the ashtray. Carefully remove the console cover.

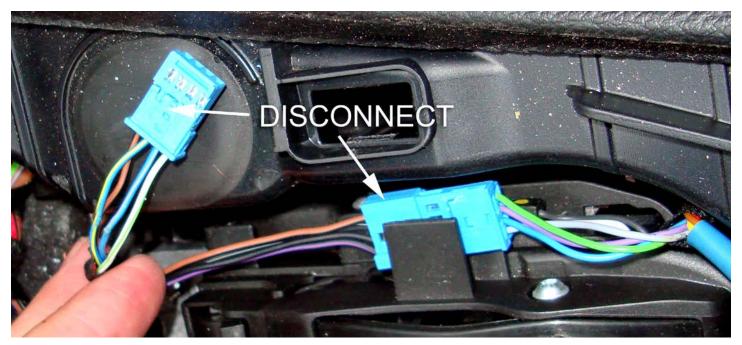
Step 12.) With the center console lid off, locate the blue connectors to the right of the shifter. Disconnect these two as shown in on the photo. This is where the blue connectors on the retrofit harness will connect.

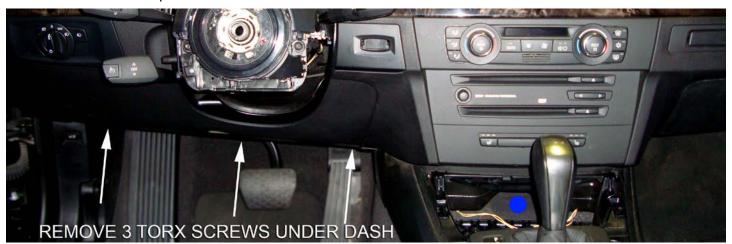
Step 13.) Remove the 3 Torx screws below the drivers side dash and lower cover to ease harness guidance through the dash. Stay low, the harness should have a clean path below the black Styrofoam in the dash. The harness should come out where the blue dot is in the photo above.

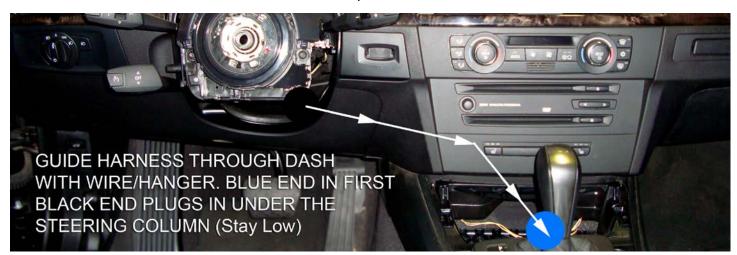
Step 14.) Guide the harness through the dash. Be careful when guiding the blue harness end through the dash not to damage the harness or anything on its way through the dashboard.

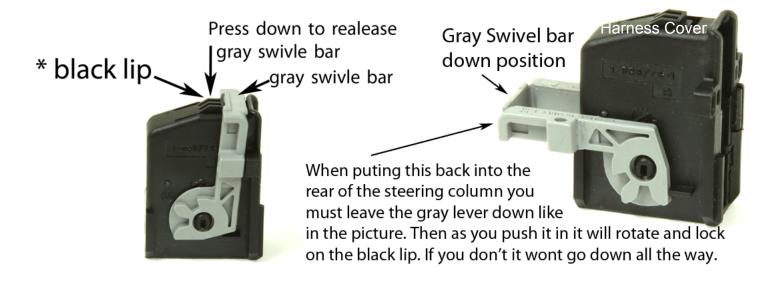
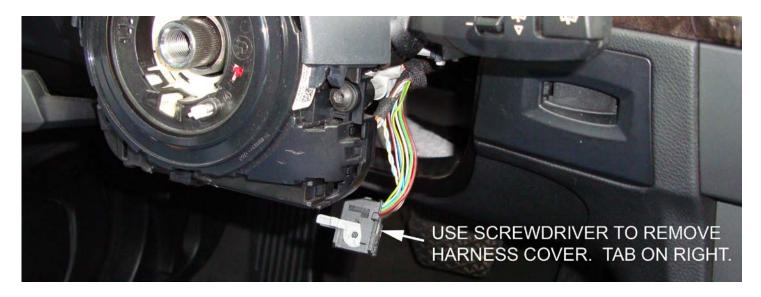
Step 16.) Locate the factory harness under the lower right side back of the steering column and remove it. There is a *black lip on the back that can be pressed and the *grey swivel bar will rotate to the left to eject the harness. Please see pictures below of the mechanism that holds the factory harness in the back of the steering column. Please pay attention to the removal of this part. Most problems occur when this harness end is put back in. Once out, take the harness cover off and attach it to the proper end of the retrofit harness. The next few steps will show you how to do that.

Cause: Harness cover with gray swivel bar loose, improperly connected, not locked in or harness inside is backwards. Factory harness is upside down on in steering column. Incorrect pins were removed.

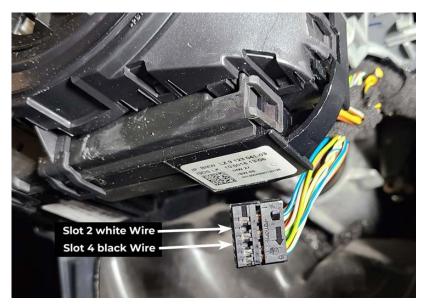
Step 18.) Once the BMS Retrofit harness is plugged in slide the factory harness cover over the black 12 pin connector. The arrow on the harness should be pointing in. It will click in when secure. This end plugs in the back of the steering column where you removed the factory harness. The grey swivel bar on the harness end will snap into place when harness is secure.

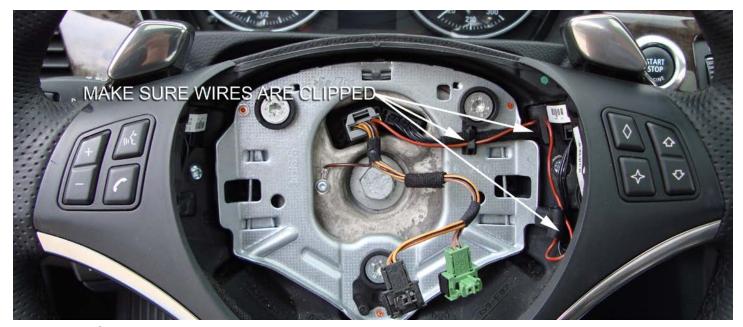
Step 21.) Before clipping the airbag back into the steering wheel make sure all wires are in their clips and out of the way as secured in both of the photos. Double check everything here. (see photo on the next page for a closer look)

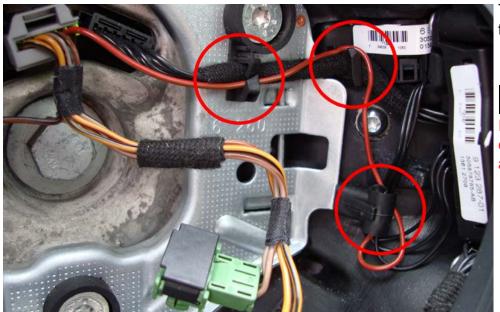
This is a closer look at where the wires should clip.

If the wires are not properly clipped and tucked away the airbag will not sit properly.

Cause: Wiring is in the way and not properly stowed behind the airbag/horn (see above photo) or the silver airbag bracket in the wheel is bent. It is in the photo above behind the wiring. This is usually caused by a deployed airbag in the used wheel you bought. You must use the airbag bracket from your original wheel.
