CERTIFICATE OF
CONFORMANCE FOR NDT
RINSE NOZZLES, SPECIFICATION
COMPLIANCE, TROUBLE
SHOOTING GUIDE & CERTIFIED
REPLACEMENT PARTS

TRI-CON/Conard Holdings LLC

Certificate of Conformance
Tri-Con/Conard Holdings
Complete Tri-Con NDT Wash Nozzle
S-1/2HH25-D

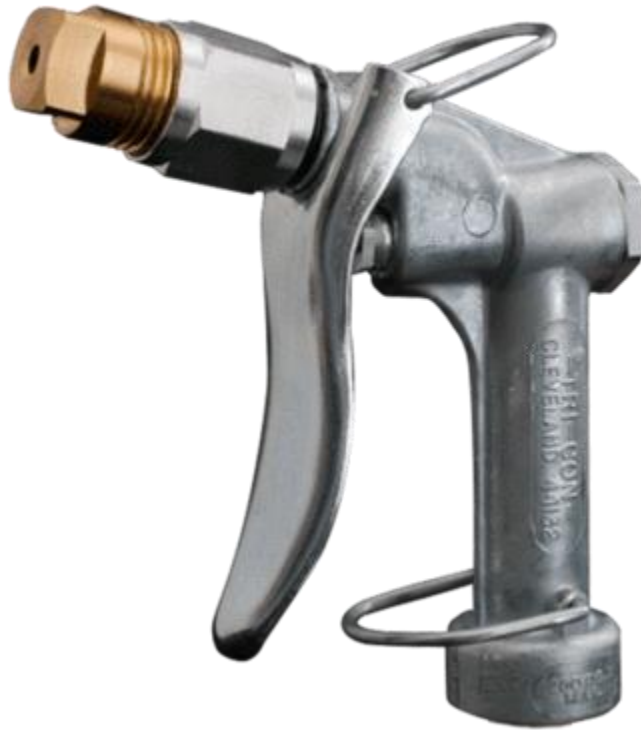
Pictured below is the Correct NDT Wash Nozzle Configuration with Spray Tip That Produces a Coarse Spray.

Page 4: Picture of the correct NDT Rinse Nozzle S-1/2HH-25-D Configuration

- 1) On the side of the spray nozzle body it will say Tri-Con Cleveland 44132
- 2) On the other side will have Pat. No
- 3) Where the hose attaches on onside will say 250 PSI
- 4) There will be an adaptor that screws onto the spray nozzle body should have a brass cone inserted into the adaptor. See pictures on page 3. **This wash nozzle & spray tip configuration does meet ASTM E 1417 Requirements.**

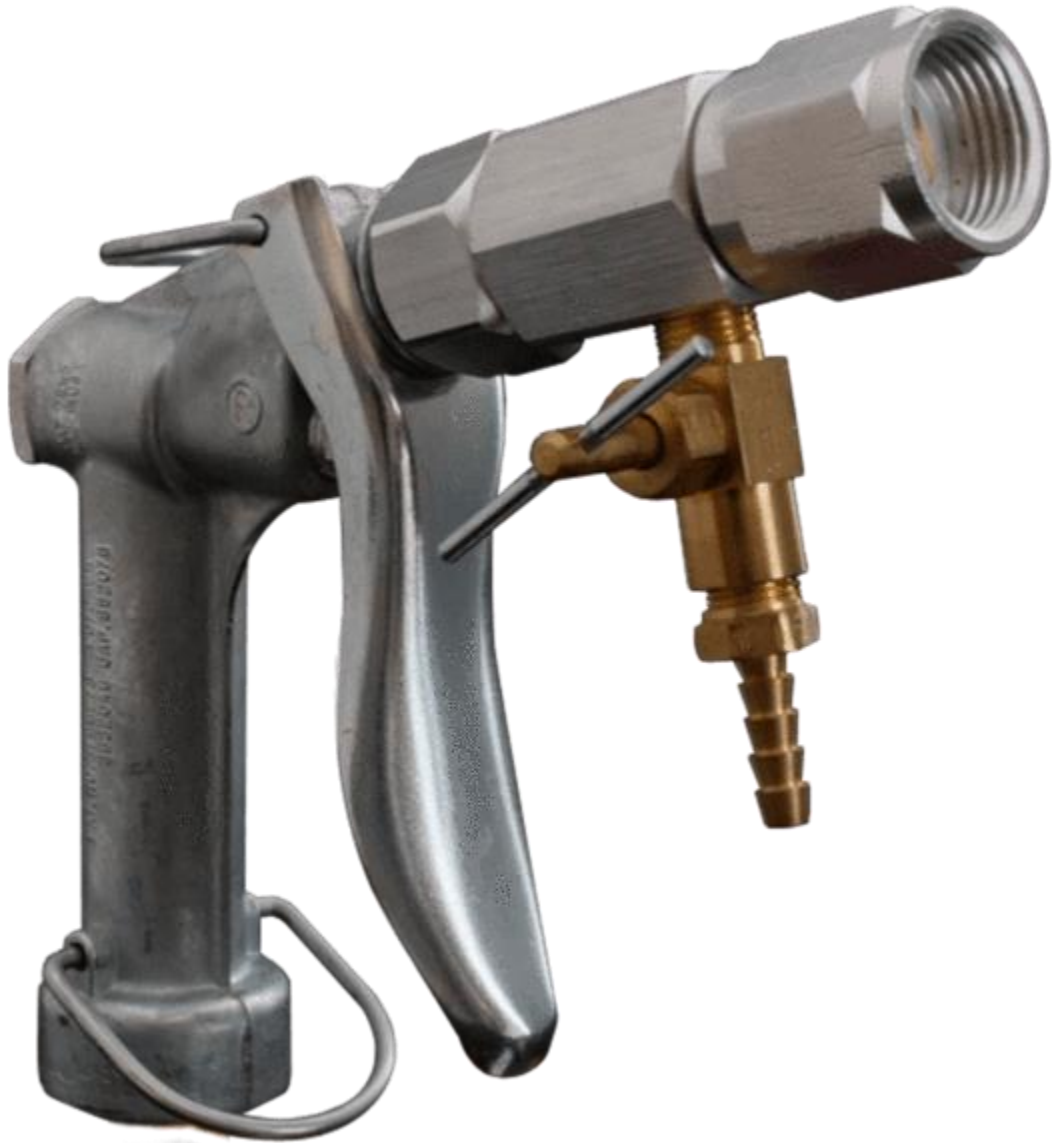
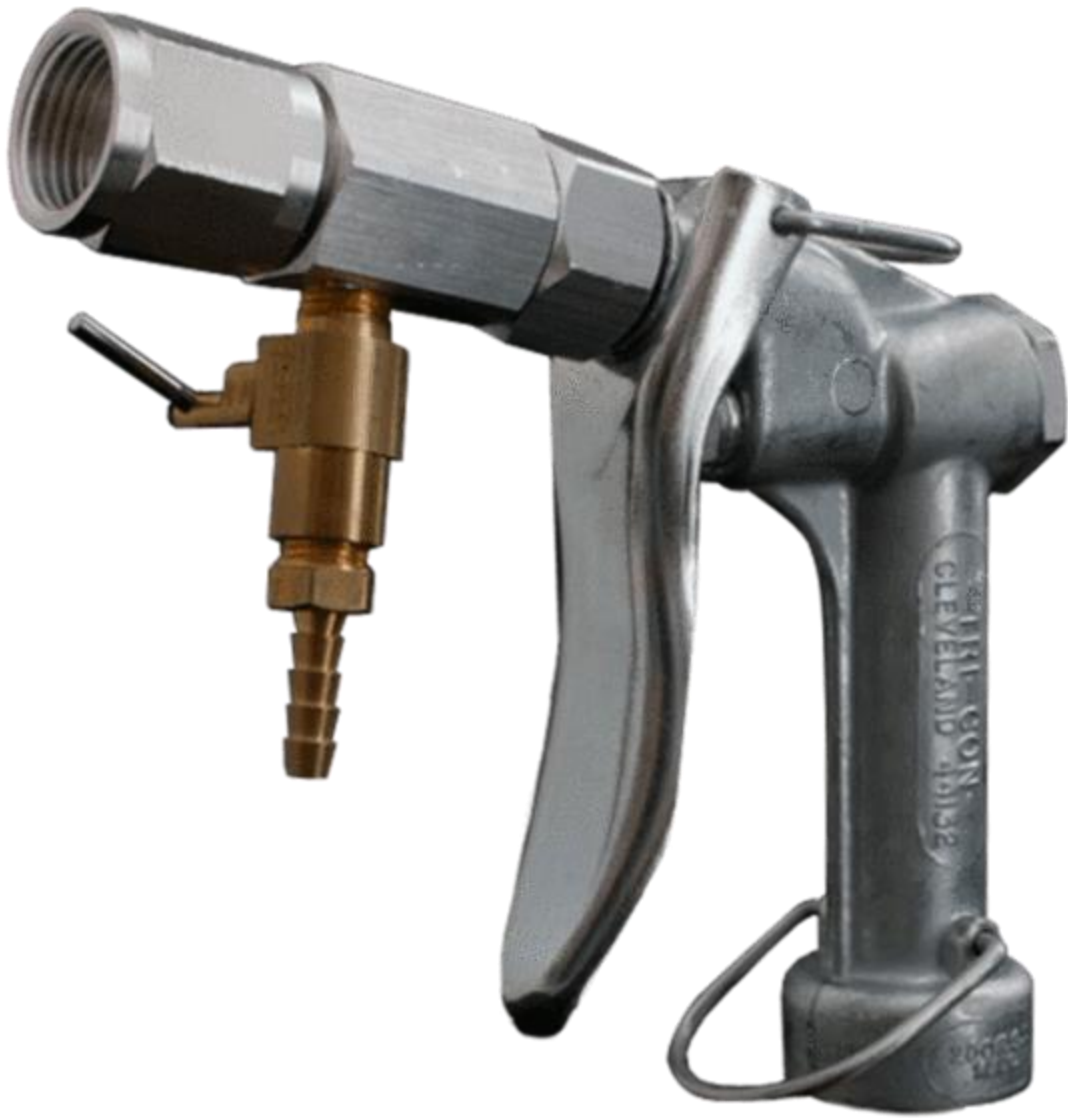
In the pictures below on pages 4-5 is the Model I-400-1 Air/Water Wash Nozzle is Correct NDT Wash Nozzle Configuration with Spray Tip if it is called out in ASTM E Specs (NDT Use / Specifications Compliance: ASTM E1417, AMS 2647D, BPVC)

Pages 5-6: Pictures of the correct NDT Rinse Nozzle I-400-1 Configuration

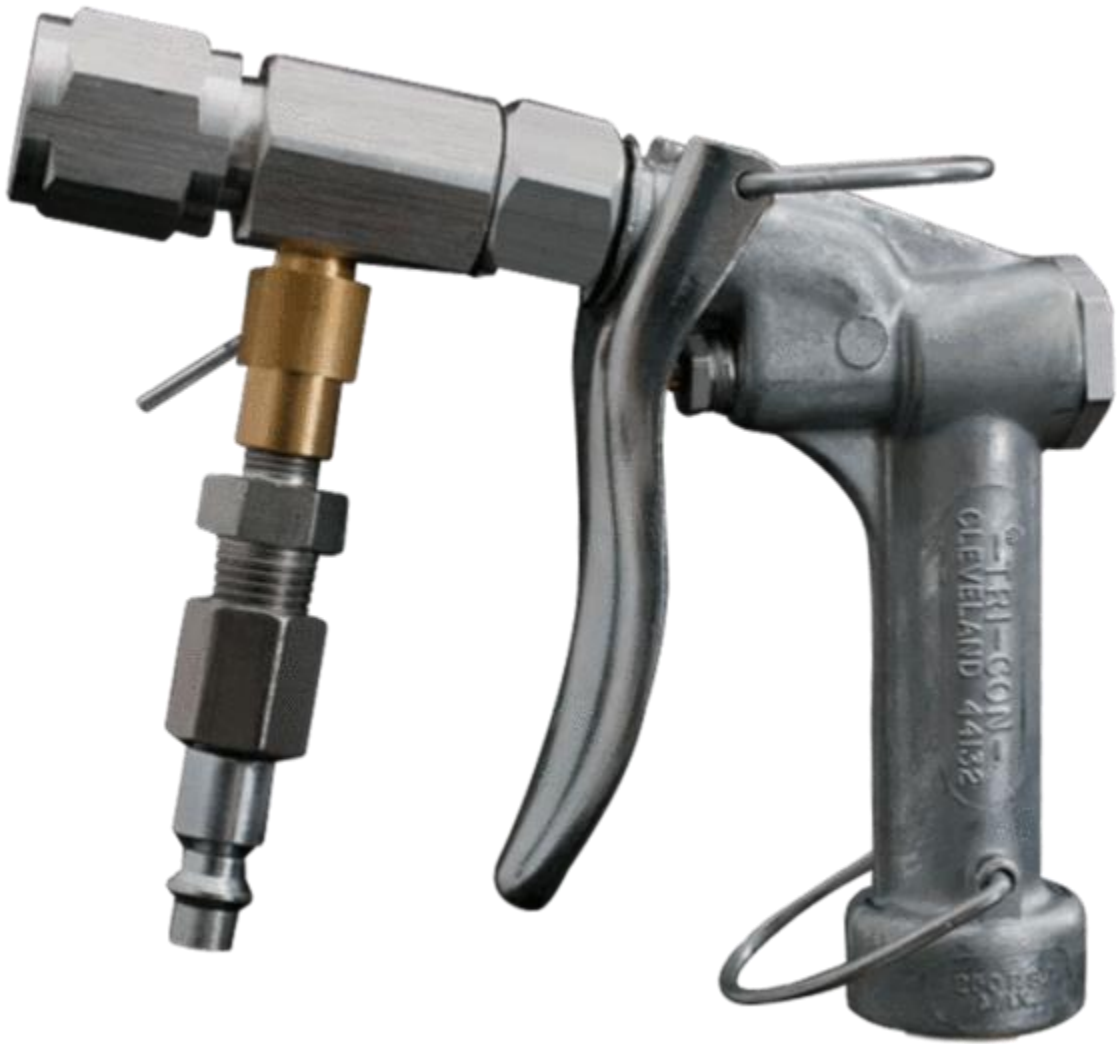
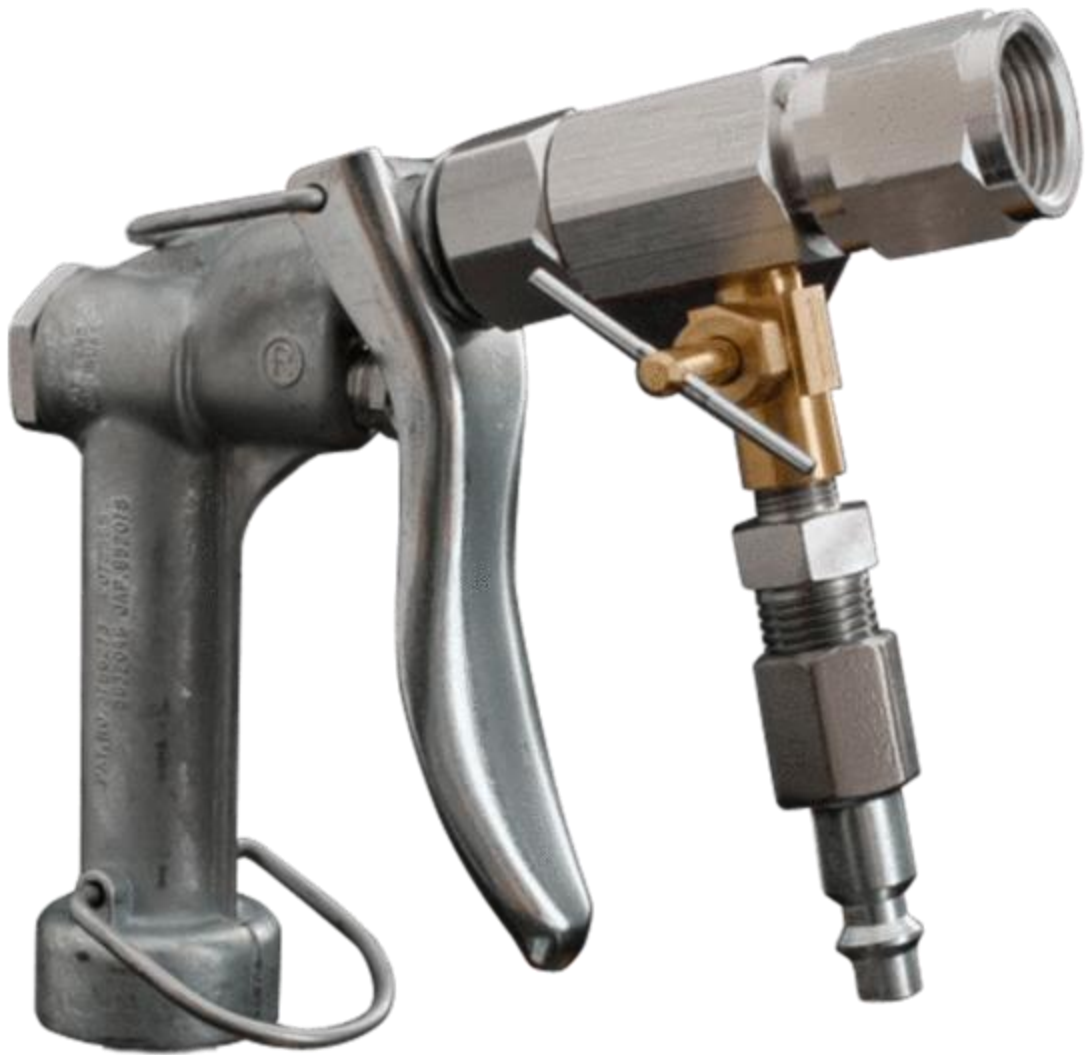
In the pictures below on pages 6-7 is the Model I-400-2 Air/Water Wash Nozzle is Correct NDT Wash Nozzle Configuration with Spray Tip if it is called out in ASTM E Specs (NDT Use / Specifications Compliance: ASTM E1417, AMS 2647D, BPVC)

Pages 7-8: Pictures of the correct NDT Rinse Nozzle I-400-2 Configuration

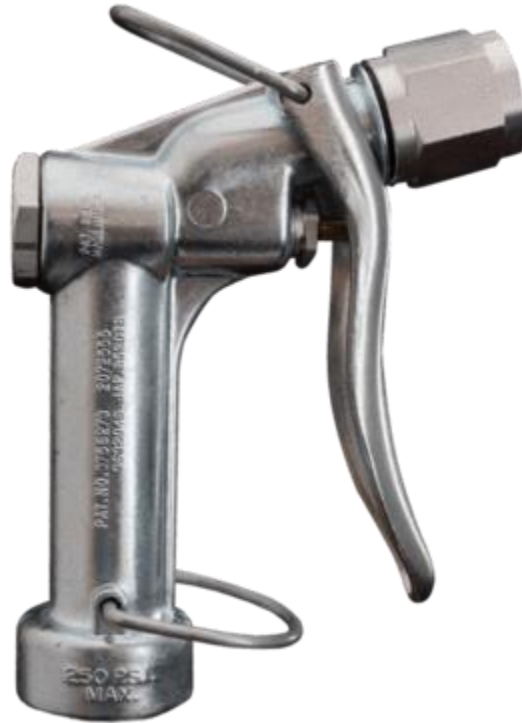
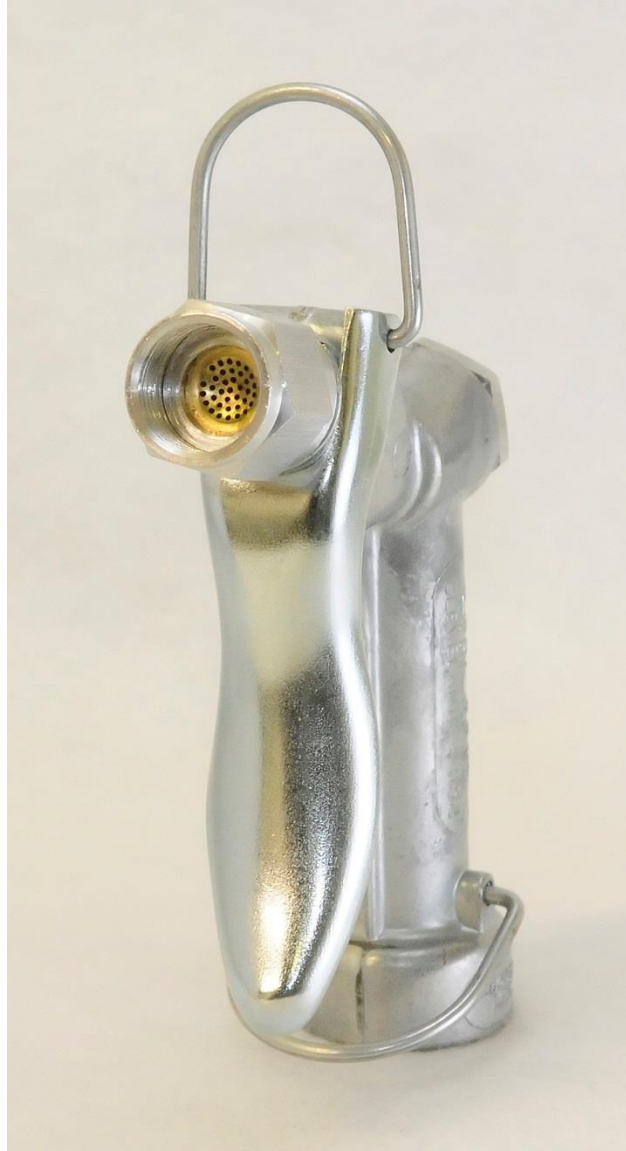
Picture below on pages 8-9 are pictures of the Incorrect Wash Nozzle Configuration
This is the model F-C-125 Reversible Nozzle Water Spray Nozzle
Provides a full fan spray when attached one way then when reversed gives you a straight stream spray. **Please note that the brass ½ HH-25 spray nozzle will not thread into the reversible spray nozzle.**

Pages 9-10: Pictures of the incorrect NDT Rinse Nozzle, Pictured is the water spray nozzle F-C-125 with reversible spray tip (which the brass spray tip doesn't thread into)

- 4) The spray nozzle tip on this spray nozzle is reversible, this spray tip is called a E-C-325-CA Reversible Nozzle Tip. See pages 8-10 for pictures. Screwed onto the spray tip one way will give you a full fan spray, unscrew the spray tip and turn it around and screw it onto the spray nozzle body this will give you a straight stream spray. This spray tip looks like the one that is on the S-1/2HH25-D NDT Spray Wash Nozzle, instead it will have a small brass screen with a lot of small holes half way down inside the casting instead of the brass 1/2HH25-C spray tip screwed into the casting. Note that this spray tip looks like you would be able to screw the brass cone ½ HH into it, which you can't do. **This wash nozzle & spray tip configuration does not meet ASTM E 1417 Requirements.**

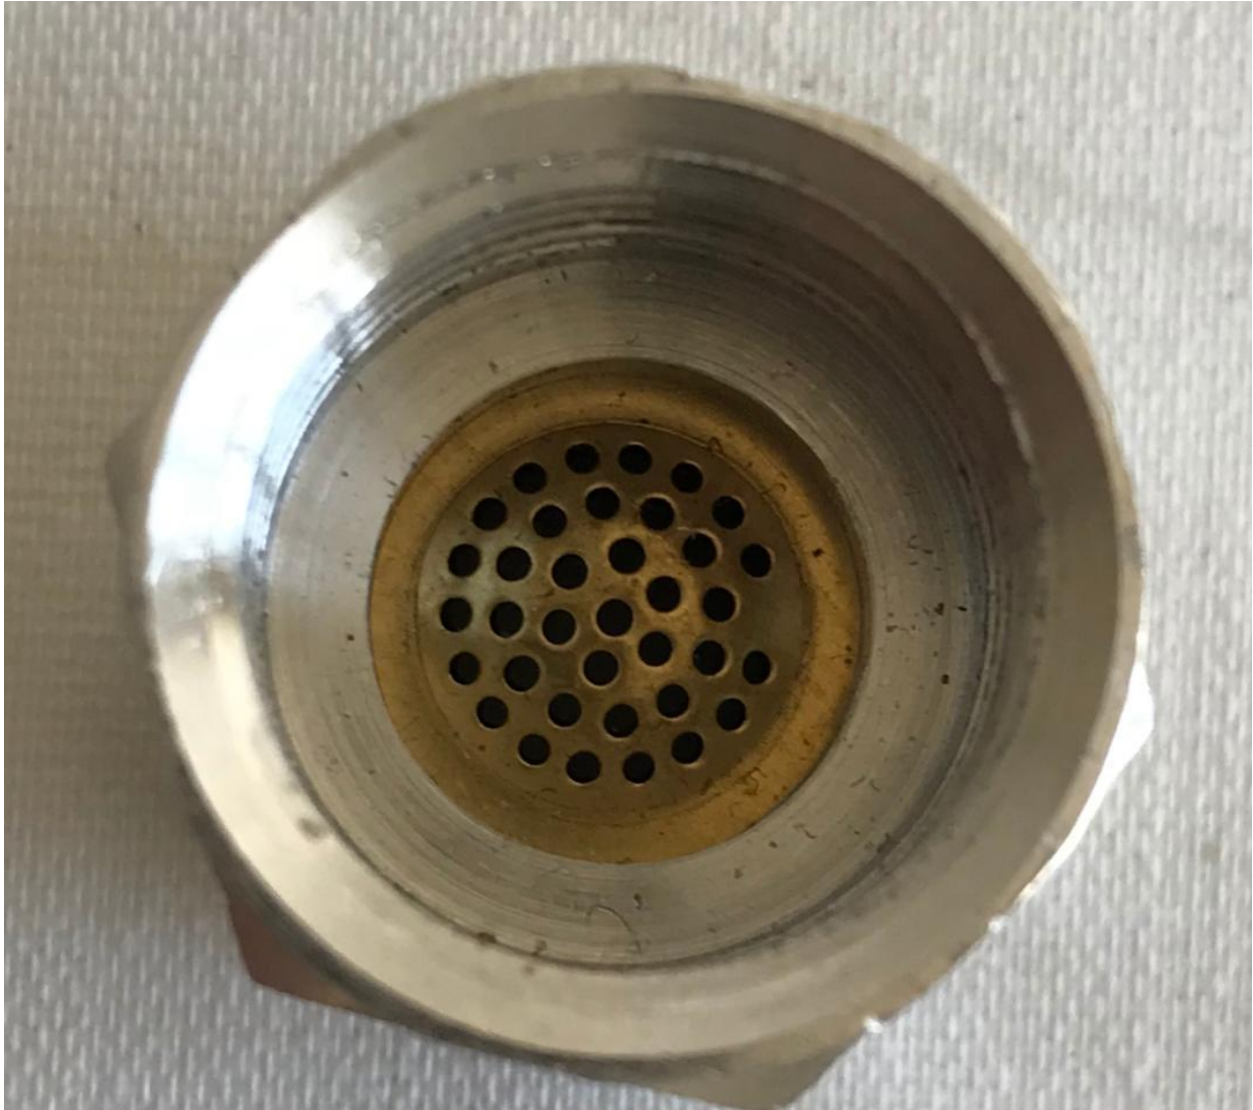
This is a picture of the E-C-325-CA Reversible Spray Tip.

This spray tip doesn't work with the S-1/2HH-25-D NDT Rinse Nozzle, nor will the brass 1/2HH-25 spray tip screw into the E-C-325-CA. Shouldn't be used with the S-1/2HH-25-N replacement nozzle by itself, during any part of the rinsing process.

The E-C-325-CA spray tip is only to be used with the following two NDT Rinse Nozzle, I-400-1 and I-400-2. Please refer to pages 3-7 for the correct configuration.

Page 11: Picture of the E-C-325-CA reversible spray tip. This spray tip is only to be used with either NDT Rinse Nozzles models I-400-1 or I-400-2

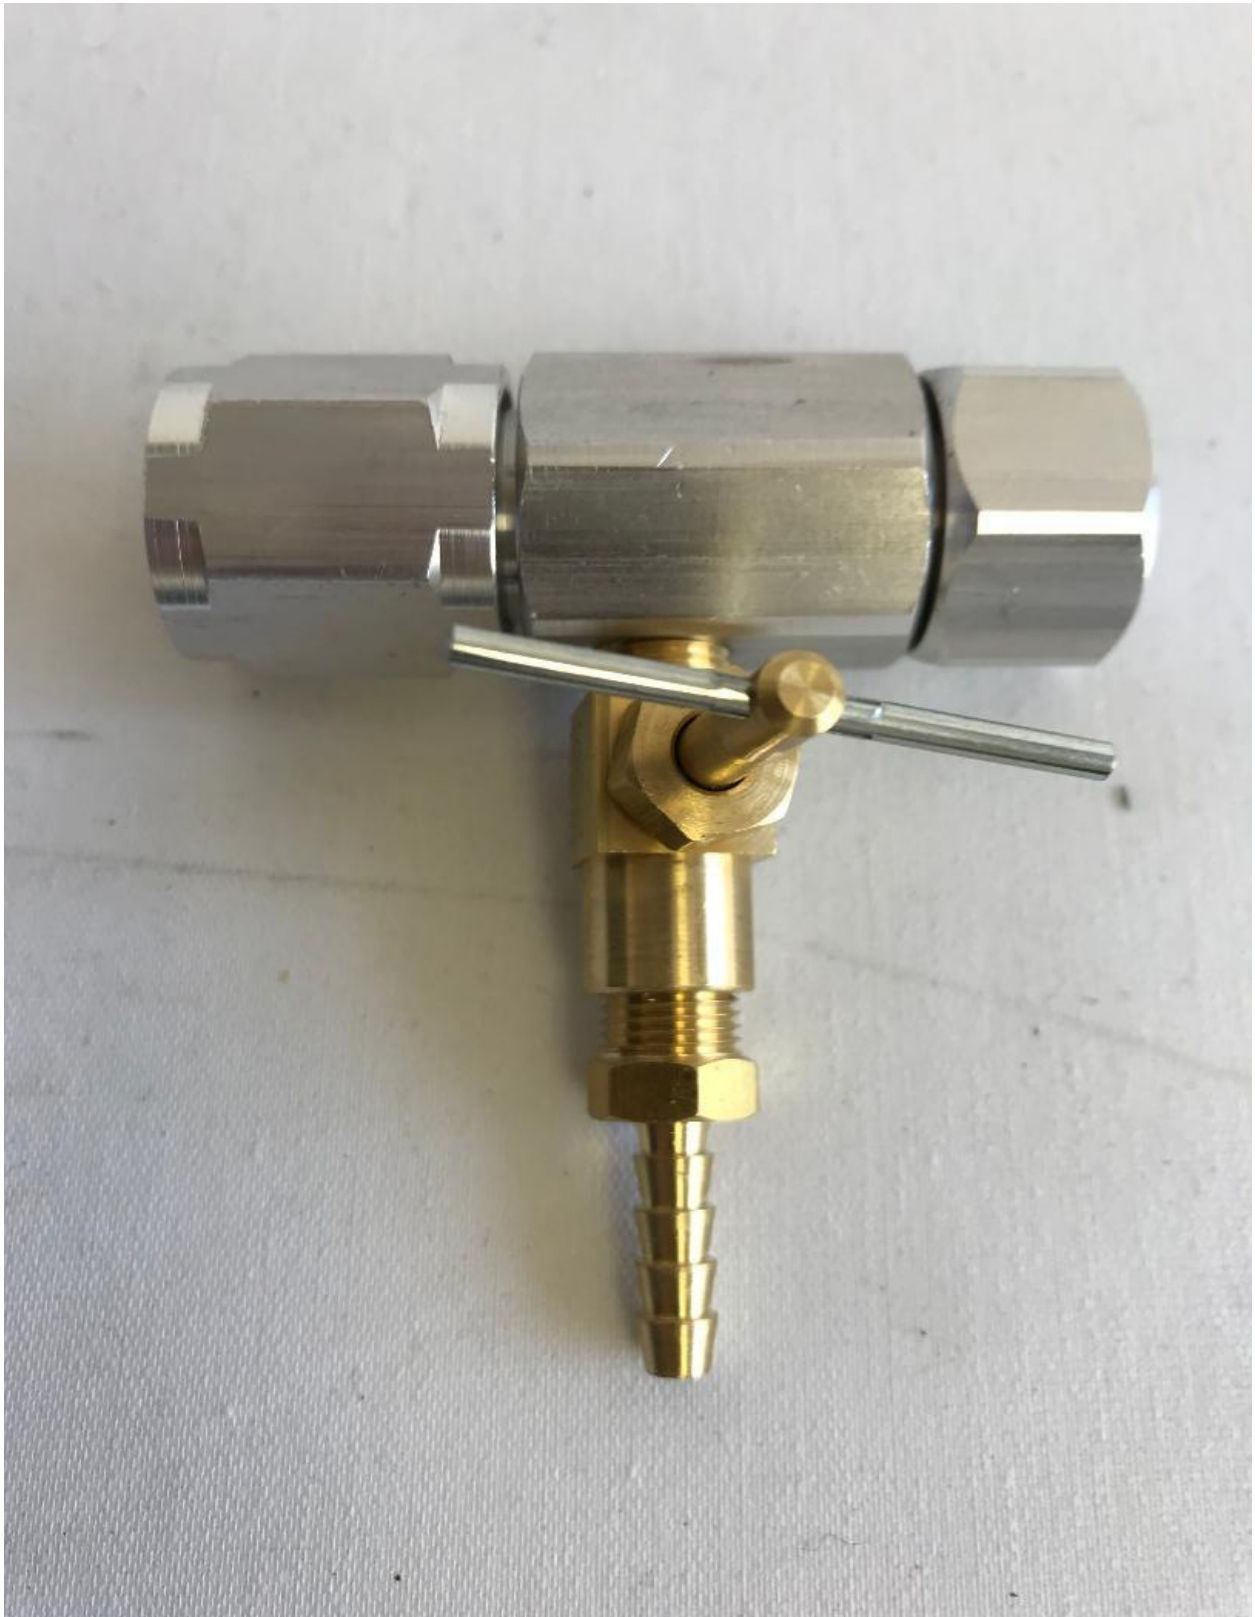
I-400-1-3 Pressure Booster Spray Head Complete (used with model I-400-1)

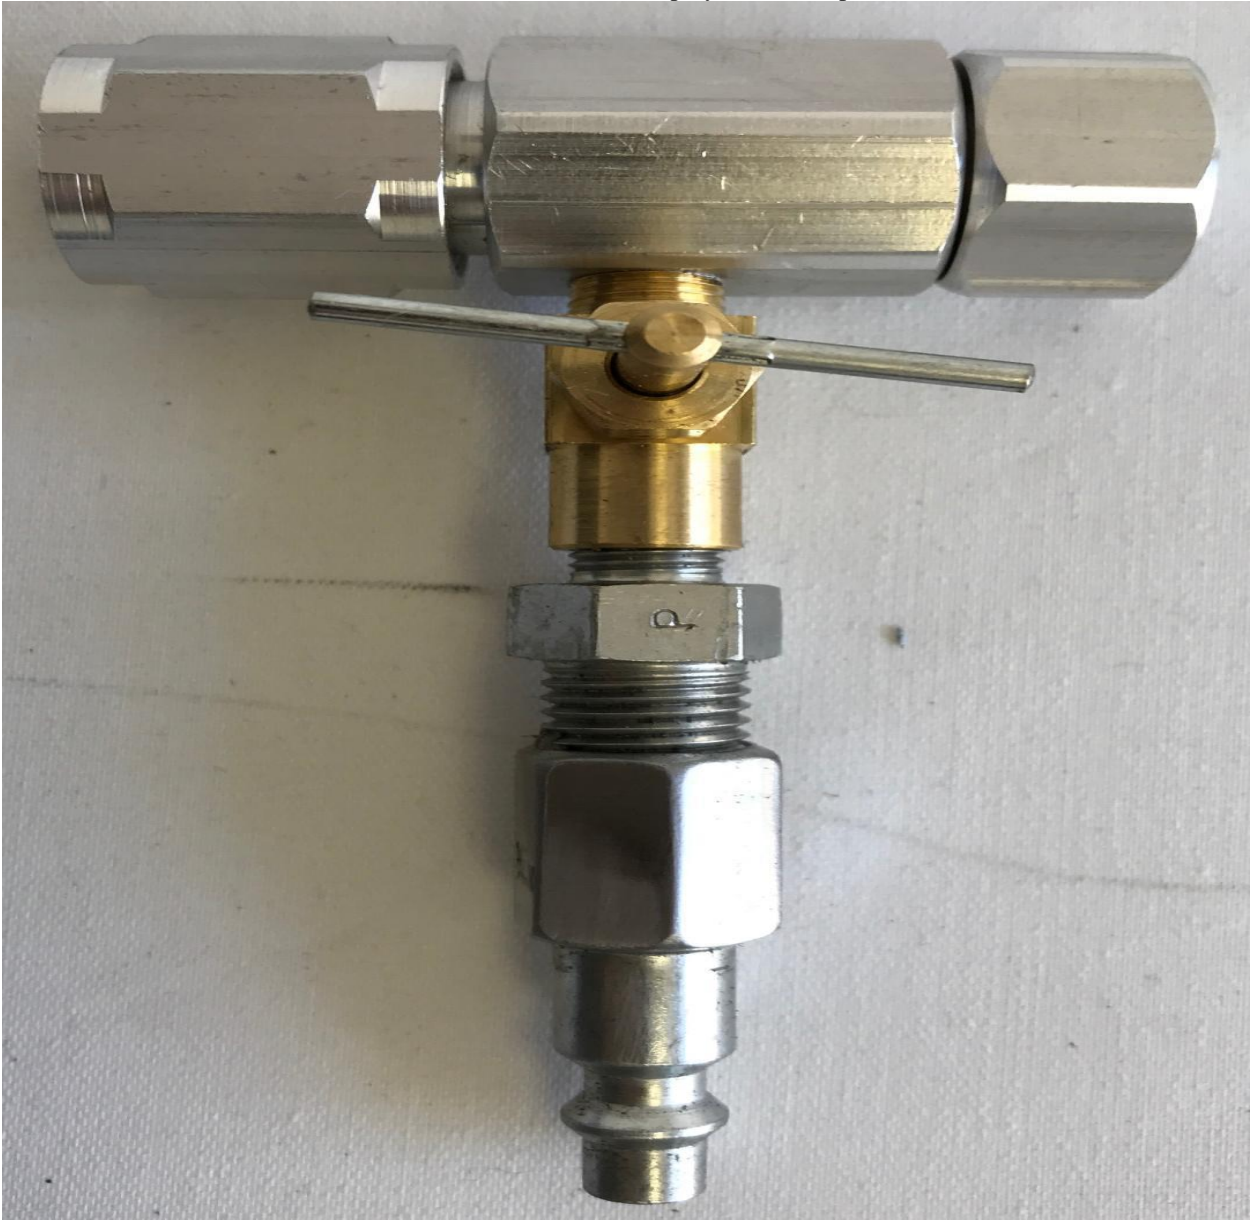
I-400-2-5 Pressure Booster Spray Head Complete
