Slip Test Report

Alhambra Tiles

BS 7976:2 PENDULUM SLIP TEST REPORT

In- House Testing: Sample Tiles

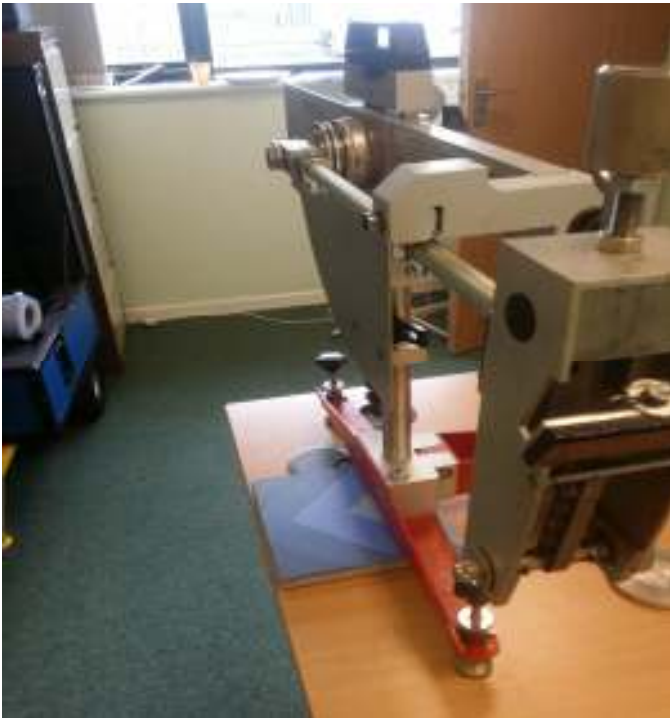
(#1)

The blue tile tested was noted to have 2 coats of Bellative seal system applied to the tile. The tile was tested in 3 directional swings, using the #96 slider. In Dry & simulating Wet conditions.

Test area	Test Result Values			Mean PTV
#1	67	64	63	65
#2	70	69	67	69

Test area	Test Result Values			Mean PTV
#1	41	40	40	40
#2	50	48	51	50

The sample tiles with each treatment shows a '**Low Risk**' in '**Dry**' & '**Wet**' conditions, to HSE guidelines. (as per HSE slips information sheet)

I recommend that a further test be carried out with the client after 3 months after the tiles have been installed to certain areas after trafficked to see any factors regarding the slip risk i.e. Contamination/cleaning chemicals etc.

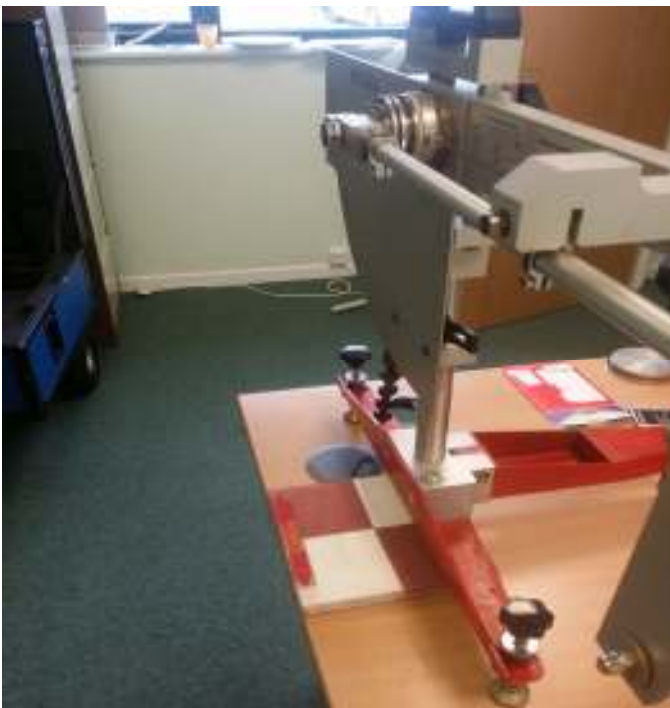
(#2)

The Beige/Red tile was tested and noted mitval tile which was sent. As previous the tile was tested, 3 directional swings using the #96 slider. In dry & simulating Wet conditions.
