Slip Test Report

ALHAMBRA TILES

BS 7976:2 PENDULUM SLIP TEST REPORT

In- House Testing: Sample Tiles

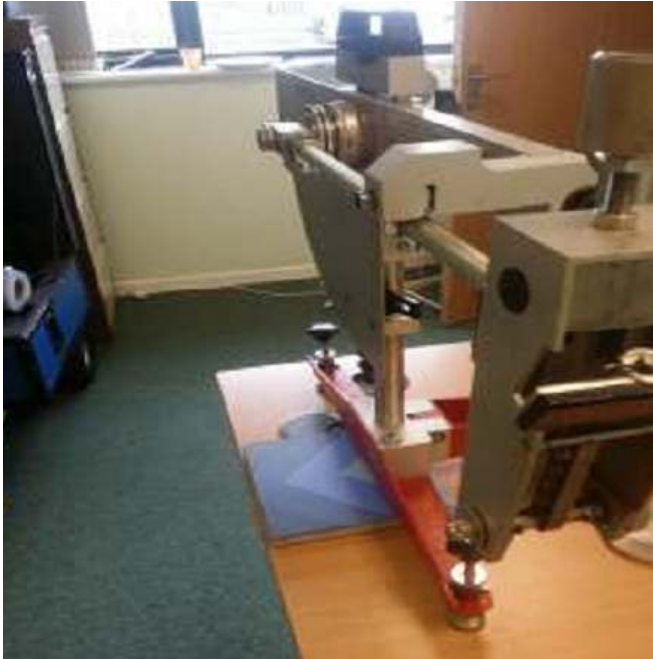
(#1)

The blue tile tested was noted to have 2 coats of Bellatrix Natural Solvent-Based seal, applied to the tile. The tile was tested in 3 directional swings, using the #96 slider. In dry & simulating wet conditions.

Test area	Test Result Values			Mean PTV
#1	67	64	63	65
#2	70	69	67	69

Test area	Test Result Values			Mean PTV
#1	41	40	40	40
#2	50	48	51	50

The sample tiles with each treatment shows a 'Low Risk' in 'Dry' & 'Wet' conditions, to HSE guidelines. (as per HSE slips information sheet). Slider Verification was validated prior to testing due to being new #96 slider used and was verified on the pink lapping film, float glass, and pavigress tile in according with UK Slip resistance group guidelines and HSE/HSL laboratory testing.

The testing took place in test conditions on what was sent to me was noted to me being new tile with treatments added to the surface, as numbered #1 & #2 in this report I recommend that a further test be carried out with the client after 3 months after the tiles have been installed to certain areas after trafficked to see any factors regarding the slip risk i.e. Contamination/cleaning chemicals etc.

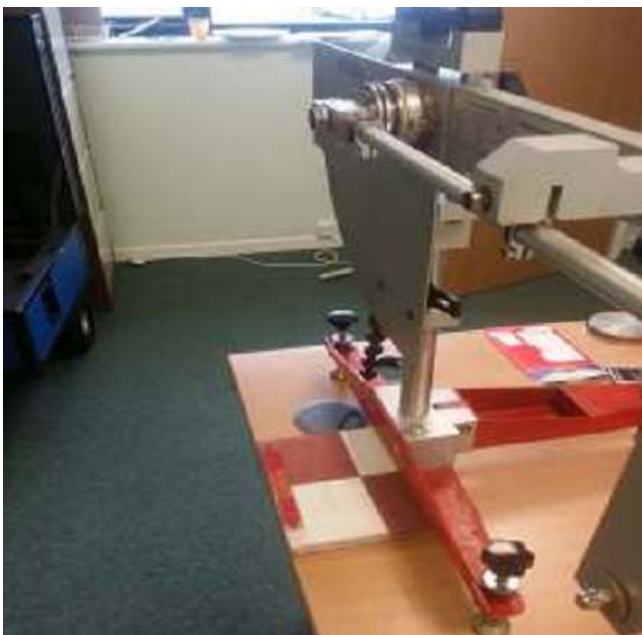
(#2)

The Beige/Red tile was tested and noted to me as a 'Mitrol' seal applied to the tile. As previous the tile was tested, 3 directional swings using the #96 slider. In dry & simulating wet conditions.
