# RECOVERING CONVICT LIVES

A Historical Archaeology  
of the Port Arthur Penitentiary

First published by Sydney University Press 2021

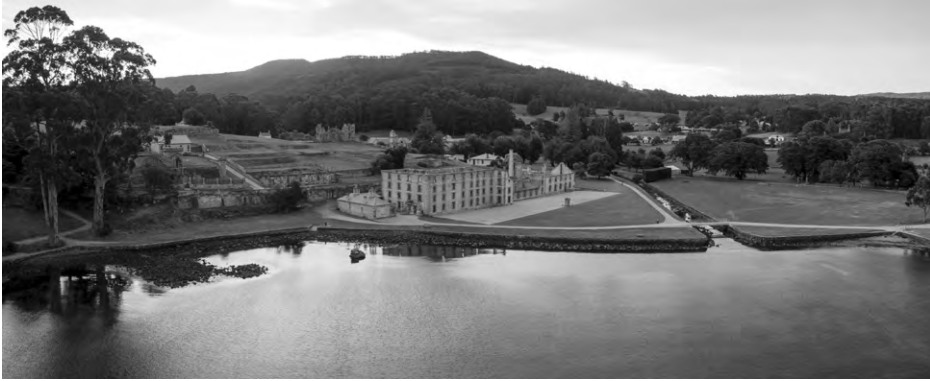
**Figure 0.2.** The penitentiary is situated at the base of Settlement Hill (left), on the former edge of Mason Cove. The cove was partly reclaimed during the 1850s. (Hype TV for PAHSMA, 2017)

The penitentiary stands on the southern side of Mason Cove, occupying ground at the base of Settlement Hill that was formerly waterfront until reclamation of the bay commenced in 1854 (Figures 0.1 and 0.2). To the rear of the penitentiary (south west) runs the elevated formation of Champ Street, then – as now – the settlement's main thoroughfare.

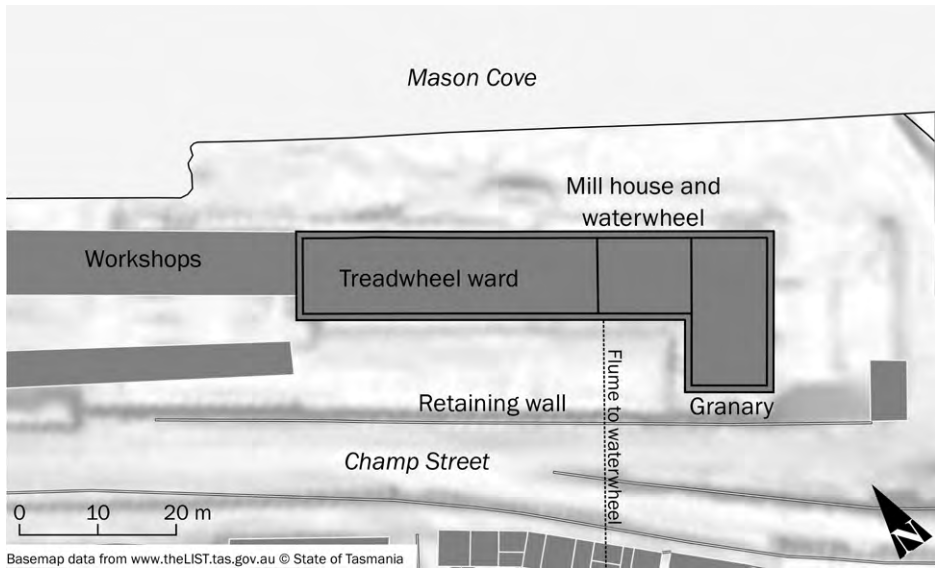
**Figure 0.3.** Detail plan showing the layout of the mill and granary in 1846.

Much of the structure that we see today was actually built between 1842 and 1845, when a large brick flour mill and granary were erected on the former site of a waterside lumber yard and workshops (Figure 0.3). The largest portion of the structure housed a large 35-foot overshot waterwheel, the mill machinery and a timber treadwheel. The latter was a punishment device for convicts, the motive power generated by 48 men stepping on the treads of a 12-foot wheel. The power of man and water were harnessed to the grinding machinery. The smaller portion of the building housed a granary and offices.

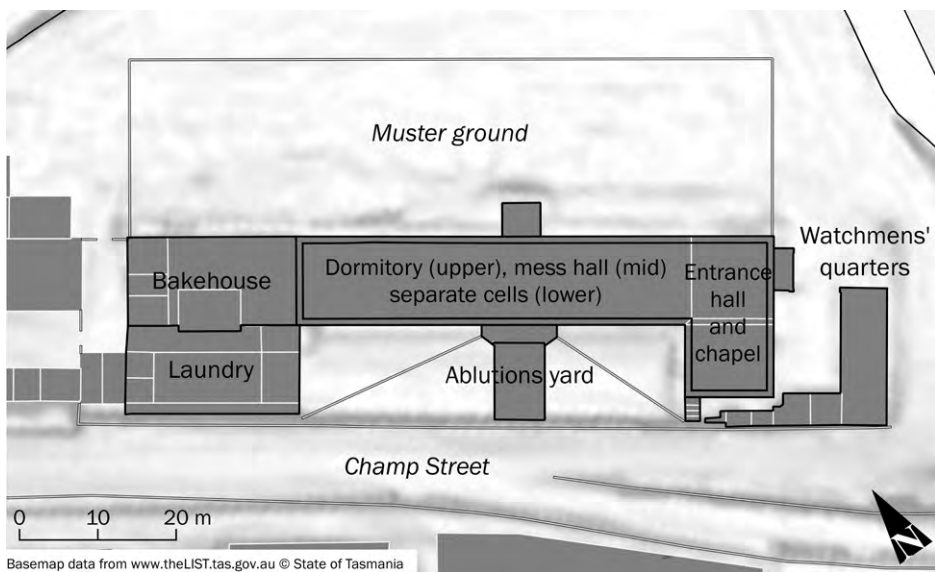
**Figure 0.4.** Detail plan showing the layout of the penitentiary in 1857.

Alterations to the structure between 1854 and 1857 turned it into a secure penitentiary building capable of incarcerating 480 prisoners (Figure 0.4). The mill and granary were gutted, leaving behind a retrofitted shell containing cells, a mess hall, dormitory, chapel and library. A new bakehouse was built to the west and a building for watchmen added to the east. At the front of the building a muster ground was laid out on newly reclaimed ground, while to the rear were added exercise yards, ablutions buildings and a laundry.

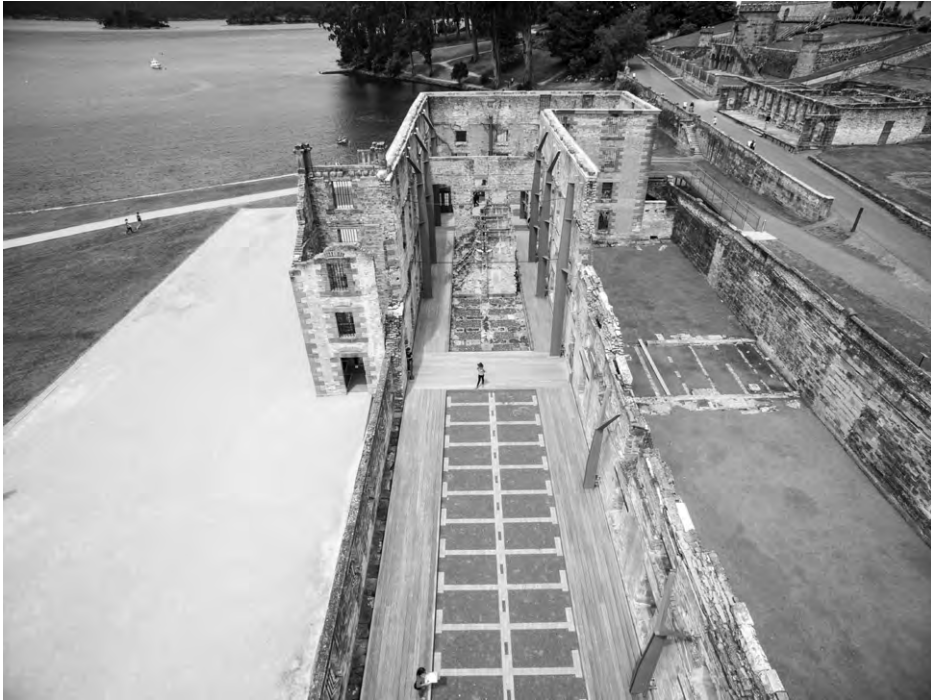
**Figure 0.5.** View looking east from the location of the bakehouse over the penitentiary. The muster ground is on the left, with the ablutions area on the right. Champ Street runs above the ablutions area. (Hype TV for PAHSMA, 2017)

The structure that remains today reflects both these phases of the building's occupation: an 1840s façade and the remnants of an 1850s interior. Much of the latter, including the structure's roof, was lost in an 1897 fire during the post-convict period. Fire and salvage claimed the penitentiary's ancillary structures, with the muster ground, exercise, ablutions and laundry spaces levelled and grassed over. This is how they remained for much of the 20th century. Today, thanks to the archaeological investigations, the area has been landscaped and interpreted to reflect its use between 1856 and 1877 (Figure 0.5).

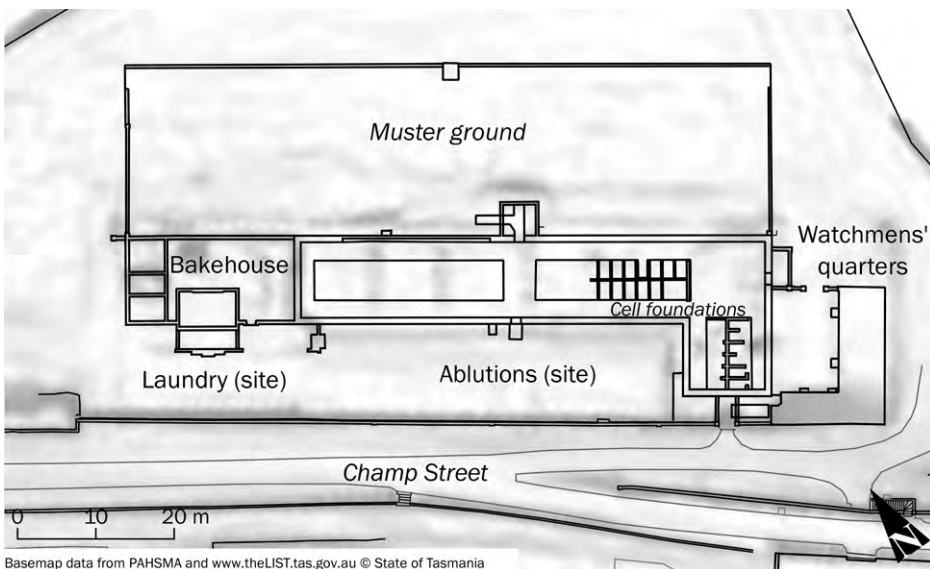
**Figure 0.6.** Plan showing the penitentiary today.

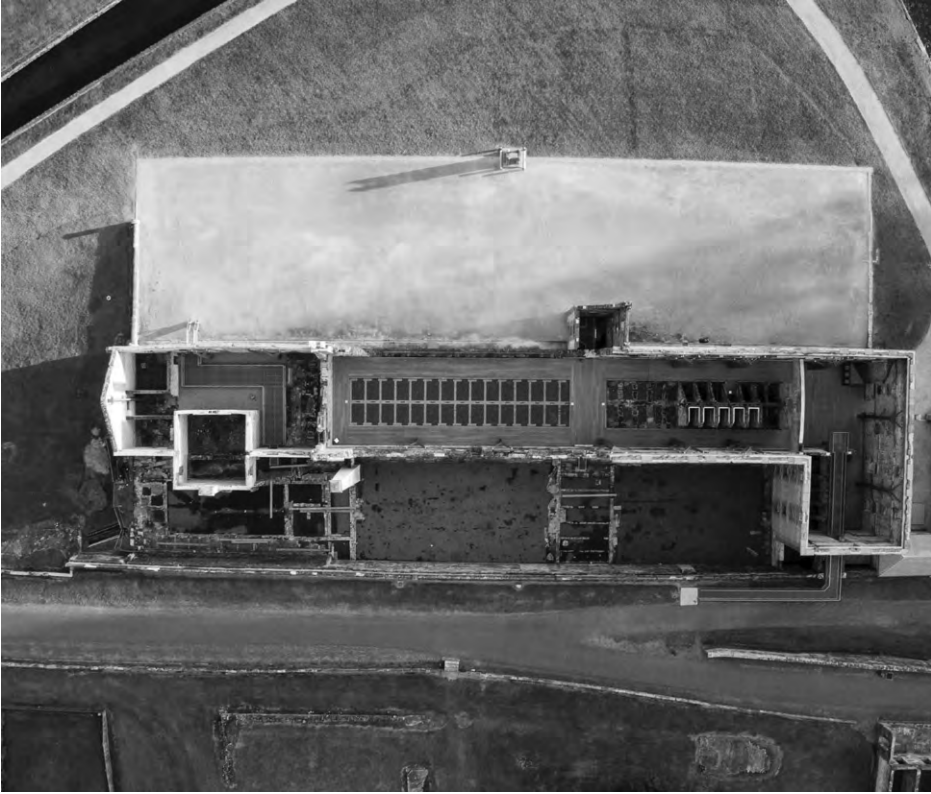
**Figure 0.7.** Aerial view of the penitentiary. (Hype TV for PAHSMA, 2017)

Throughout this book, reference will be made to five main areas where excavation occurred: the penitentiary, encompassing the area of the former mill and granary; the bakehouse, referring to the footprint of that building; the muster ground; and the ablutions and laundry areas (Figures 0.6 and 0.7). Of these, the penitentiary, bakehouse and laundry were enclosed, multi-storey and multi-roomed buildings. The muster ground and ablutions were largely open, the latter fitted with exercise yards, shelters and sheds.

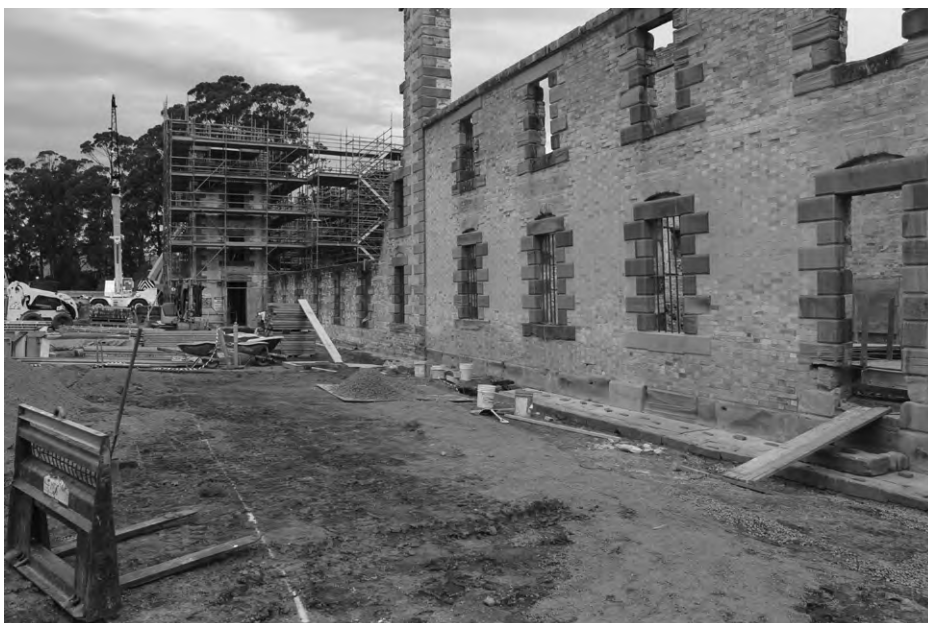
**Figure 0.8.** Photo taken from the muster ground during conservation works in 2015. (PAHSMA 2015)

The archaeological excavations upon which this book is based were carried out during 2013–16 (Figure 0.8). They were undertaken as part of the larger penitentiary precinct conservation project which began in 2011. The project has been guided by the *Conservation Management Plan 2011: Penitentiary Precinct, Port Arthur Historic Site, Tasmania* and involved the large-scale conservation and structural work within the main penitentiary building, as well as improvements to existing drainage infrastructure.<sup>1</sup>

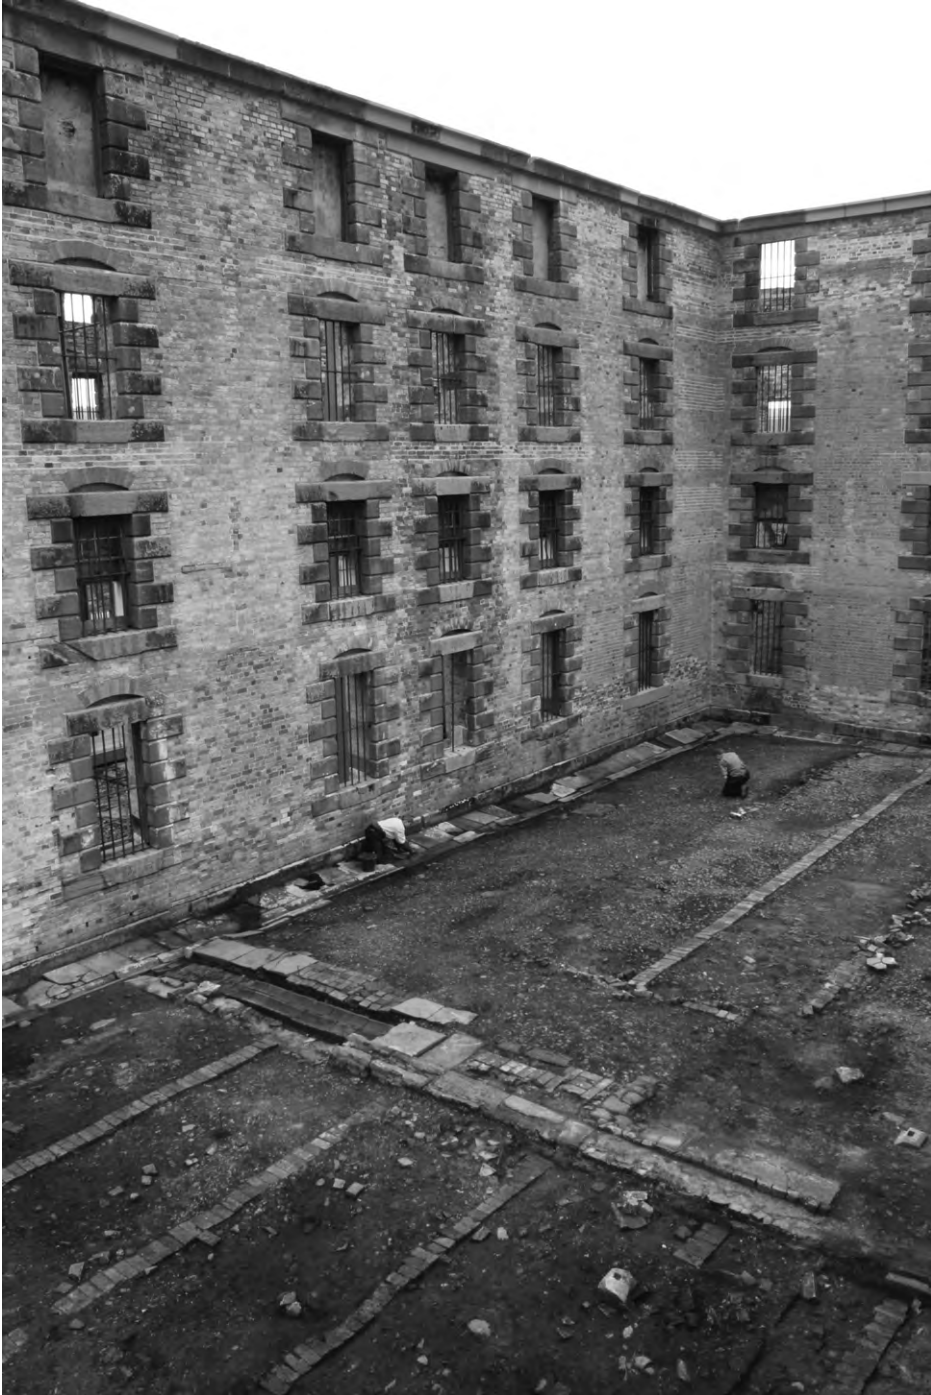
**Figure 0.9.** During the 2016 excavations of the ablutions area. (PAHSMA 2016)

The excavations in 2016 comprised the open-area excavation of the ablutions and laundry areas (Figure 0.9). The former was excavated by a team of seven archaeologists between January and May 2016. During November and December 2016 the laundry was excavated by a team of five archaeologists. These large investigations resulted from the need to carry out further conservation works within the precinct, at the same time as providing an opportunity to research and interpret some of the lesser-known stories and areas of the site.
