TEST REPORT

REPORT NUMBER: 102639790TOR-001
ISSUE DATE : September 28, 2016

Report of Load Testing of Polycarbonate Rail Connectors used in Connecting 2x4 Wood Rails of Guards to Posts.

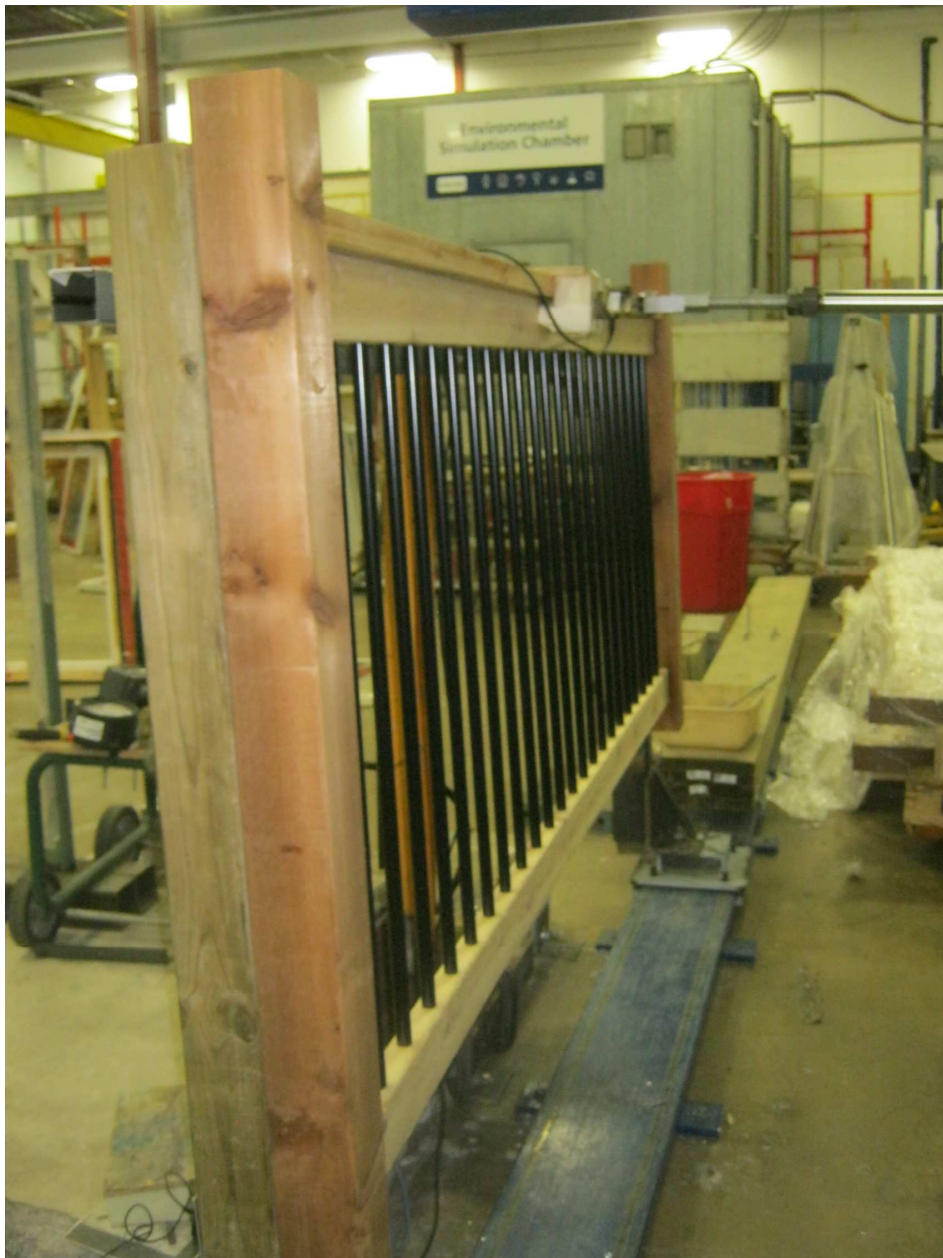
Photo 1 Guard with Polycarbonate Rail Connectors Undergoing Loading at Midspan

The initial position of the top rail at mid span was measured. A concentrated horizontal load of 200 lbs (delivered with a 4"x by 4" platen) was applied to mid span of the top rail by means of a calibrated load cell/single ram/pump system and held for 1 minute, whereupon the position of the top rail was measured. The load was then released and the residual position of the top rail was measured.

A test load of 500 lbs (factored load of 2.5) was applied to mid span of the top rail and the rail movement was measured at full load and after removal of the test load. After release of the load, the system was evaluated for residual deflection, failure, evidence of disengagement of any component and visible cracks in any component.
