TaaS Phase 2 Report (RPT0381A)

for OnPoint Systems

Spirent Professional Services

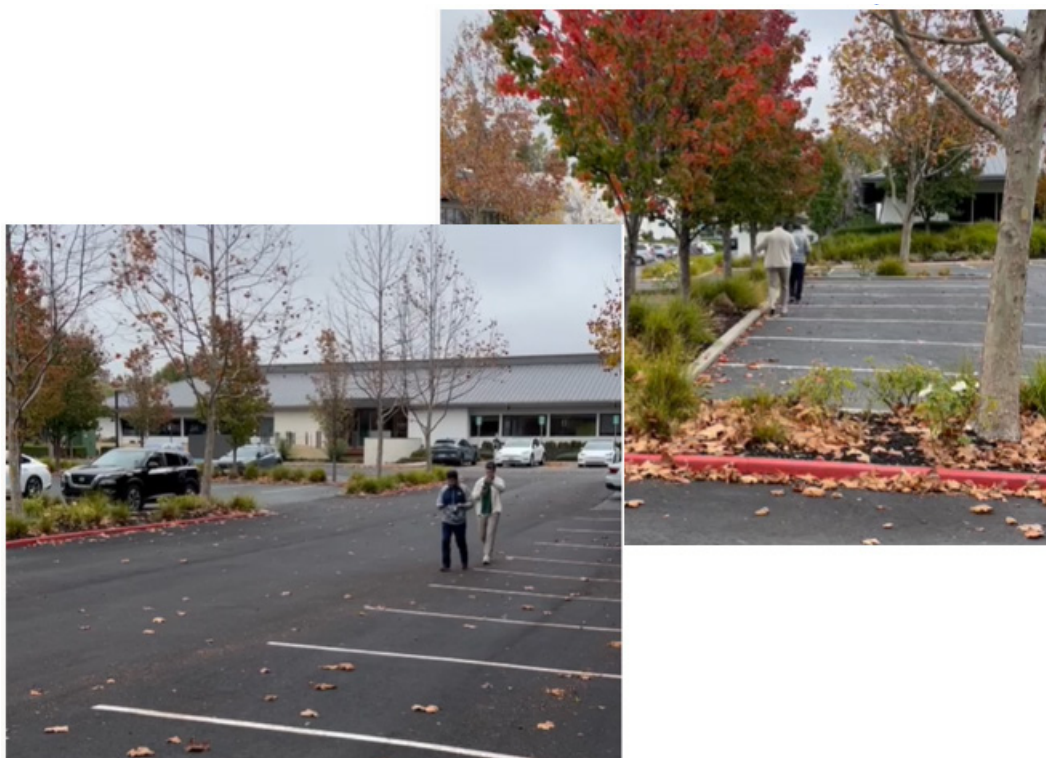
Figure 3: Measuring the fence line.

The distances either side of the fence were measured using a measuring tape and three flags for each device were used to measure the distance away from the fence that each warning/correction was broadcast (Figure 3).

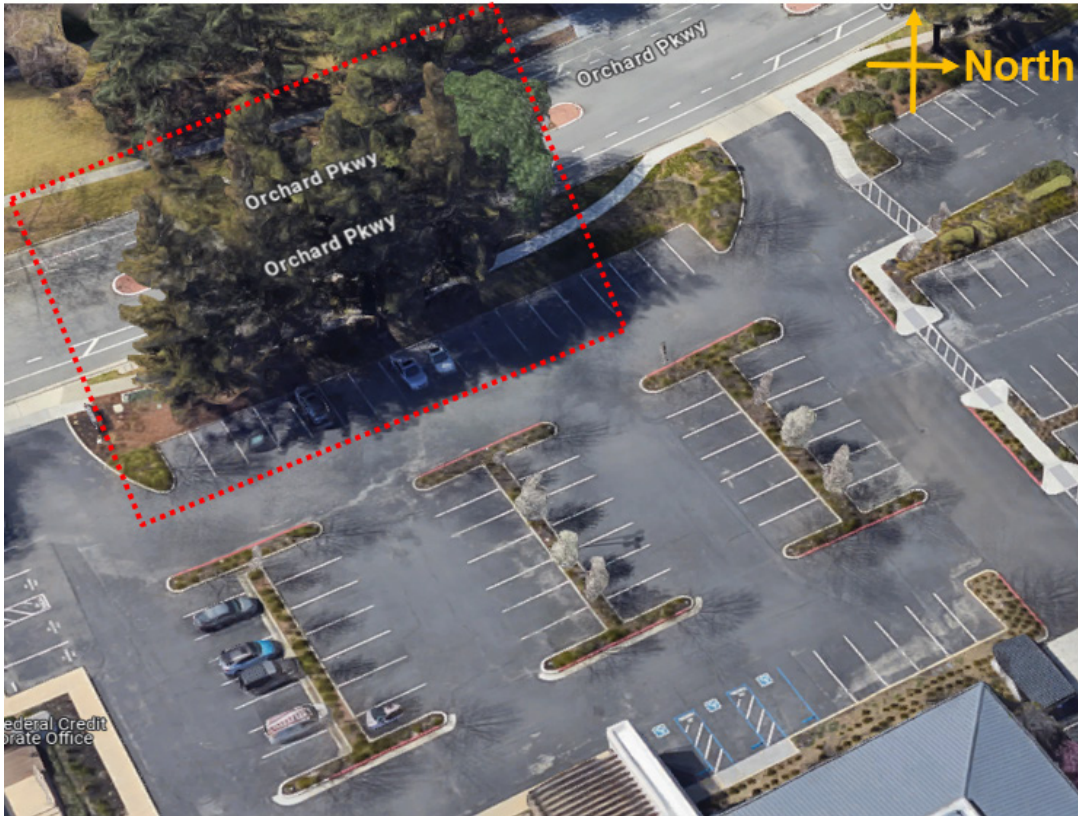
This test used the opposite side of the virtual fenced area (Figure 6), which had heavy conifer tree coverage (red rectangle) blocking the western hemisphere.

Figure 5: Location of Test 2.

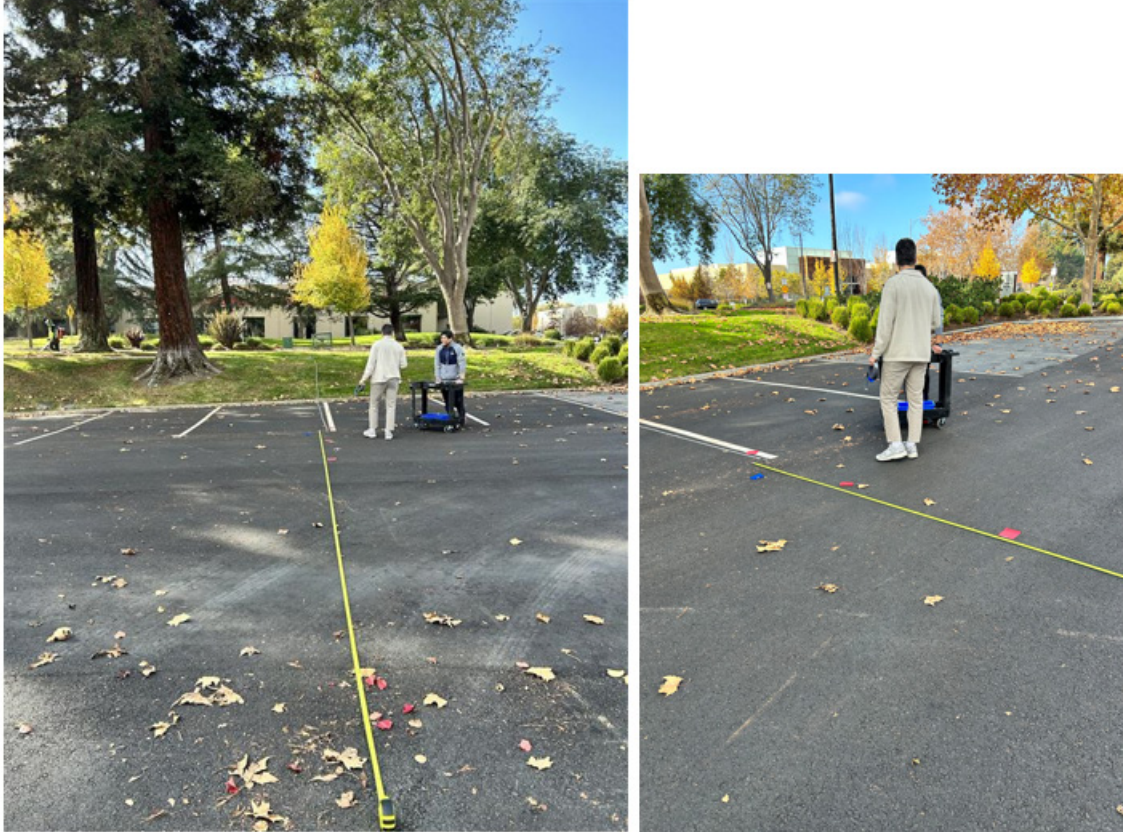
As one can see in Figure 7, the distances either side of the fence were measured using a measuring tape and three flags for each device were used to measure the distance away from the fence that each warning/correction was broadcast.

Figure 7: Measuring distances using tape measure either side of the fence.

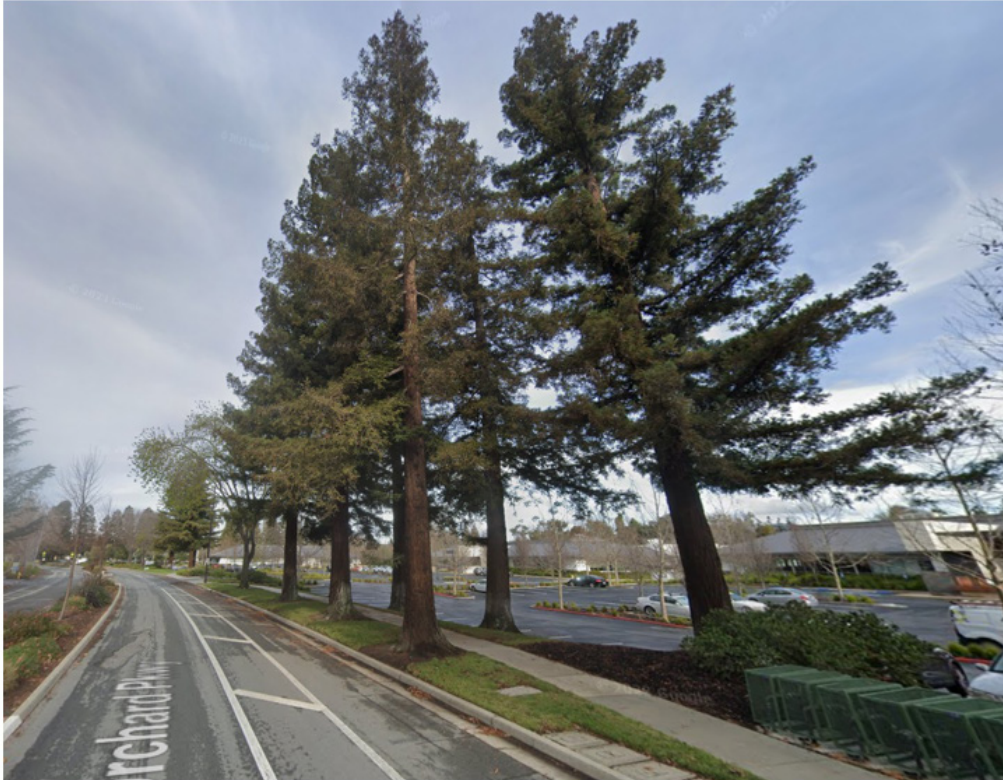
Figure 9: Location of Test 3

For this test, virtual fences were constructed directly under the trees (Figure 10). Each fence was created to span either side of the sidewalk, with one edge passing through the trees running across the sidewalk. The dog collars were carried from clear open sky towards the fence, under the trees.

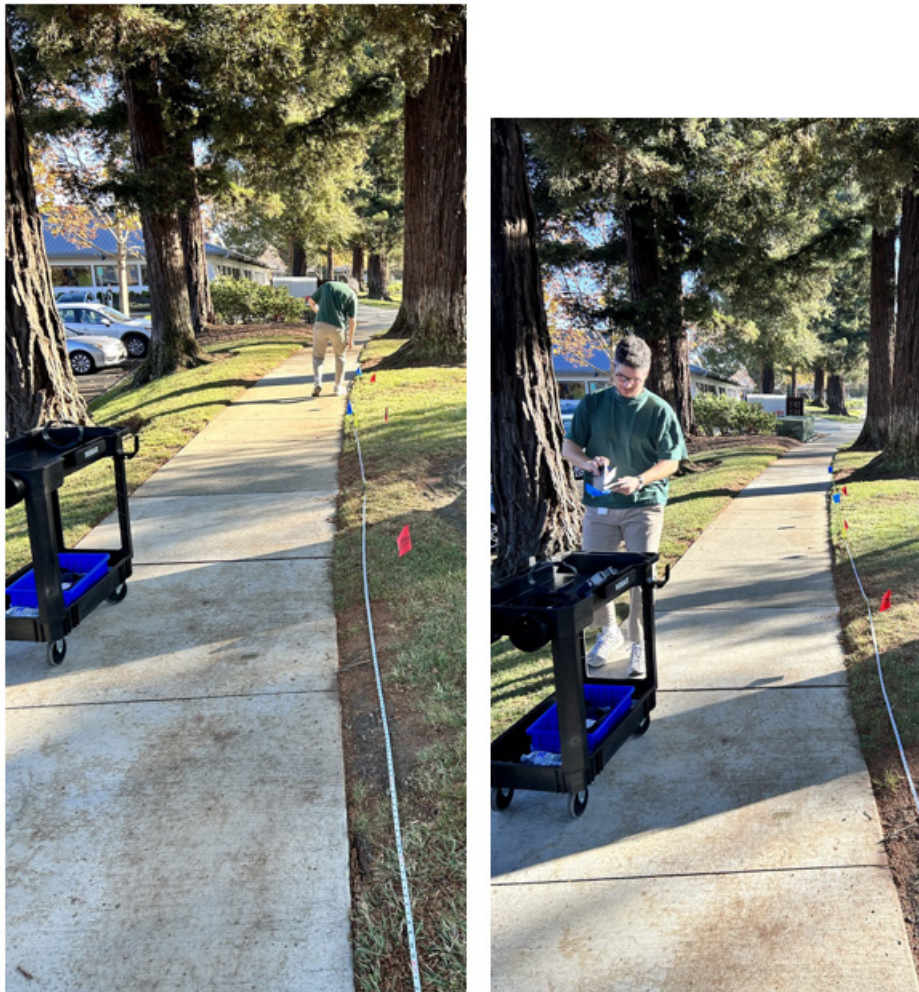
Figure 11: Measuring distances from fence.

Again, as can be seen in Figure 11, measuring tape and flags were used for the tests. SpotOn's first warnings varied from -295 cm to -437 cm, giving a mean of -369 cm, which is 69 cm more than the threshold value of -3 m. The Halo device varied between 0 and +226 cm, way beyond than the -2.6 m threshold for the first warning. Its mean value was +120 cm. Basically, all the first warnings broadcast from the Halo device were beyond the fence-line, and not before as one would expect.

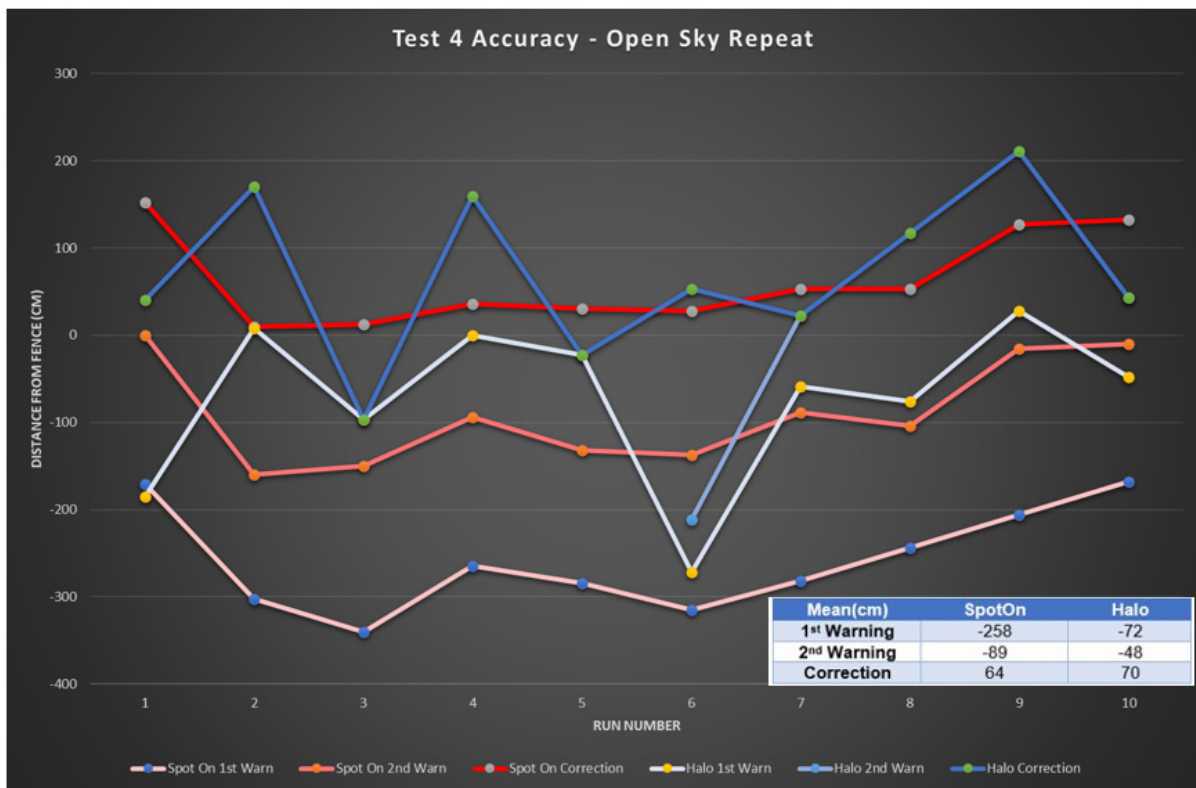
The tests were, again, repeated ten times. The vertical axis shows the distance from the fence line that the dog collar warnings occurred.

SpotOn's first warnings varied from -340 cm to -170 cm, with a mean value of -258 cm, close enough to the -3 m threshold. Halo's warnings showed a higher variation with an average -72 cm indicating that they were quite far from the -2.6 m threshold value. Their value varied from -272 cm to +8cm.

The second warnings for the SpotOn collar showed a mean value of -89 cm, 61 cm far from the -1.5 m threshold. Their values varied from 0 cm to -160 cm. Halo broadcast only three warning, during runs six, seven and ten. Their average value was -48 cm.

The SpotOn corrections showed a good consistency, with most of the values close to 0cm, while during three runs there was a divergence with values ranging from +131cm to +152 cm and an average value of 64 cm away from the fence-line. The Halo device showed higher variations with values ranging from -97 cm to +211 cm and a mean of 70 cm, very close to the SpotOn's.

Figure 15: Warning alert distance from fence across all runs

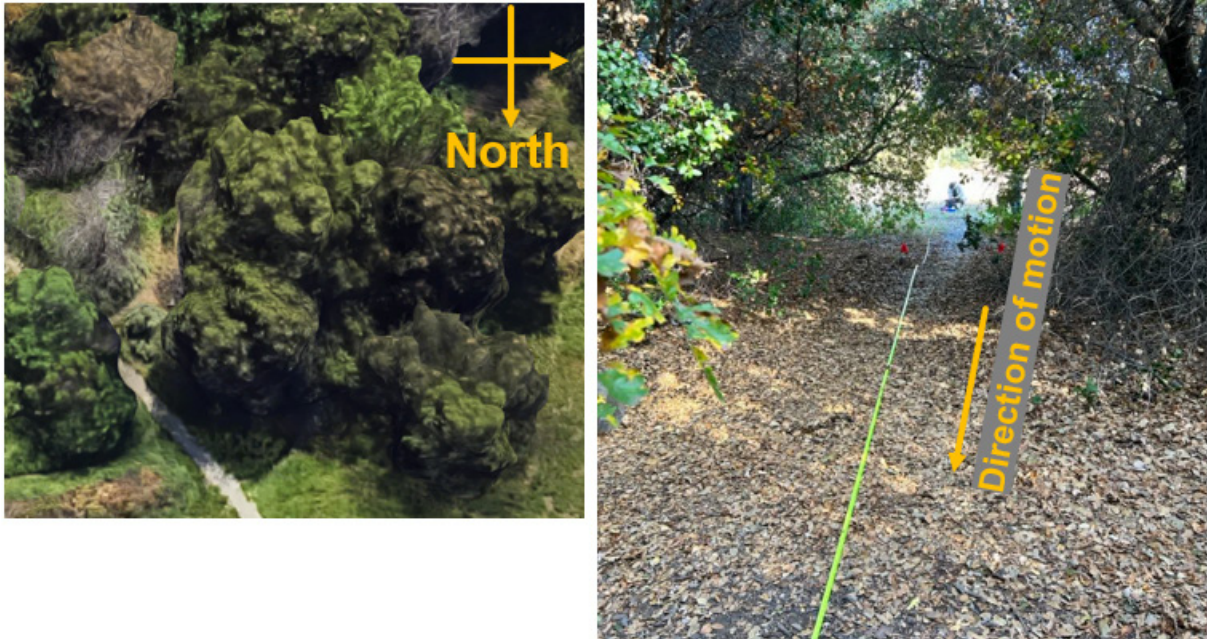
Figure 16: Ulistac Natural Area.

The purpose of this test was to evaluate the performance of both devices in situations where the fence-line is inside a forest-like environment. Ulistac Natural Area was chosen as a suitable example (Figure 16). The dense vegetation offered a challenging environment.

The same was observed for the second warnings. SpotOn values varied from -41 cm to +239 cm, with a mean value of 96 cm and a standard deviation of 93 cm. Halo, however, showed even higher variations which ranged from -64 cm to +536 cm and an average value of 222 cm, while its standard deviation was 170 cm.

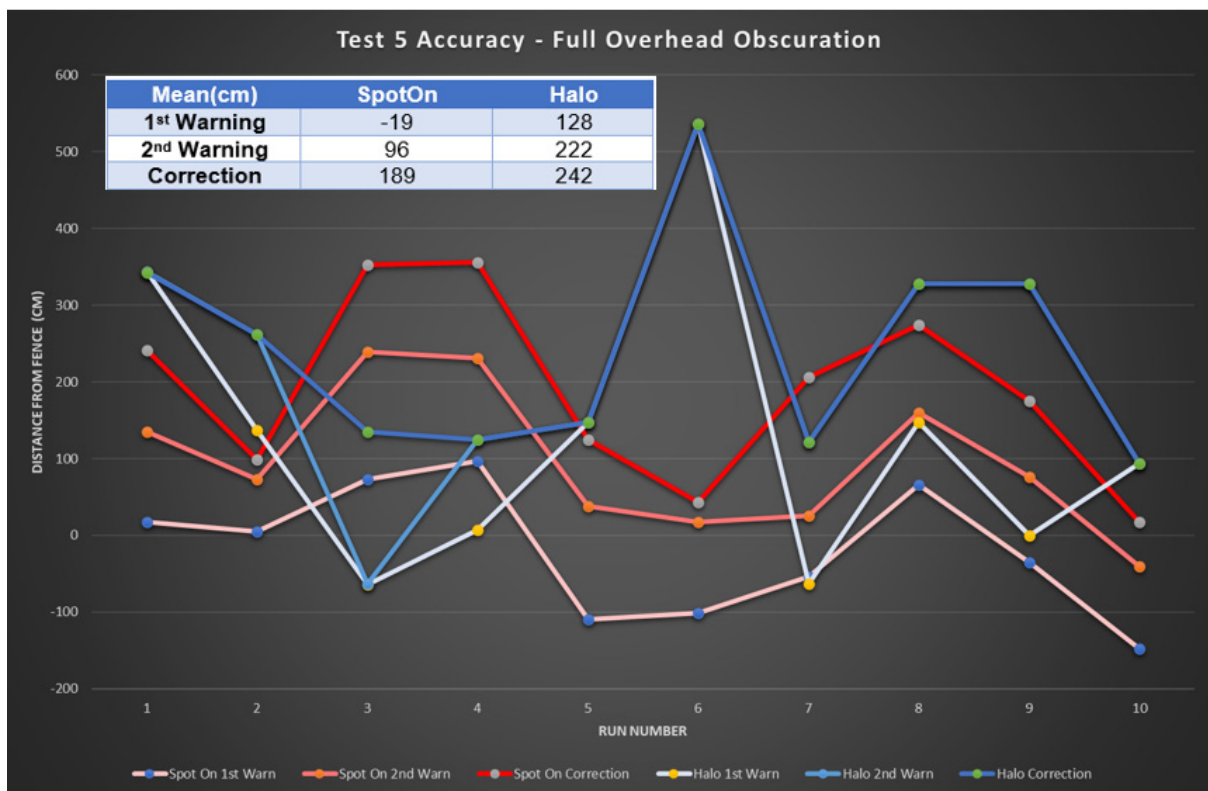
The challenges this environment added to the tests are depicted in the Figure below. Both devices struggled to perform according to specs.

SpotOn's first warnings varied from -147 cm to +97 cm, with an average value of -19 cm and a standard deviation of 84 cm. The Halo device showed larger deviations from the -2.6 m threshold, with values varying from -64 cm to +536 cm and a mean value of 128 cm. Its standard deviation was 188 cm.

The same holds true for the corrections. SpotOn's reported values were all beyond the fence-line, with the values in runs six and ten close to the fence line (+43 cm and +18 cm respectively). In total, the values ranged from +18 cm to +356 cm, with a mean of 189 cm and a standard deviation of 188 cm. The Halo device showed values varying from +94 cm to +536 cm, a mean of 242 cm and a standard deviation of 142 cm.

Figure 18: Warning alert distance from fence across all runs

Both devices faced difficulties to perform according to specs during the fifth test, in the Ulistac Natural Area, in the presence of dense vegetation. This was an extreme test case and performance was expected to be worse. However, the SpotOn still performed better than the Halo collar.
