TEST REPORT

Number: GZHT02354657

The Following Sample Was Submitted And Identified By/On Behalf Of The Applicant As:		
End Uses	:	Non-Sterile Medical Face Mask
Ratings	:	Type IIR
Sample Name	:	Disposable Medical Mask(Non-Sterile)
No. Of Sample	:	One (50 pieces)
Size	:	17.5cmX9.5cm
Colour	:	Black
Standard	:	EN 14683:2019+AC:2019
Brand Name	:	YINHONYUHE
Manufacturer	:	BAODING YINHONG YUHE MEDICAL DEVICE MANUFACTURING CO., LTD
Date received/ Test Started	:	Oct 26, 2020
Ref	:	Type No.: YH/YY-2099R

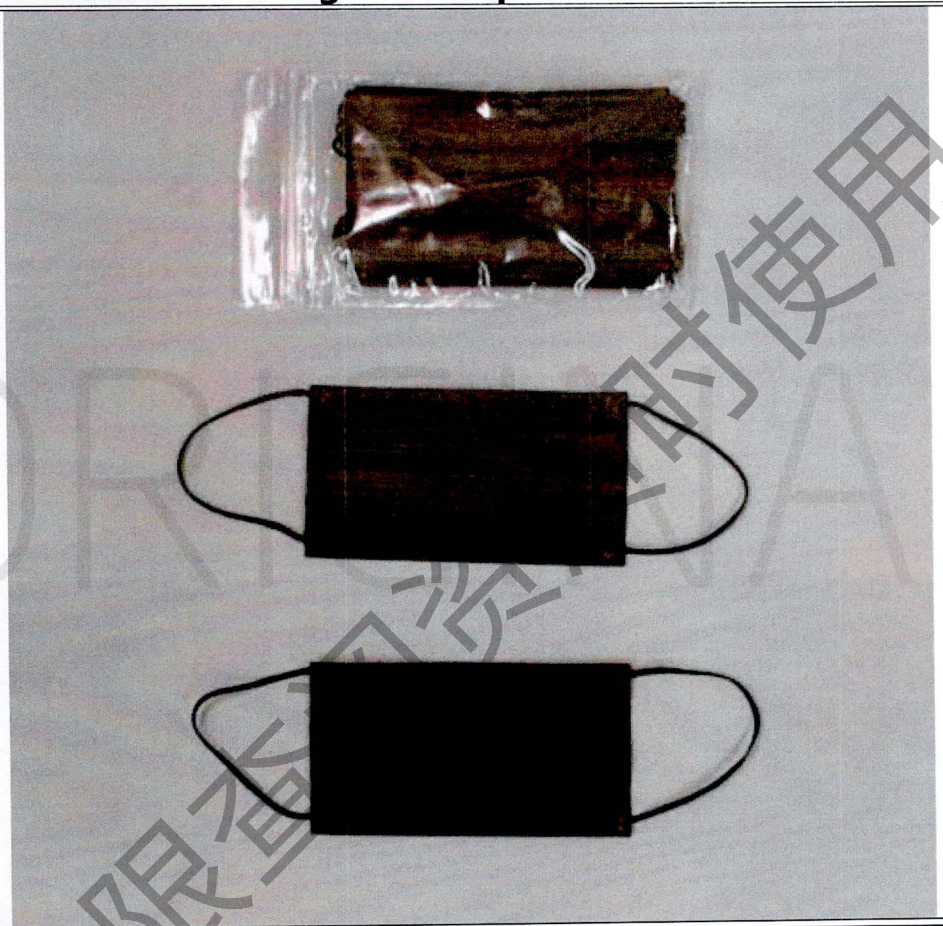
Original Sample Photo

Summary of testing:
With reference to following standard: • EN 14683:2019+AC:2019 Medical face masks – Requirements and test methods Type IIR
Materials Used in The Submitted Sample Were Found To Comply With The Type IIR Requirements of EN 14683:2019+AC:2019 with respect to Microbial Cleanliness, Bacterial Filtration Efficiency, Differential Pressure and Splash Resistance Pressure tests.
