September 10, 2019

Excerpts of the report by fluidfreeride engineer in relation to caliper malfunctioning of Mercane WideWheel electric scooter

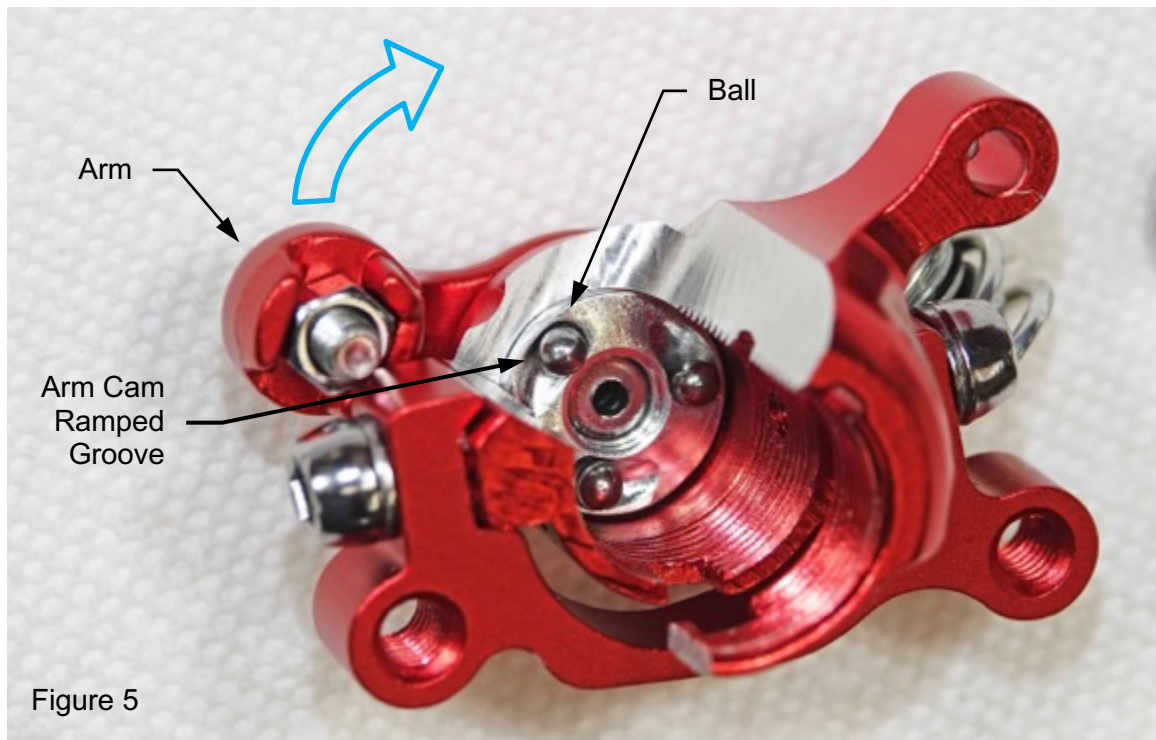
1. The Arm is directly attached to the Arm Cam. Pulling on the Arm causes the Arm Cam to rotate.
2. The Piston Cam is guided so that it cannot rotate but it is free to move axially (in and out).
3. The Arm Cam and Piston Cam have faces with ramped grooves. See figure 5. Three ball bearings fit into the grooves. As the Arm and Arm Cam are rotated, the balls ride up the ramped grooves causing the piston to move towards the rotor (disc).

8. If the Piston Cam is allowed to move too far towards the Rotor (disc), the balls can ride up out of the ramped grooves, causing the snapping, sticking, and the inability to increase the braking force.
