## User Inspection Notice

### ISC RP205 / RP209 Pip-pin Ropegrabs

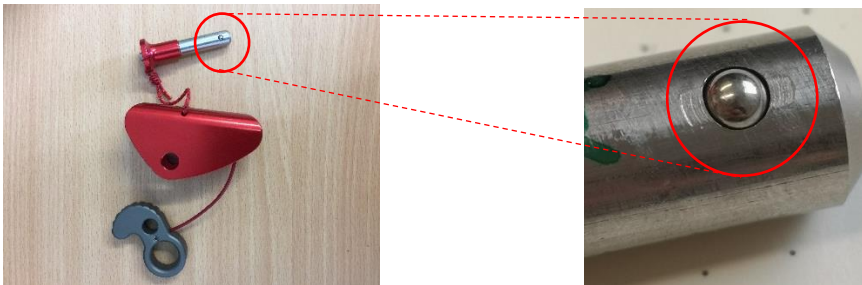
ISC are requesting that all owners of the above listed items inspect the pip-pin mechanism in the axle of their rope grab. There has been a report of the ball-bearings falling out of the hole over time. This has, currently, only been reported by a single customer, however, as a responsible manufacturer, ISC is issuing this notice to alert all users to the issue.

Following an investigation into the customer raised issue, it is discovered that there is a possibility that a number of devices may be affected. The ball-bearings act as a locking mechanism for the axle, and if they are not in place the axle could work loose. For this reason, if the ball-bearings are not present the device should not be used.
