WHO KILLED THE COVER?

A GUIDE FOR COMMON COVER ISSUES

PLASTIPACK LIMITEDTM
© Plastipack Ltd

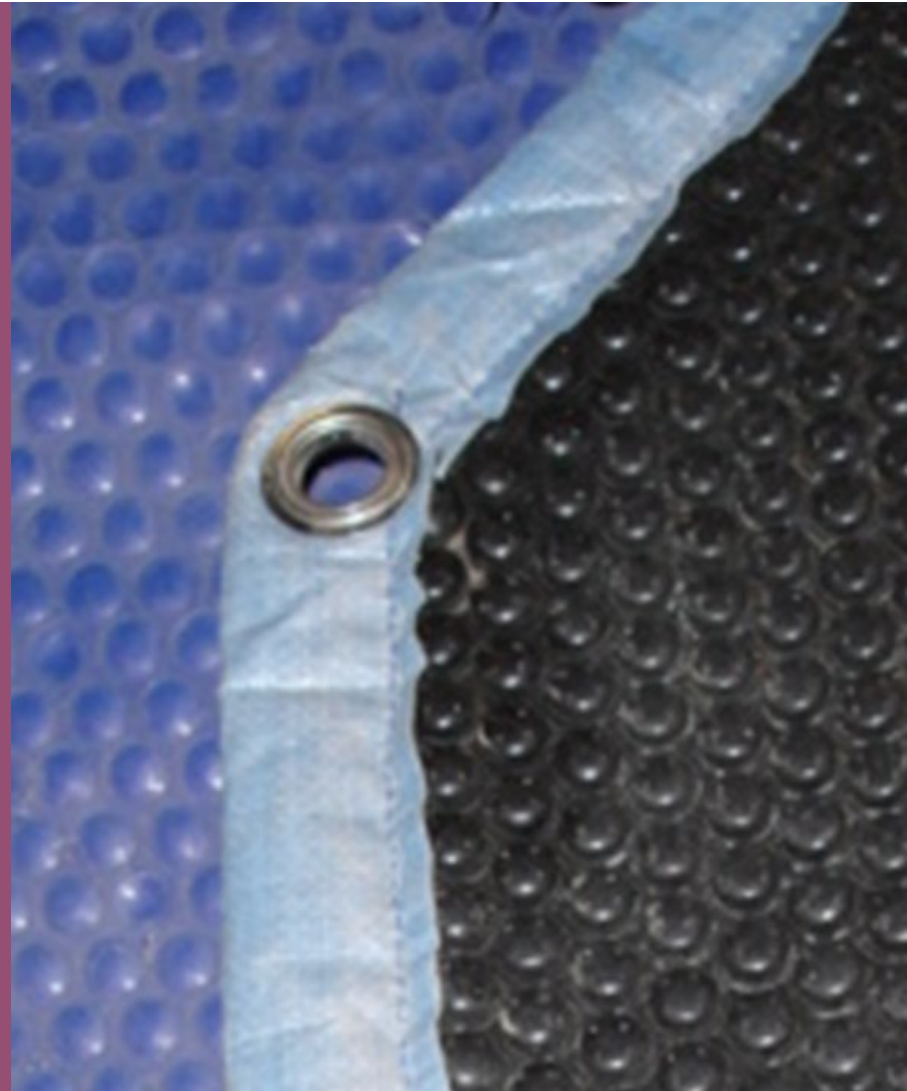
Chemical Degradation

Most issues involving premature degradation are the result of elevated chemical levels within the pool.

Frequently, a sudden deterioration of the cover can be the result of a shock treatment.

Noticeable effects:

- Bleaching of the underside of the cover.
- Bleaching of the hemming/edge.
- Material has turned brittle - in particular on the bubble layer.
- High residue amounts on the cover.
- Oxidation of eyelets.
- Strong chlorine smell

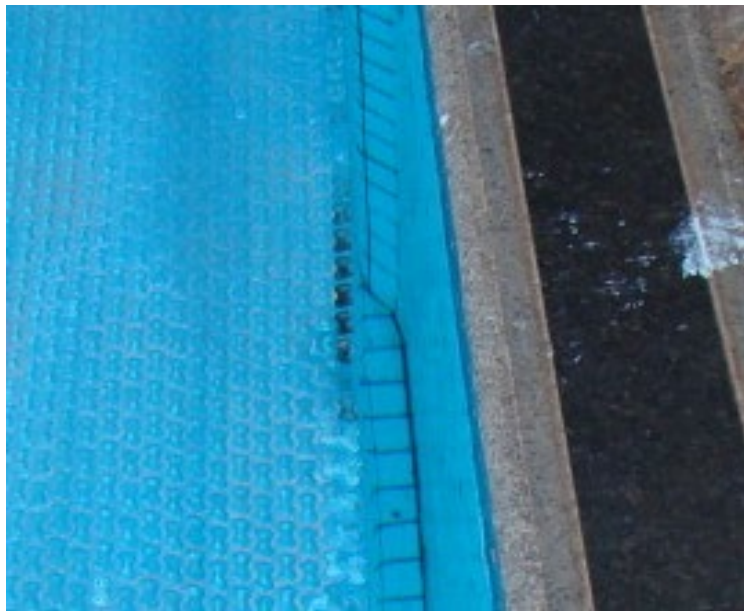
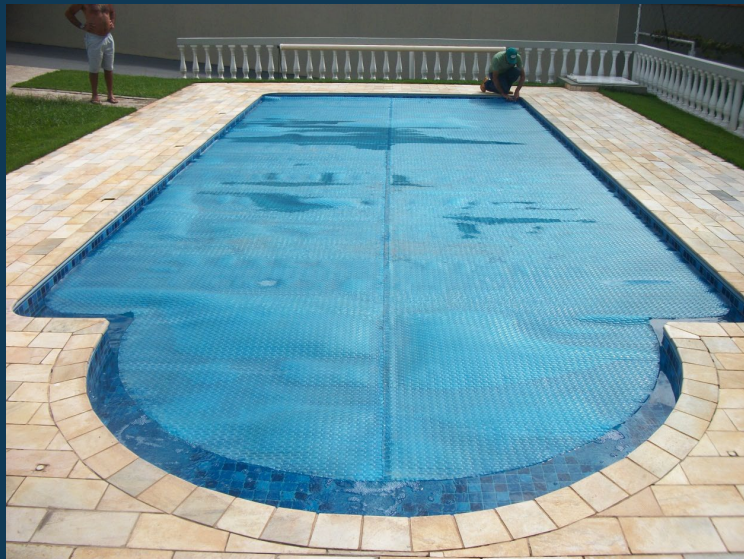
Shrinking Cover

Shrinkage of the cover can happen and is usually exaggerated by bubble swell.

Shrinkage is the result of the polymer in the material releasing stress as it gains molecular mobility.

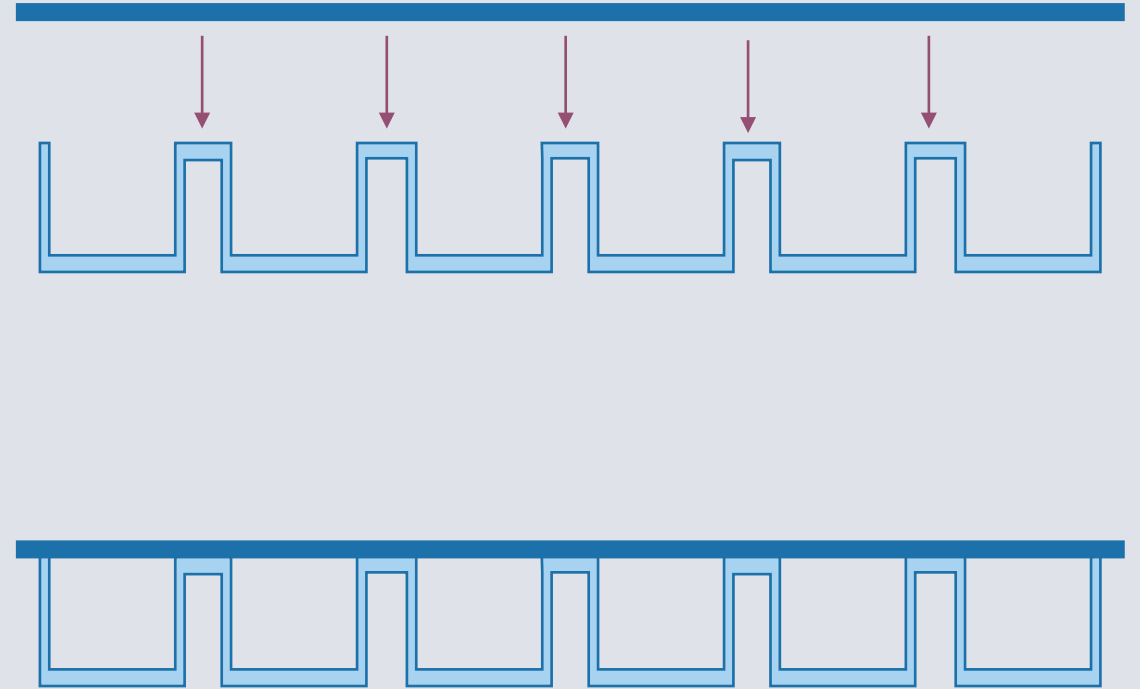
Delamination is incredibly rare and most often is the result of the cover overheating when being stored off the pool.

When folded or left on a reel system exposed, the material quickly heats up and causes the air within the bubbles to expand.

Should delamination occur without indications of improper storage, please contact Plastipack immediately.

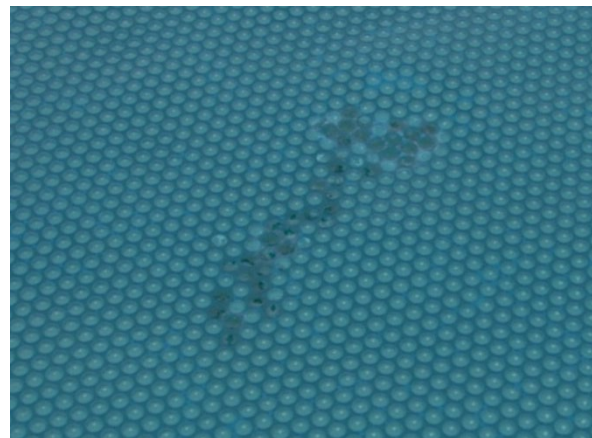
Magpie

This is more common than would be imagined. Small groups of punctured or torn holes are often caused by birds.

We have found that a few CD's hanging from a string will cause reflections that discourage the birds from lingering around the pools.
