American Bonanza Society Air Safety Foundation

Flight Controls, Flaps and Trim System Inspection, Repair and Rigging Guide

For Beechcraft Bonanza, Debonair, Baron and Travel Air

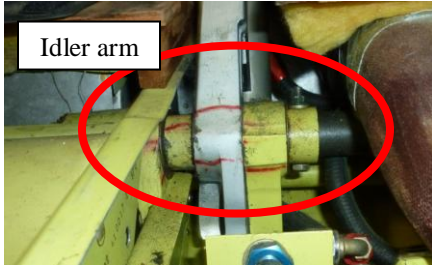
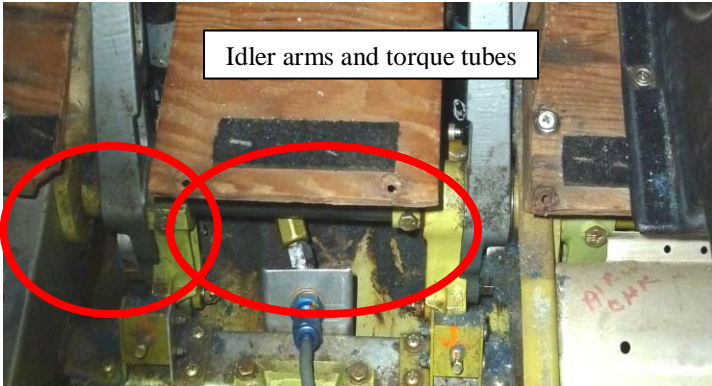
Discrepancy: Wear or elongation of rudder pedal pivot bolt holes.

Tip: Worn or elongated pivot holes are usually the result of using the brakes to steer the airplane.

5. To replace or relocate pedal arms from the copilot side to the pilot side:

- a. Place the aircraft on jacks.
- b. Note the left rudder pedal torque tube has a steering bell crank and aileron/rudder bungee bell crank on the inboard end. The right torque tube has a nose landing gear retract rod idler arm attached on the inboard end.

- c. Remove the center console cover and floorboard for easier access to the torque tube ends.
- d. Remove the bolts from the torque tube. There is one bolt on the inboard side of each rudder pedal.
- e. Slide the torque tube inboard to remove the rudder pedal arms.
- f. Use the same procedure for the pilot side, except the bolt must be removed from the steering bell crank. Move the torque tube inboard and remove the rudder pedal arms.

- g. Install replacement arms or relocate the arms on the torque tube.
- h. Reinstall the bolts.

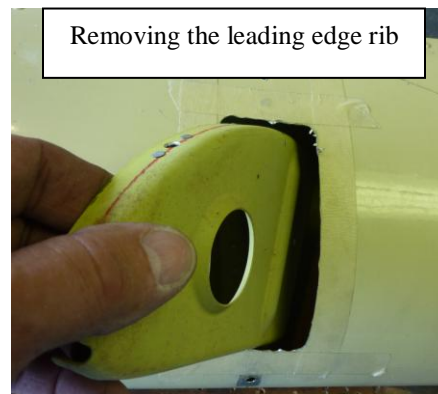
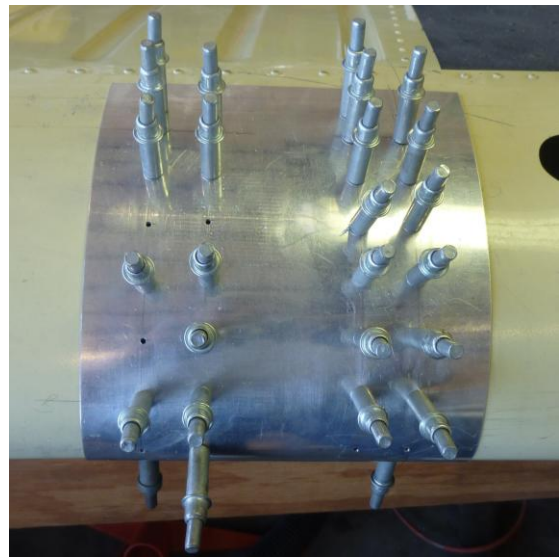
Rib replacement and flap leading edge repair:

Discrepancy: There is crack damage to the nose rib assembly for the flap actuator attachment bracket.

1. Pull the flap motor circuit breaker.
2. Remove the flap from the aircraft.
3. Remove the flap actuator attach bracket.
4. Inspect the attach bracket and replace it if cracks are discovered.
5. Drill out the rivets on the top and bottom of the leading edge rib.
6. A section of the leading edge skin will need to be cut out to remove and replace the leading edge rib.

- a. Cut a rectangular access port 4 ½ inches long and 2 inches wide, 1” inch on each side of actuator bracket attach screw centerline, or at least 1/8 inch wider than the crack or tear on the skin.
- b. Cut a line 4 ½ inches up and aft of bottom cut line starting at the skin crack. Move the leading edge rib side to side to finish cutting.

Tip: The top and bottom mounting holes of the flap attach bracket will require slight elongation because of the added skin thickness of the doubler.

19. Reinstall the attach bracket.
20. Reinstall the flap.
21. Check the flap travel because of the thickness of the doubler.
22. Adjust as required.

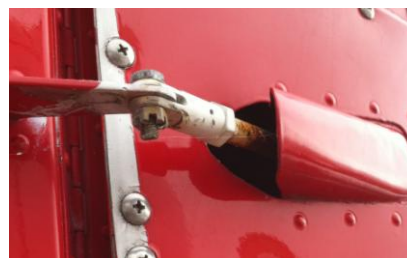
Discrepancy: The Baron/Travel Air rudder trim actuator has excessive free play.

1. Check the bushing in the rudder trim tab horn for wear. Replace if worn.
2. Check the trim actuator attach bolt for wear. Replace if worn.
3. Tighten the bolt on the clevis. You should be able to rotate the bolt with a firm grip.

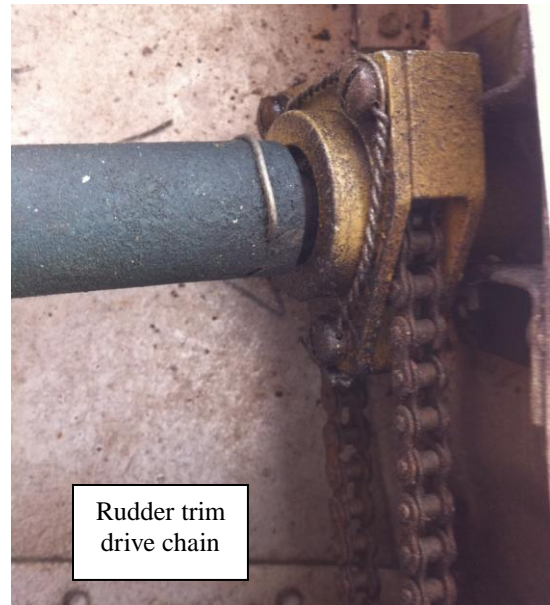
Discrepancy: The rudder trim actuator drive chain is binding.

1. Check the trim drive chain for dirt build-up.
2. Clean the chain with cleaner degreaser.
3. Lubricate the chain with light oil or LPS2

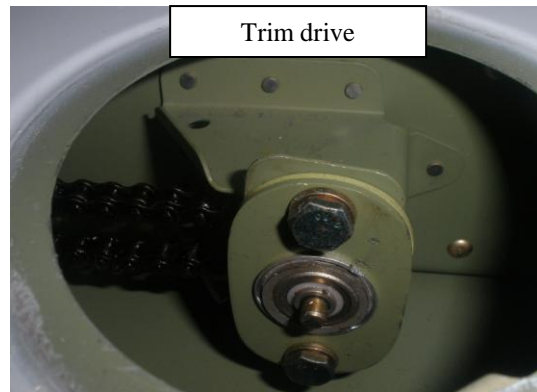
Trim drive

Tip: Often a step will wear in the brass Acme thread nut in the actuator. Grease may be dirty, old, and caked.

3. Check the trim actuator for freedom of movement.
4. Disconnect the drive chain from the actuator drive shaft.
5. Gain access to the drive through the top of the horizontal stabilizer.
 - a. Set the trim to 0 degrees.
 - b. Remove the actuator drive bearing block.
 - c. Operate the actuator to full travel in both directions, turning it with your fingers.
 - d. Movement should be easy and smooth. If it is not:
 - i. Remove the elevator.
 - ii. Remove the trim actuator through the trailing edge of the stabilizer.
 - iii. Disassemble the actuator.
 - iv. Clean the actuator and inspect it for wear per instructions in the Beechcraft Maintenance/Shop Manual.
 - v. Repair as required.

- vi. Correctly set end play with an adjusting bushing prior to installing the actuator back into the stabilizer.
- vii. Reassemble and install the actuator.
- viii. Set the actuator to the proper measurement for 0 degrees.
- ix. Attach the trim chain to the tab actuator drive.
- x. Check the cockpit indicator is at 0 degrees and the actuator rod end measurement is correct.
- xi. Install both attach bolts in the actuator drive shaft bearing block
- xii. Torque the bolts.
- xiii. Reinstall the elevator.

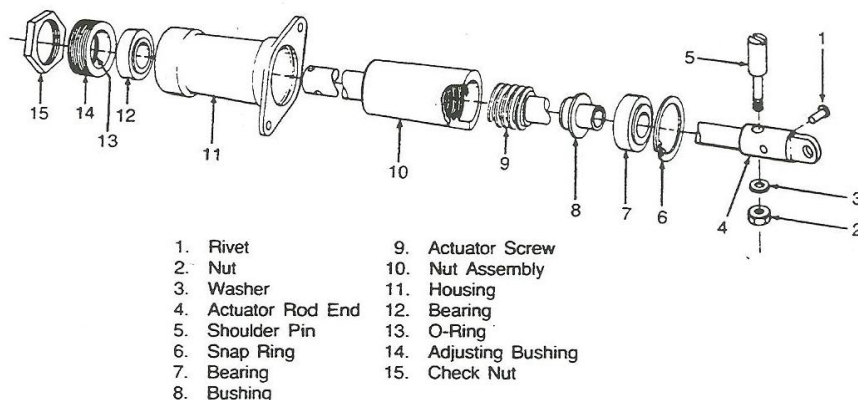
Trim actuator

Discrepancy: There is excessive trim tab end play.

Tip: End play in the rod that is not corrected will result in accelerated wear on associated parts (control horns, clevises and internal wear in the trim actuator). Worn bolts (from lack of lubrication) receive most of the wear.

Tip: The bushing can be replaced without removing the actuator.
