TREATMENT REPORT

Job No: 21.034
Date: 23 December 2021

ARTIST/ATTRIBUTION: [John Cleavelly (1747 – 1785)]

MEDIUM AND SUPPORT: possible aquatint on wave paper

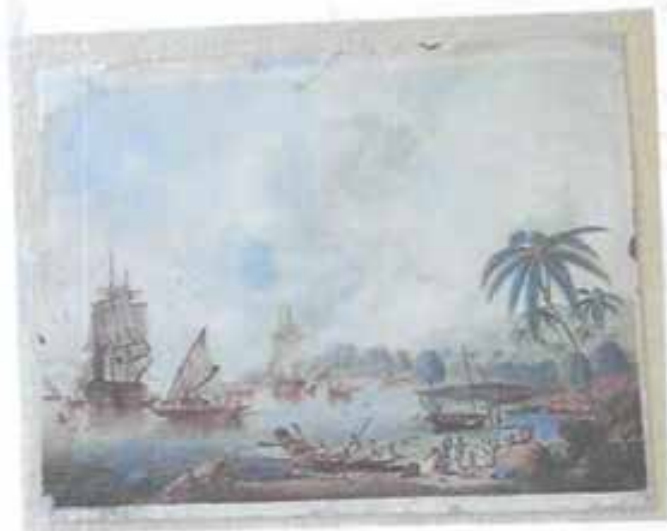
Main issues are: staining, loss, tear, creases, foxing "bubbling" of substrate

- Wave paper
- Some overall discolouration
- May be attached to backing board
- Various areas of brown presumed past repairs to print.
- Area of abrasion
- Staining with tide lines

- Numerous losses of substrate
- "Bubbling" of substrate. Bubbling suggests that the art-work is attached to a secondary support and the "bubbling" is where the adhesion between the two is failing.
- Fading
- Creases
- Tear at top centre edge and right edge
- Areas of loss at corners and edges

- Thought to possibly be an aquatint, hand coloured print
- Most likely fading and colour change overall
- Discoloured
- Colour change apparent
