INTERMODAL MATERIÉL  
AND  
NAUTICAL/NUCLEAR ANALYSIS  
**IMANNA**  
LABORATORY INC.

CERTIFICATION TEST REPORT 15050-1  
OF  
MECHANICAL STRENGTH TESTS  
ON  
6-INCH SLIMLINE CLEATS  
FOR  
ACCON MARINE, INC.

**REPORT NO.:** 15050-1  
**IMANNA JOB NO.:** 15050  
**CUSTOMER P.O. NO.:** VERBAL  
**CONTRACT:** N/A  
**PAGES IN REPORT:** 7

**DATE:** April 19, 2000

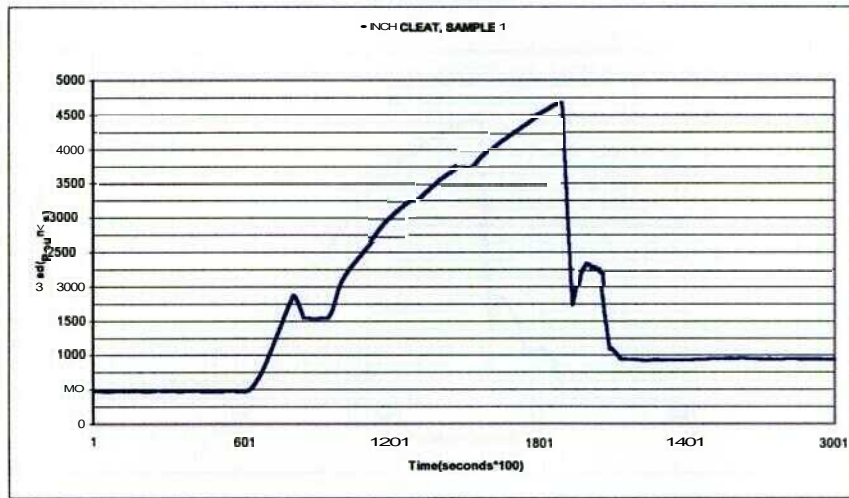
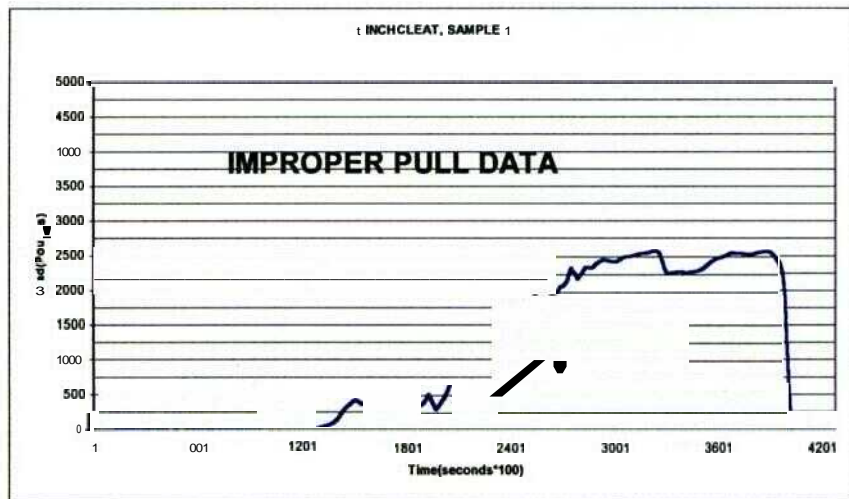
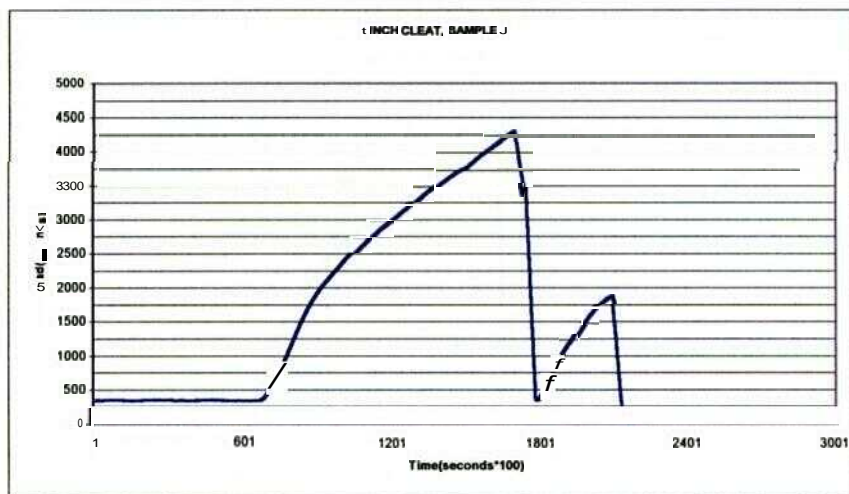
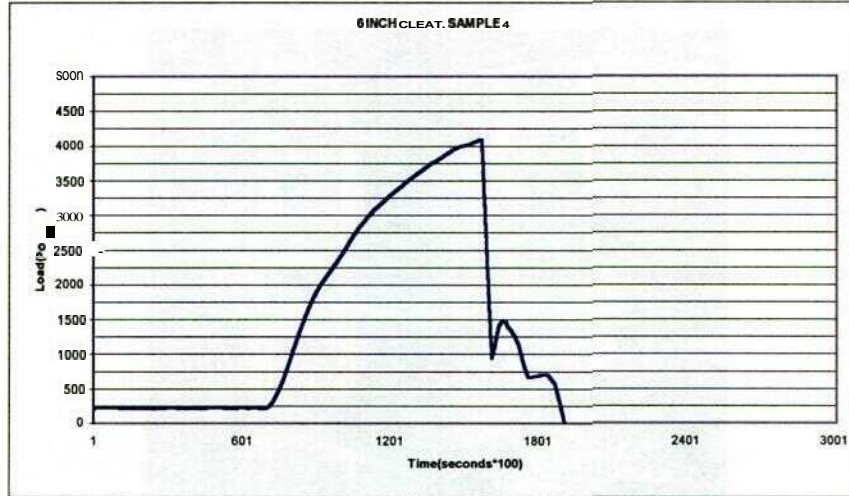
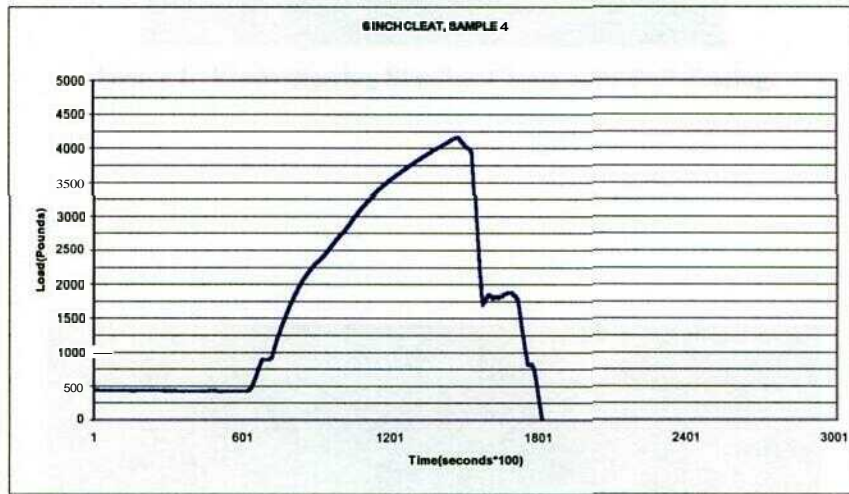
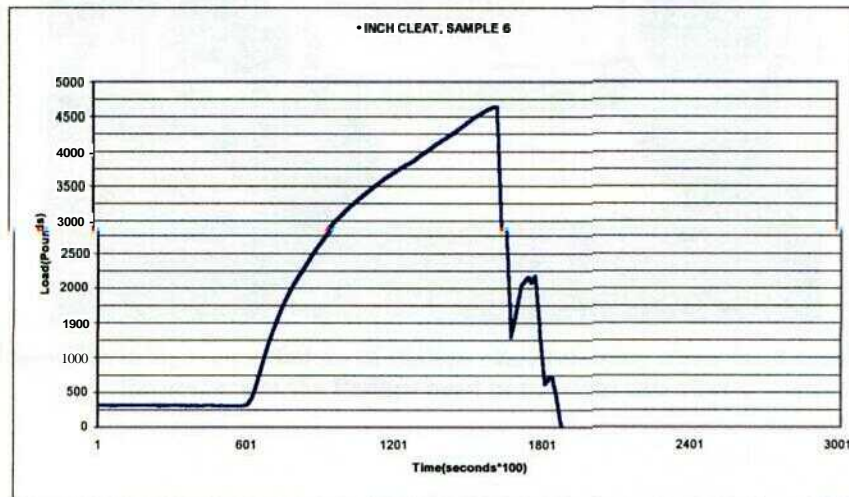
6 INCH CLEATS

The typical first observed deformation appeared to be when the entire cleat-mounting base lifted up from the steel plate it was mounted to. Although this deformation occurred at an average of 50% of the Ultimate Failure load, it did not appear to significantly contribute to the ultimate failure of the system.

**Figure 1. Photo showing Slimline Cleats after Pull Testing,**
