Ontario Structure Inspection Manual (OSIM)  
Bridge Inspection Report  
Township of Stone Mills

Prepared by:  
Jewell Engineering

Dated October 22, 2020

RE: Cataraqui Region Conservation Authority  
2020 OSIM Bridge Inspection Submission  
Our File No. 200-9678

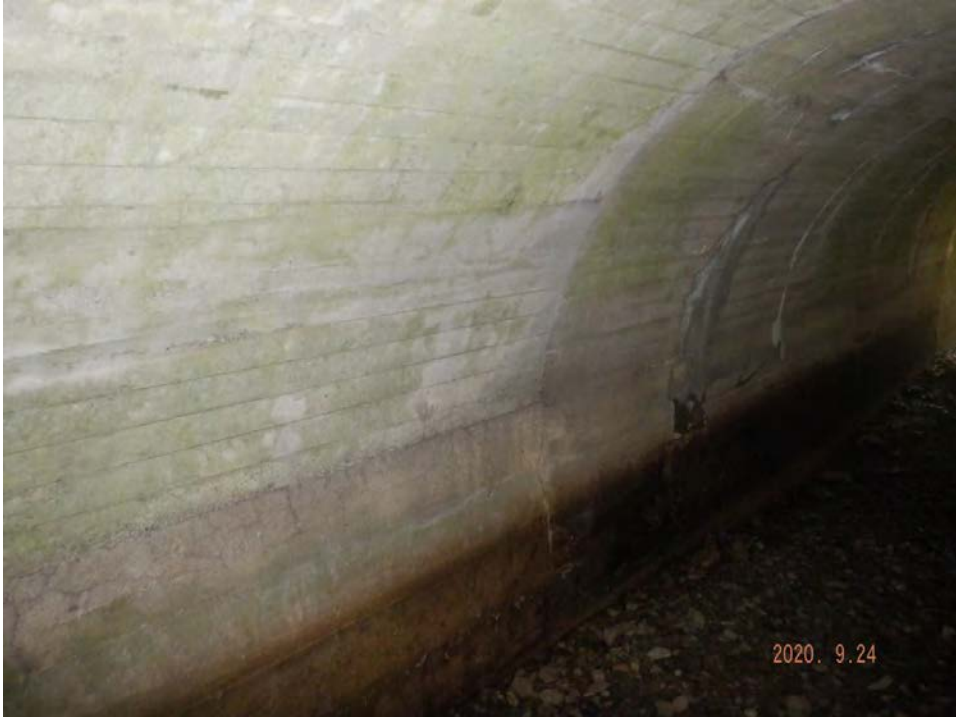
East wall (typical)

Structure has some cracking with efflorescence and delamination in walls. Overall structure remains in servicable condition.

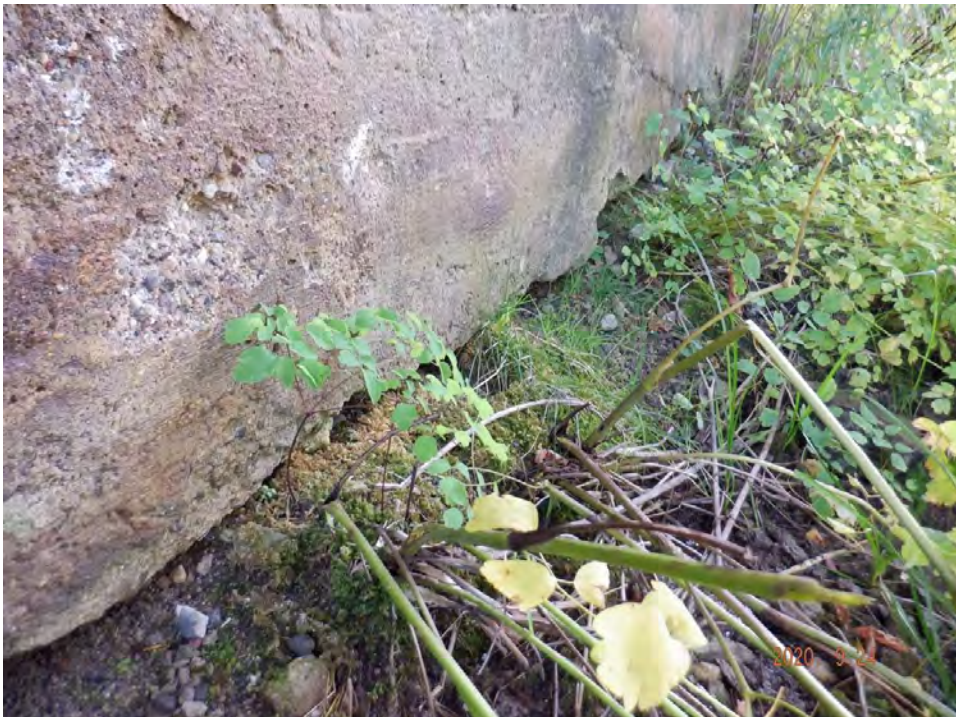
Erosion at base of east abutment wall

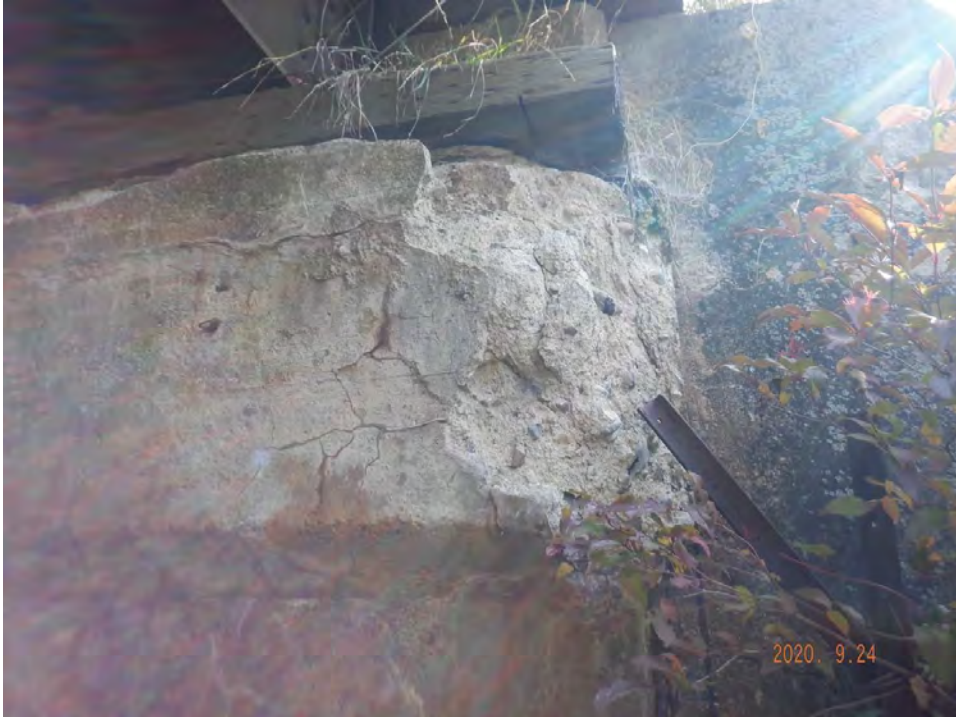
Disintegration in south end of east abutment

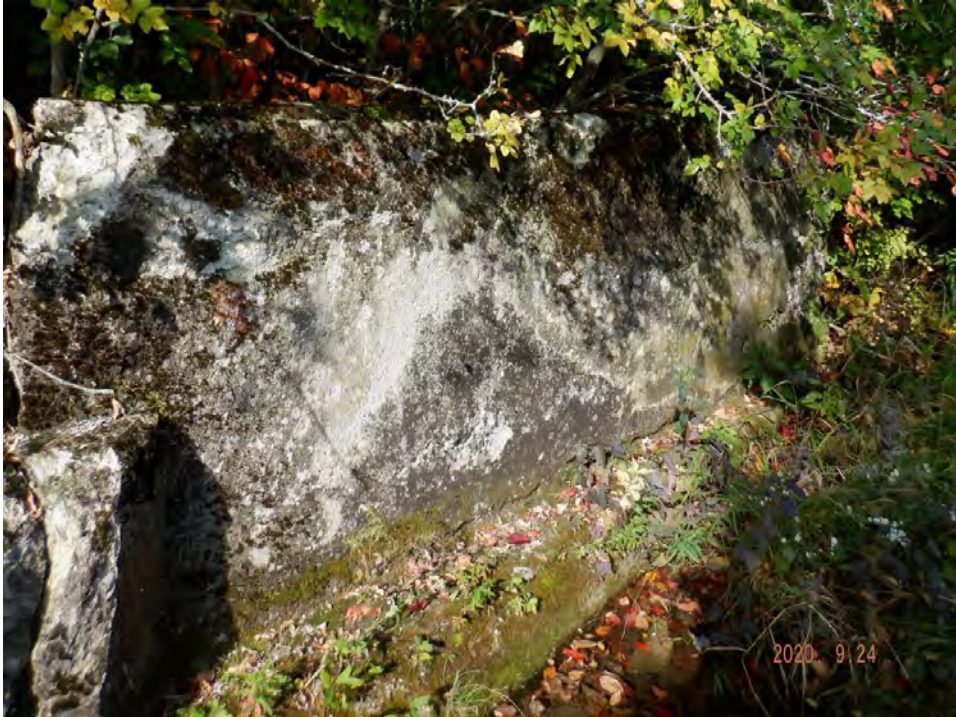
Northwest retaining wall

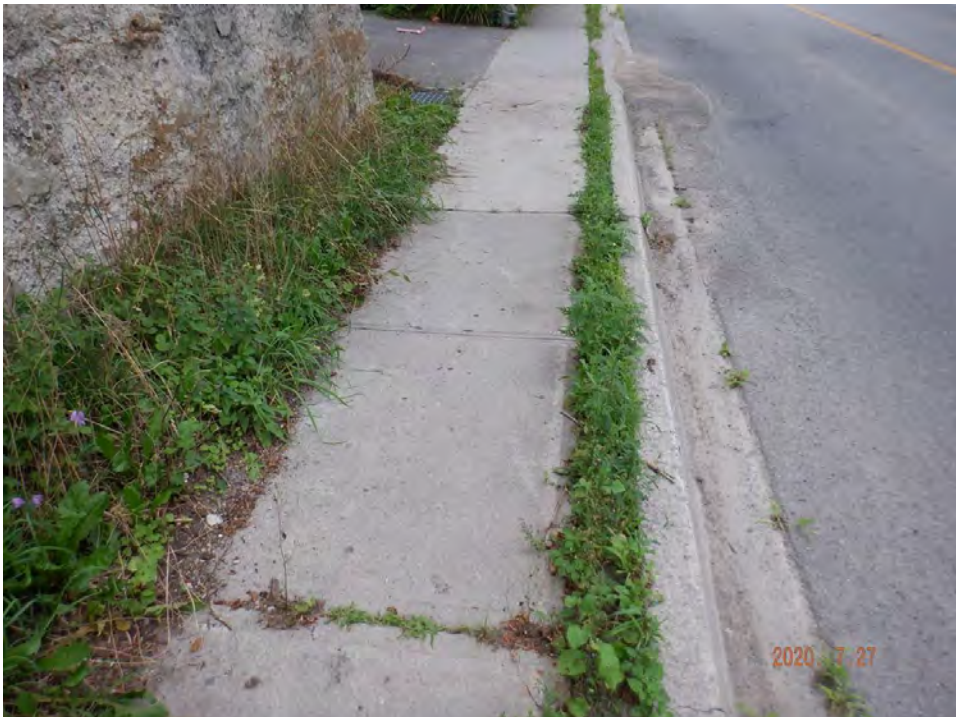
Sidewalk below bridge

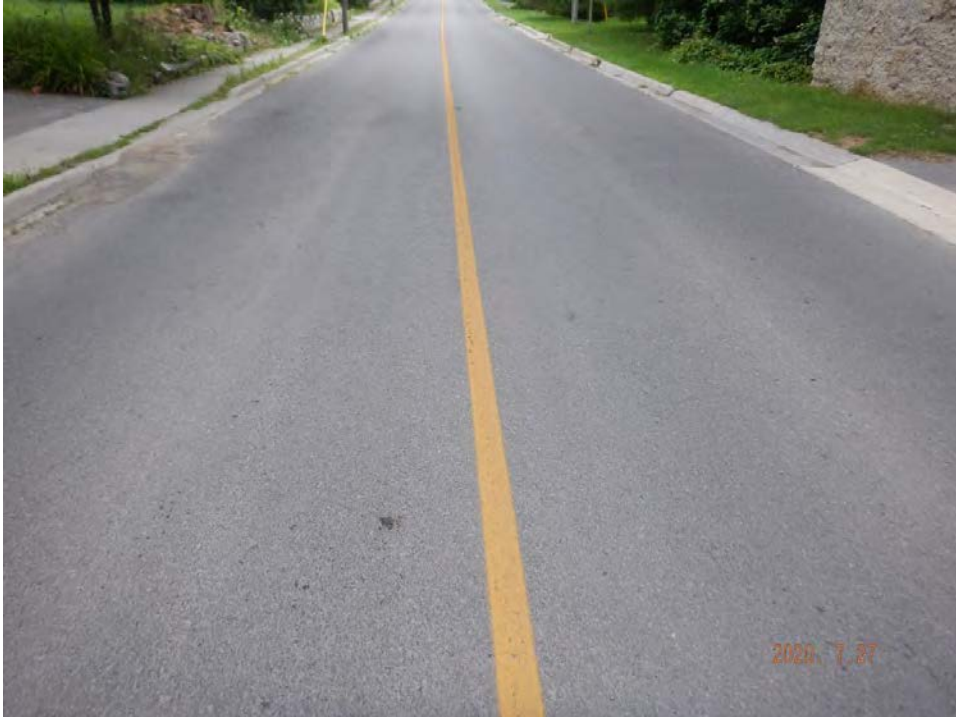
Wearing surface below bridge

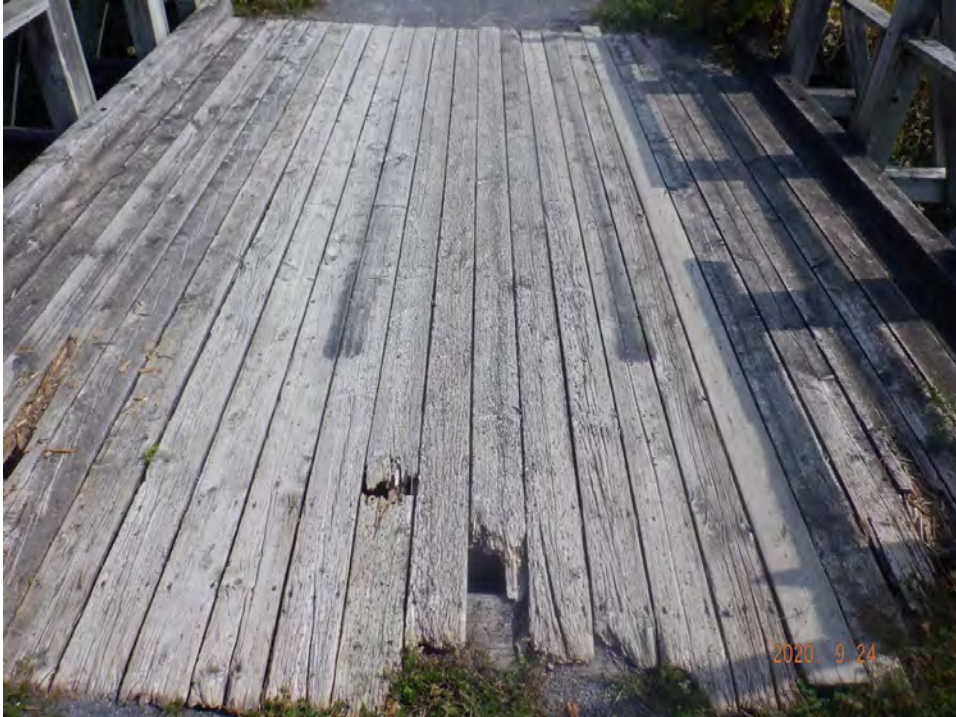
Deck wearing surface

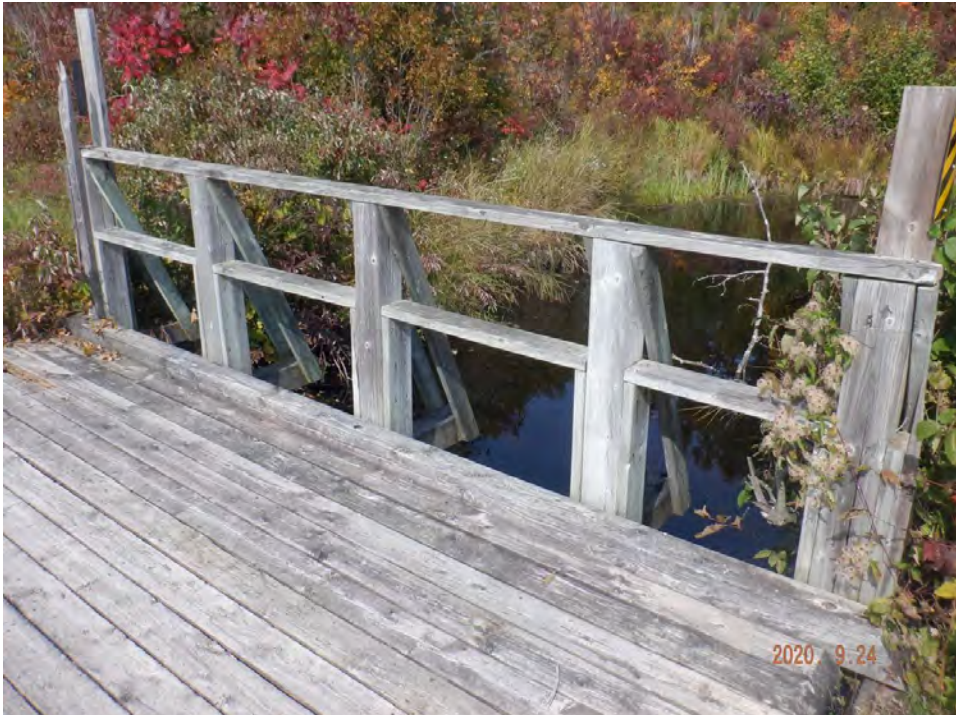
North railing system

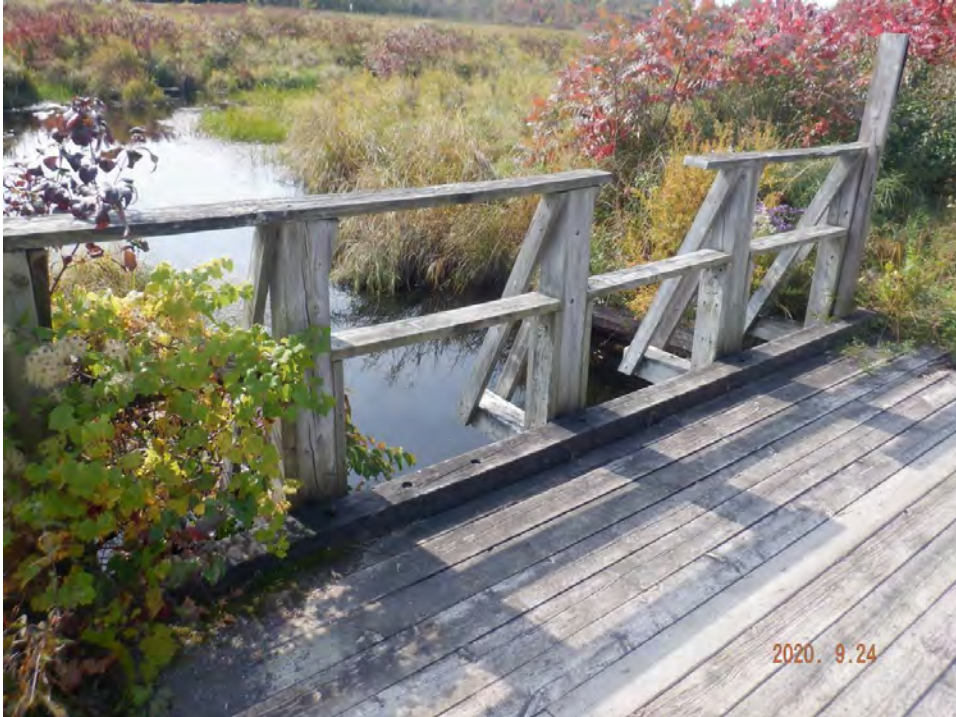
South railing system

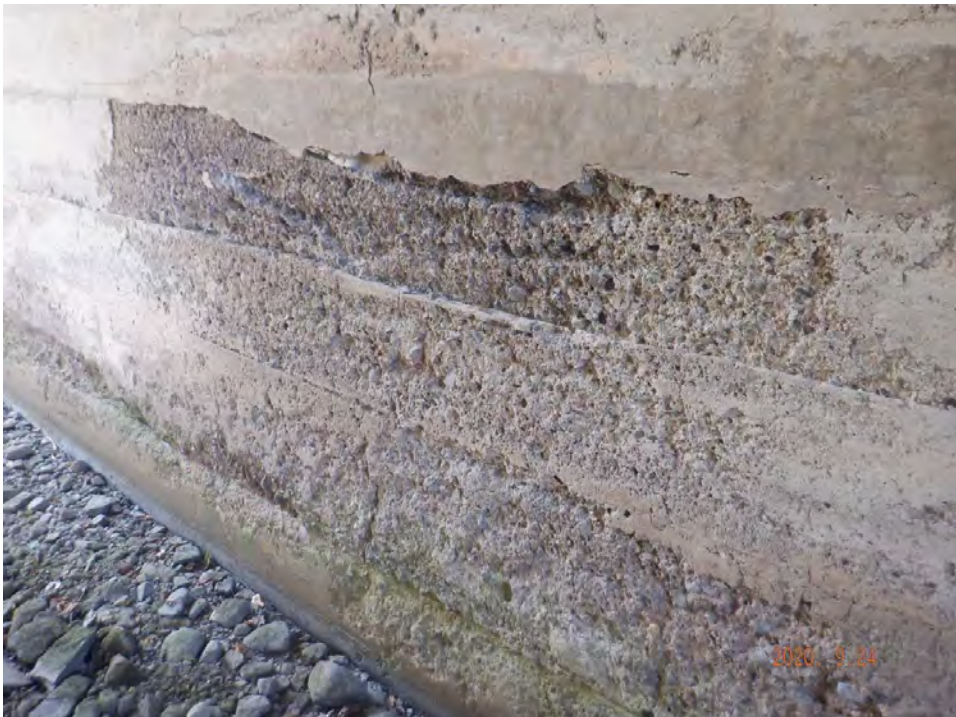
Moderate scaling in wall

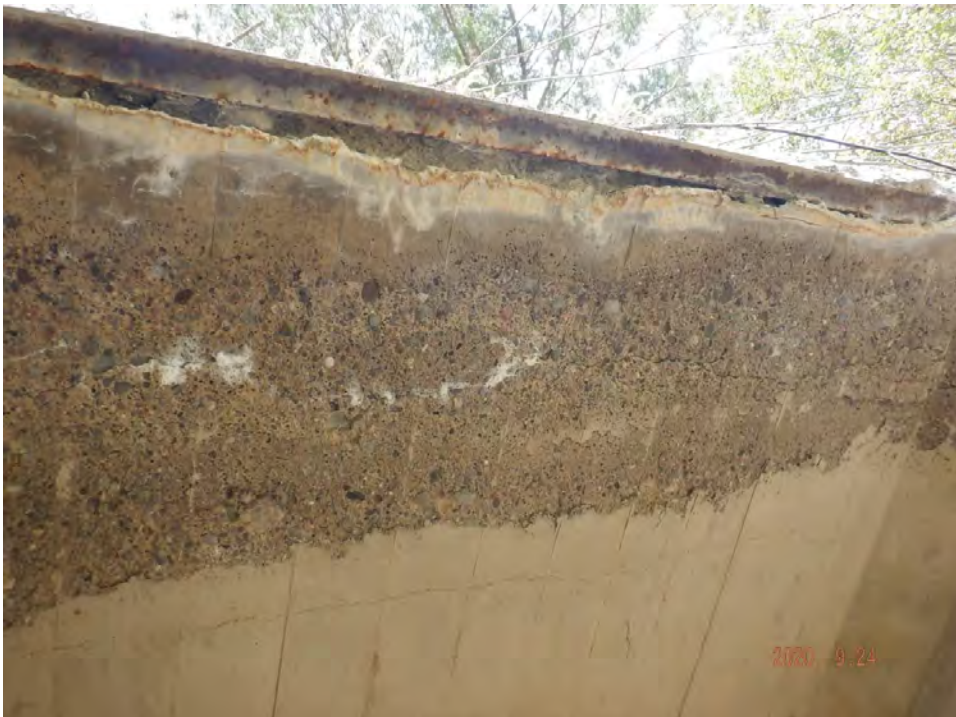
Scaling and disintegration in soffit end

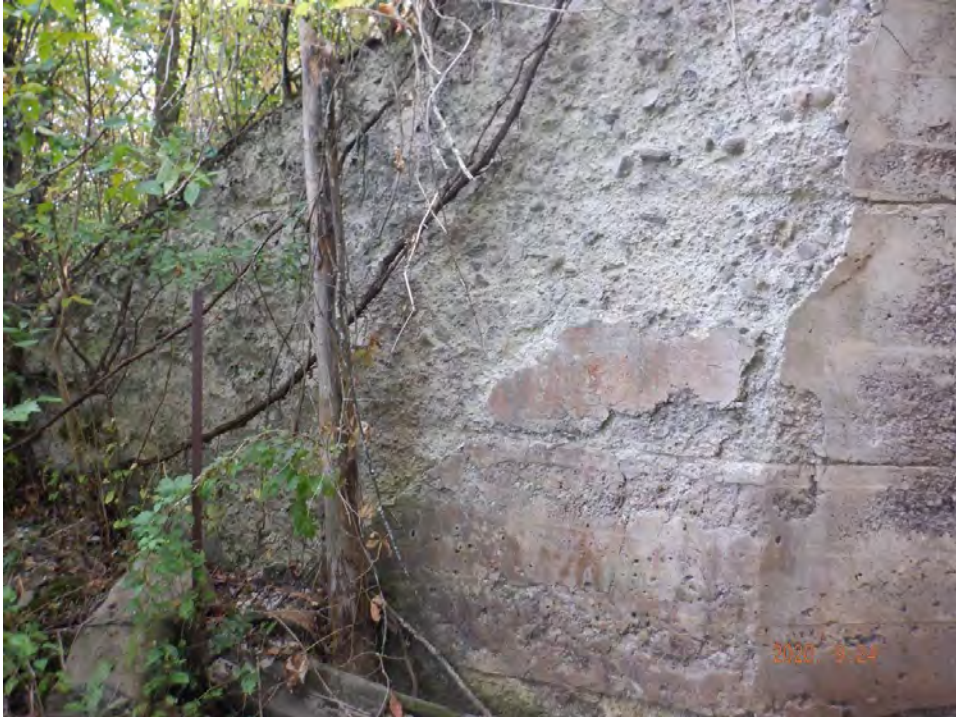
Severe disintegration in northeast wingwall
