Leadloch, North Lanarkshire: Historic Environment Assessment & Survey

Appraisal

issued 19th April 2022

on behalf of Mark Hamilton Landscape Services

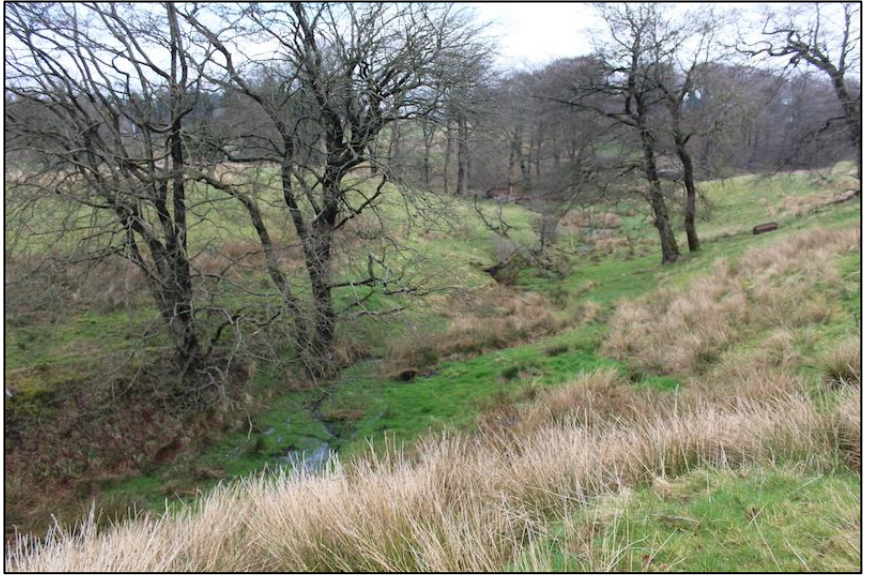
No	Site	HER Ref:	Description	NGR	Image from Site Inspection
S3	Leadloch; Quarry	Canmore: - WoSAS: -	<p><i>Desk Based Assessment</i></p> <p>A quarry S3 is depicted on 1st edition Ordnance Survey (1860) as a shaded triangular depression where the quarry is named as the “old quarry” in the 2nd ed Ordnance Survey. The quarry is not depicted on modern mapping; however, the quarry is identifiable through aerial and LiDAR imagery.</p> <p>S3.1 is a possible quarry located to the NW of S3 and was identified through LiDAR and satellite imagery.</p> <p><i>Walkover Survey</i></p> <p>The quarry S3 is a large single bowl with surrounding trees and woody vegetation. Its S side measured more than 4m deep. A small burn runs through the centre with no determined course.</p> <p>The feature S3.1 is a small single bowl quarry surrounded with trees and woody vegetation and is oval shape on plan. The bowl measures approximately 3m deep on the S side with an ephemeral entrance to the N.</p>	NS 9175 6010	<p>S3</p>

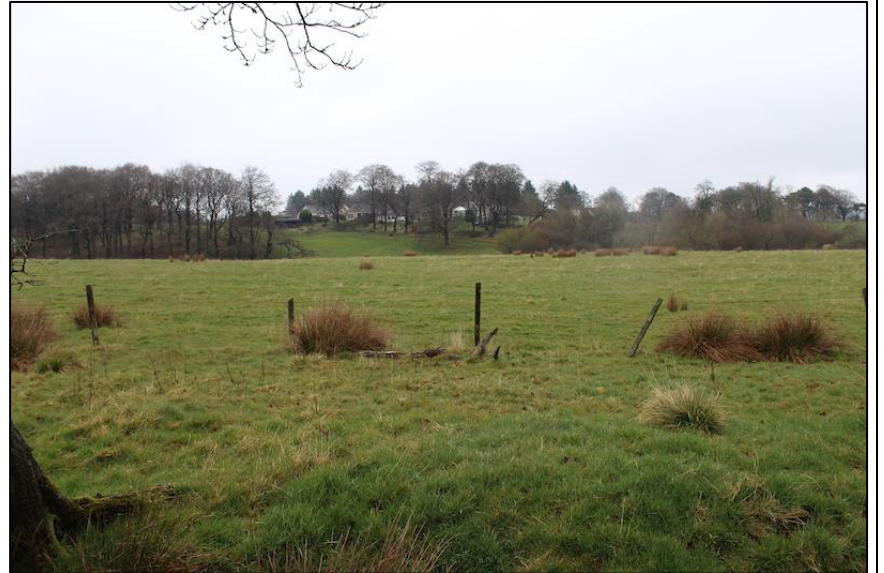
No	Site	HER Ref:	Description	NGR	Image from Site Inspection
S12	Easter Plantation; Banks	Canmore: - WoSAS: -	<p><i>Desk Based Assessment</i> A possible bank S12 was identified through LiDAR running a length of approximately 123m from ENE to WSW. Another possible bank S12.1 was identified through LiDAR running a length of 80m from E to W. A further bank S12.2 was identified through LiDAR running a length of 72m E to W. The banks were also identified on historical mapping as probable field boundaries.</p> <p><i>Walkover Survey</i> The banks S12, S12.1 and S12.2 were not discernible on the ground.</p>	<p>S12 NS 9190 6000 to NS 9180 5990</p> <p>S12.1 NS 9170 5990 to NS 9170 5990</p> <p>S12.2 NS 9160 5990 to NS 9160 5990</p>	<p>S12</p>
