This Service Information bulletin supersedes SI B11 04 04 **dated October 2004.**

Service Action: E46 M3 S54 Connecting Rod Bearings Replacement

E46 M3 coupe/convertible with S54B32 engine produced from 02/12/2001 up to 05/22/2003

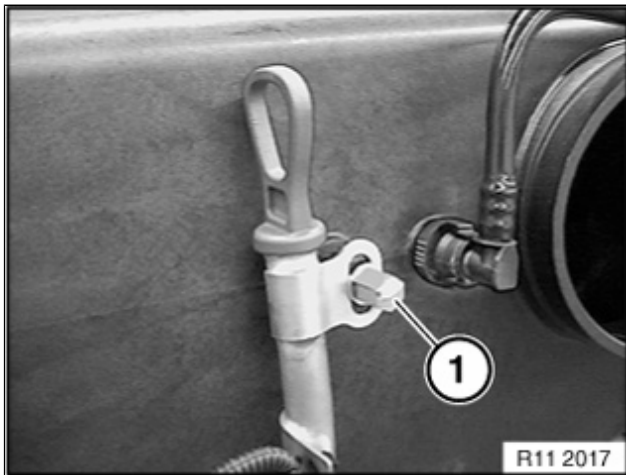
3. Detach guide tube (1) for oil dipstick from the intake manifold.

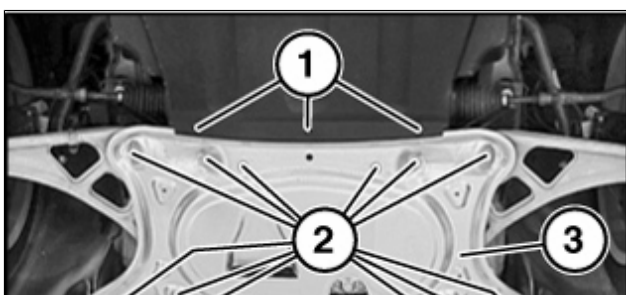
5. Remove engine splashguard. Remove thrust (3) plate on front axle support. For removal instructions refer to RA 51 71 374.

Important: When reinstalling thrust plate, use a set of new M10 x 30 x 1.5 screws provided in the parts kit. Then, the

reinforcement plate screws must be tightened in two stages:
 - first, torque with 59 Nm
 - then, angle torque to 90°
 Using Torque Angle Measuring Tool (p/n 90 88 6 009 120 available through the Automatic Tools Shipment Program)

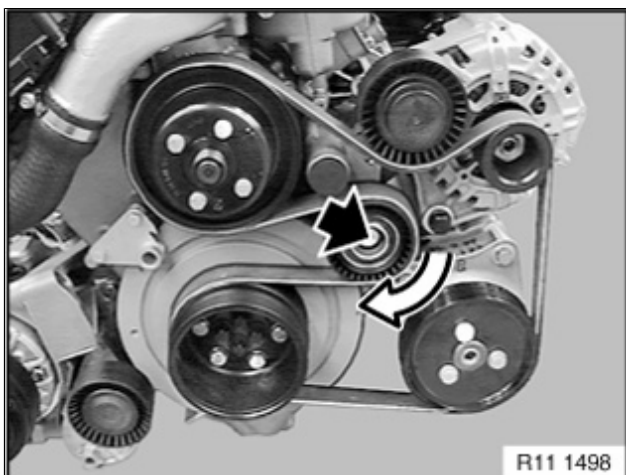
10. Detach oil lines from the power steering pump bracket.

11. Remove drive belt from the power steering pump belt pulley. In order to do this, remove the plastic cover from the belt tensioner pulley. Using a 6 mm Allen key, compress tensioner by rotating it clockwise until p/s belt can be removed.

12. Remove power steering pump without disconnecting power steering lines. Secure steering pump to the body by using plastic wire ties.

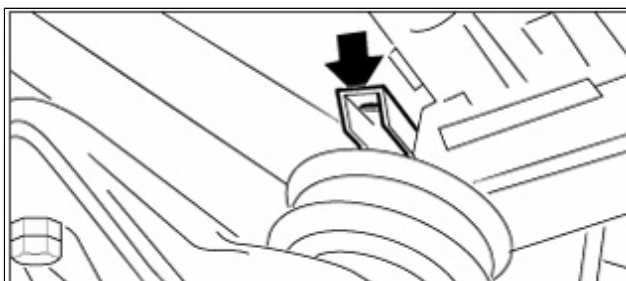
13. Unfasten two nuts at the bottom of the engine mounts.

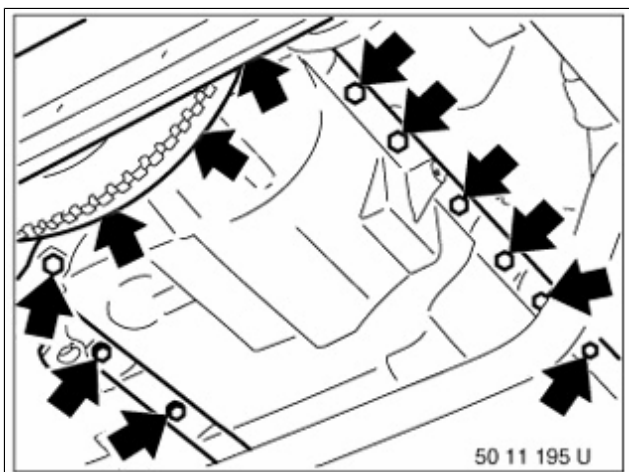
21. Unfasten oil sump screws and carefully remove oil pan.

Important: Three screws on the left side of the oil pan (near the oil condensate return hose) are 5 mm longer than the rest of them. On SMG transmission equipped vehicles, if necessary, disconnect bracket for engine oil lines to ensure sufficient clearance for oil sump movement. When reinstalling, use new Oil Pan Gasket (p/n 11 13 1 437 237 ordered separately). Also, apply a small amount (bead approximately 3 mm wide and 2 mm high) of HYLOMAR Sealing Compound (p/n 81 22 9 400 339) in areas around timing cover/engine block/bell housing joints. Detailed procedure can be found in the instructional CD. Then, torque down oil pan screws (M6) to 10 Nm when reinstalling.

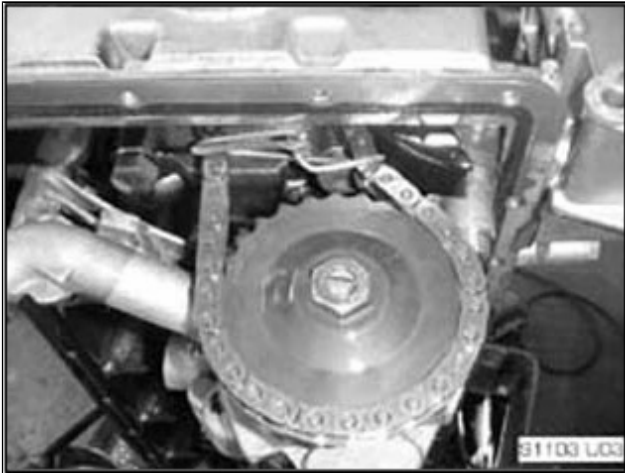
23. **Important:** To reduce tension exerted by the oil pump chain when loosening the sprocket nut, remove all slack existing in the chain. It can be done by tightening chain around the sprocket (as shown on the illustration) with approx. 7" of soft wire (e.g., from a wire hanger). This will protect plastic tensioner from possible damage while loosening the sprocket nut.

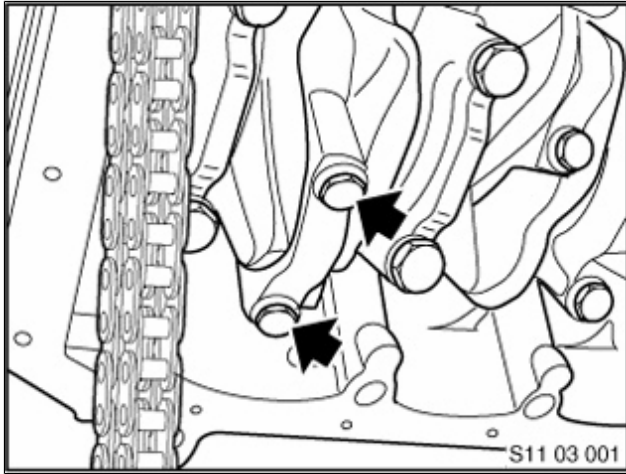
27. Connecting rod bearings bolts can be accessed from the bottom, in the following sequence: cylinders 1 and 6, cylinders 3 and 4, finally cylinders 2 and 5, when rotating crankshaft in clockwise direction. Using a special tool (p/n 90 88 6 115 100) at the crankshaft vibration damper pulley, turn crankshaft clockwise until number 1 cylinder connecting rod bolts are accessible.

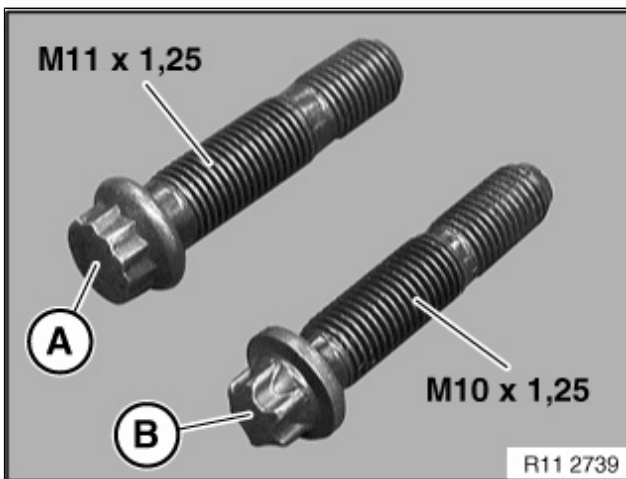
28. Remove connecting rod bolts (use M12 mm, 12-point socket on vehicles with M11 x 1.25 bolts; or Torx E12 on vehicles equipped with M10 x 1.25).

Important: On vehicles produced up to 12/13/2002, the M11 x 1.25 connecting rod bolts (A) will be reused with the new bearings. **It is essential to mark them and then reinstall them in the same order (e.g. bolt from the exhaust side must be reinstalled again on the exhaust side, etc).** On vehicles produced from 12/13/2002, the new design M10 x 1.25 connecting rod bolts (B) have to be replaced with the new connecting rod bearings. The M10 x 1.25 bolts have to be ordered separately (p/n 11 24 7 834 310 – 12 bolts per vehicle).

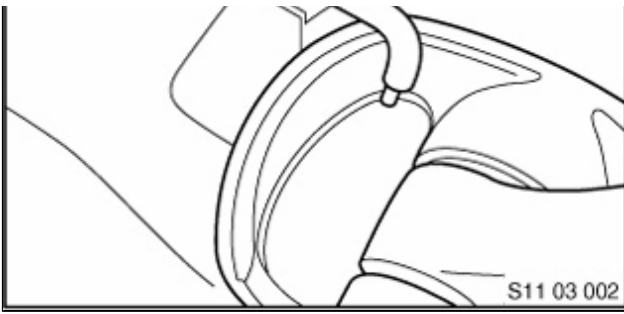
Note: If the removed connecting rod bearings exhibit signs of excessive wear (e.g.: exposed shiny, copper bedding on the inner surface; missing, sheared-off locking tabs; or deep, shiny grooves on the outer surface indicating "spinning"), then contact the Technical Hotline Drivetrain for further instructions.

Important: When pulling down pistons for connecting rod bearing shell disassembly, make sure not to damage oil spray nozzles, which are located at the bottom side of the block (between crank bearing supports).

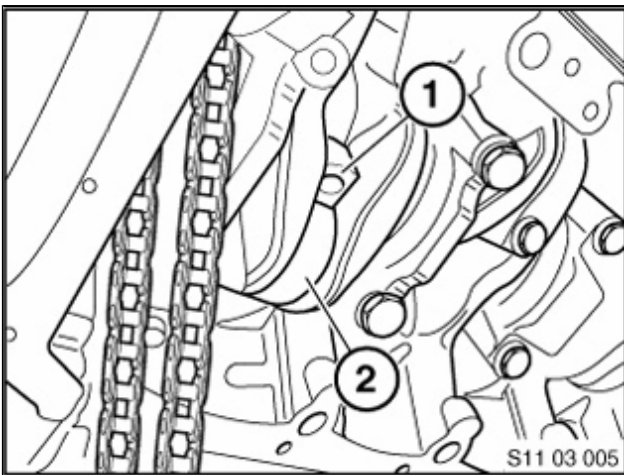
31. Clean connecting rod bearing surface with fiber-free cloth, then install "blue" bearing shell and moisten it with clean 10W-60 engine oil.

32. Then, carefully push the connecting rod (1) upwards and over the crankshaft journal (2), making sure that crankshaft surface is not scratched in the process.

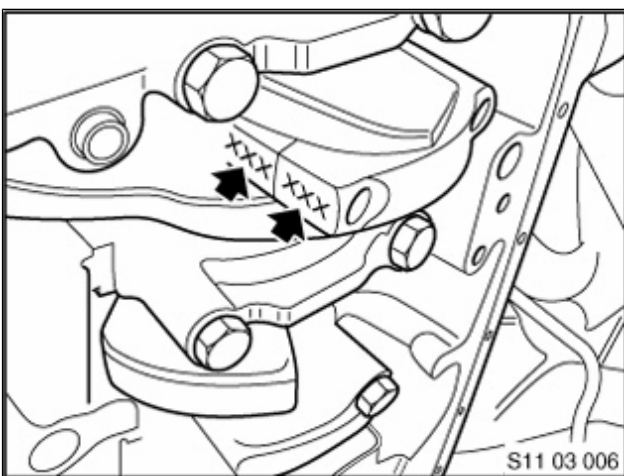
33. Install "red" bearing shell in the corresponding connecting rod cap and moisten it with clean 10W-60 engine oil.

34. Install connecting rod cap in the proper position, with matching serial numbers stamped on cap and rod as shown on the illustration.

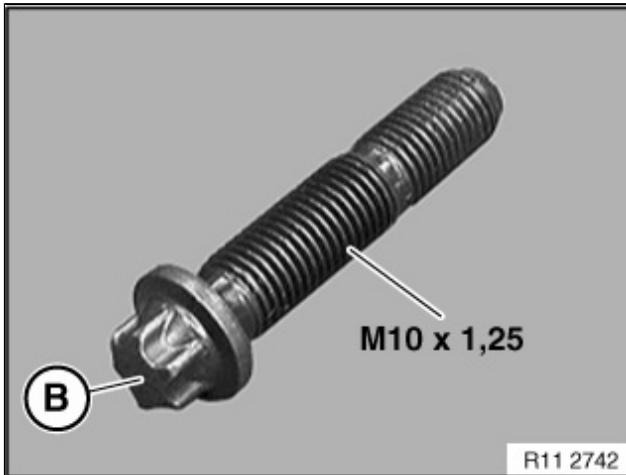
37. On vehicles from 12/12/2002 production, the M10 x 1.25 con rod bolts must be tighten at least **three** times in order to reach its maximum tensile strength.

Important: Not adhering to the tightening specifications detailed below, will result in serious engine damage.

Vehicles with M10x1.25 con rod bolts;

First tightening of conrod bolts:

- settling torque: 5 Nm
- initial torque: 30 Nm
- angle torque to 105°, in one single stroke.

Use the Torque Angle Tool (p/n 90 88 6 00 9 120 available through the Automatic Parts Shipment Program). Then, release the torque by backing off conrod bolts by approximately one turn and then retighten them again.
