Introduction

This a Case Study where one of their vehicles was driven in with a “Runs Rough” complaint. Which after further inspection, turned out to be more catastrophic than anticipated.

Engine: 2001 Chevy 3500 6.5 liter Diesel
Miles: 105,993

Complaint: "Runs Rough"

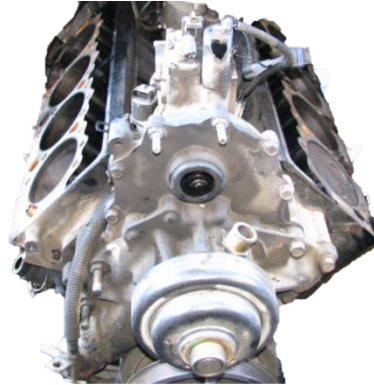
Core Charge

Your replacement engine just got about more expensive due to no core credit. That’s \$3,000 plus another \$3,000 you will be charged for not providing a rebuildable core.

As the antifreeze and water congealed with the engine oil, **ProOne** kept the lubrication film from breaking down. This is evident as we review the condition of the piston ring lands, piston skirts, cylinder walls, rod bearings and valve stems. This engine still qualifies for at least 80% core return dollars
