Loss of control and collision with terrain involving de Havilland Canada DHC-1 Chipmunk, VH-UPD

Coffs Harbour, New South Wales | 29 June 2014

ATSB Transport Safety Report
Aviation Occurrence Investigation
AO-2014-114
Final – 4 February 2016

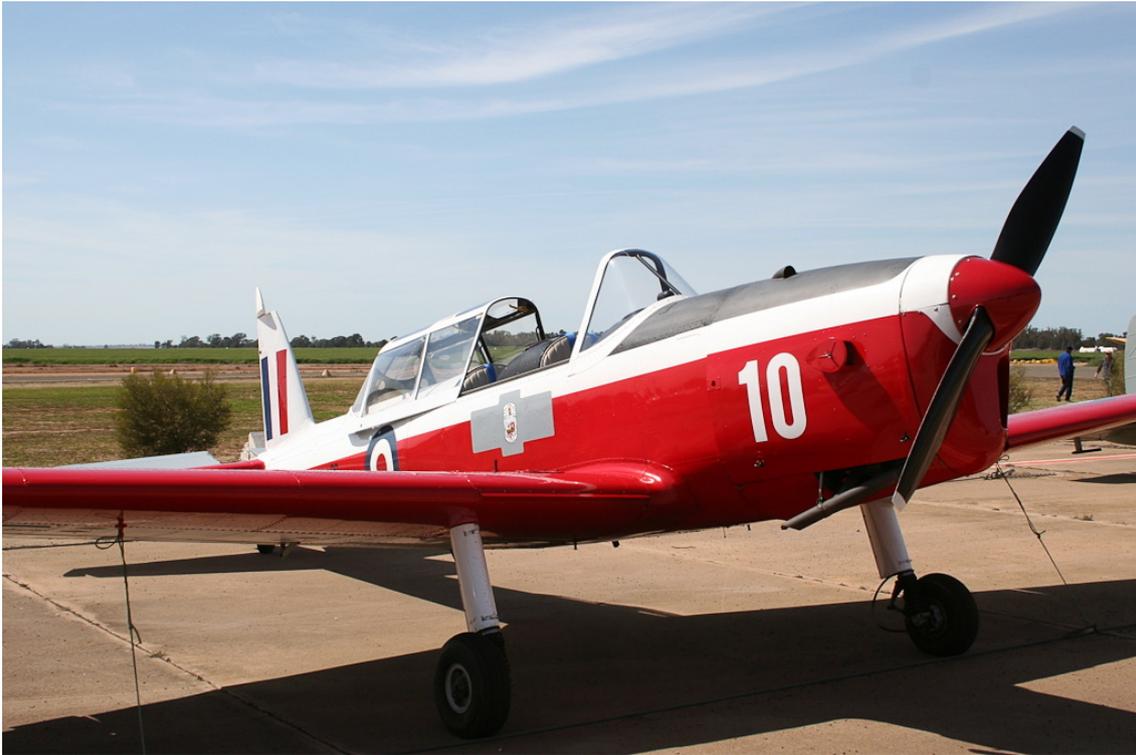
Figure 1: DHC-1 Chipmunk, registered VH-UPD, in 2009

The aircraft, a de Havilland Canada DHC-1 T Mk 10 Chipmunk, was built in the United Kingdom (UK) in 1950 with the constructor's number C1/0111. It was first registered as a civilian aircraft in Australia in 1956 (Figure 1).
