# **BENDTSEN'S**

## **Oldsmobile Installation Instructions**

**303/324/371/394 Oldsmobile and 331 Cadillac (49 - 53 only) to manual transmission.**

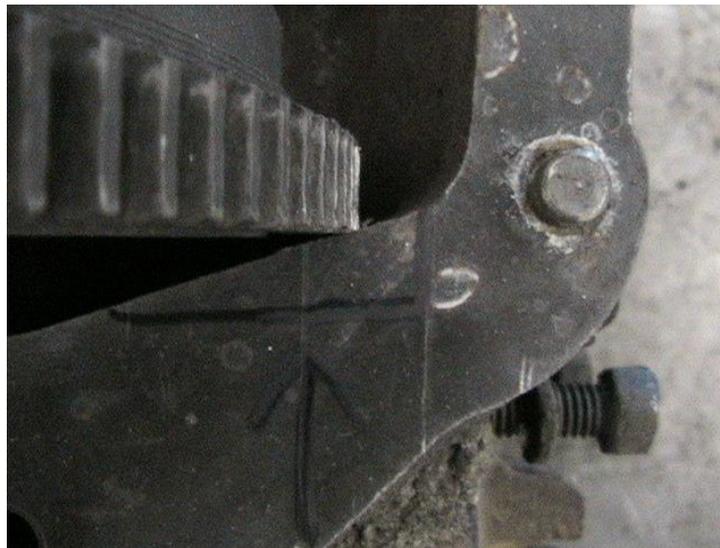
Install the provided flywheel. If you have a 303 or 324, the flywheel should not have a balance weight. If everything goes on OK, install the provided bolts. They are 12 point ARP bolts. Torque them to factory specs. Make sure that they don't hit the block behind the crank. Check to see if the ring gear hits the block. Some of the Olds blocks have more material in the flywheel area than others. I can only surmise that it was because of the 166 tooth ring gears used with the slim-jim transmissions. These flywheels had a smaller diameter. If this is the case, you will have to grind material away to clear the flywheel ring gear. I've enclosed a picture of the area that can be a problem.

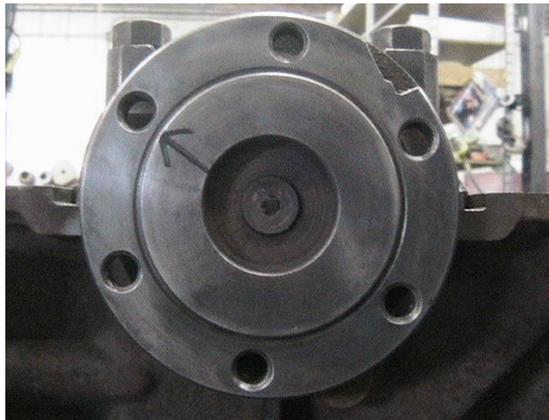
The arrow in the picture above shows the position of the offset bolt hole in relation to the notch in the crankshaft. The 1949 to 1953 cranks had a pilot bearing hole because the early Hydro's used this hole to center the input shaft with a bearing just like the manual trans did. The 1954 and 1955 cranks probably had the pilot hole in them also because they still used the Hydro's. The 1956 and later Olds crankshaft only had a pilot bearing hole drilled if it came from the factory with a manual trans. The Jetaway trans came out in 1956 and it had a different style input and torque converter driveplate. If you are rebuilding your engine it would be wise to have the machine shop machine a pilot bearing hole for you.

Make sure that the crank flange is super-clean (no burrs). I've enclosed a picture of an Olds crank with an arrow pointing to the offset bolt hole. Look at the position of the factory notch in the crank compared to the position of the offset bolt hole. This will be the same on all offset crankshafts. There is a '0' stamped next to the offset bolt hole in the new aluminum flywheel. Make sure it is lined up correctly. The aluminum flywheel has a replaceable insert that is the same size as other inserts sold in the aftermarket catalogs.

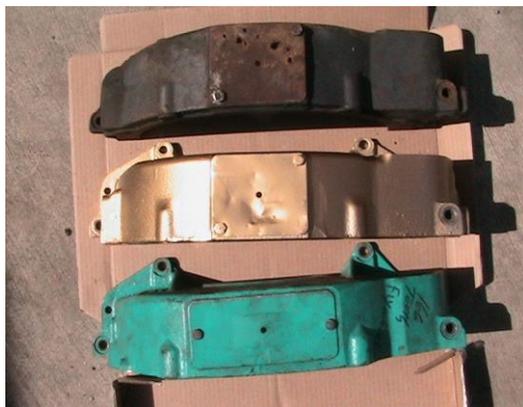
The 3 different inspection covers.

Here are the 3 types of lower inspection housings / starter housings that came stock on the different year Old's engines. The greenish blue one is the 166 tooth unit used on the Slim-Jim cars. The bottom (gold) unit is a 1954 to 1964, 176 tooth ring-gear type cover. The middle one is a 145 tooth ring-gear style cover from a 1949 to 1953 Olds. The 145 and the 176 locate the starter in the same spot, but take different starters. The tooth pitch was the difference. The early motors (& Cadillac) used a coarse pitch gear and the 1954 and later engines used the fine pitch gear. You can use the 176 tooth flywheel in all the motors if you get the right starter and the balance is correct. They also rotate the starters differently. The cover in the bottom pictures have extra bolt bosses that if used, rotate the starter correctly for the older motors. Some covers have 2 sets of bolt holes.

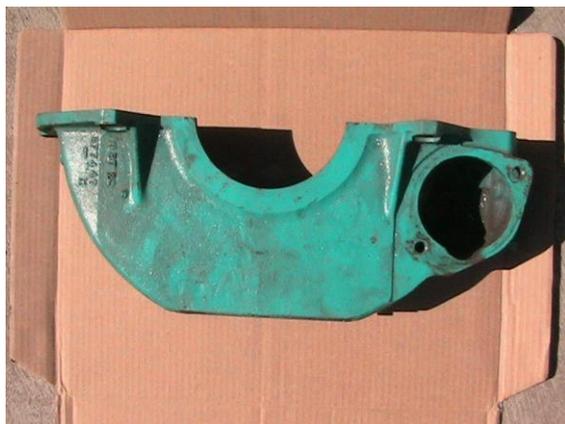
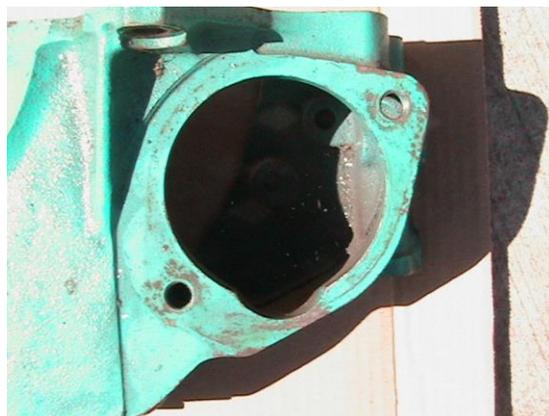
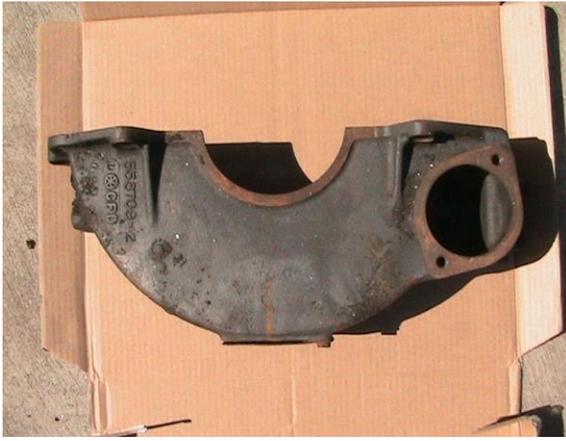
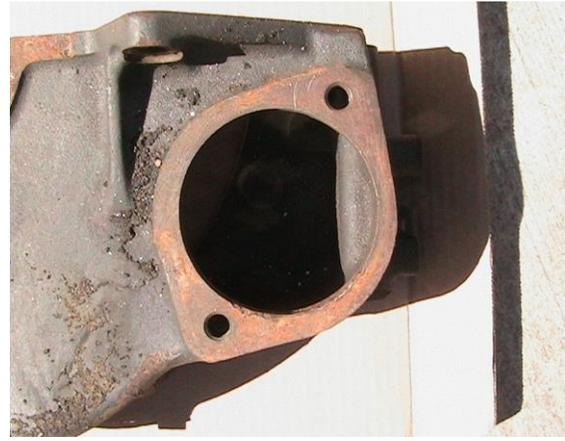
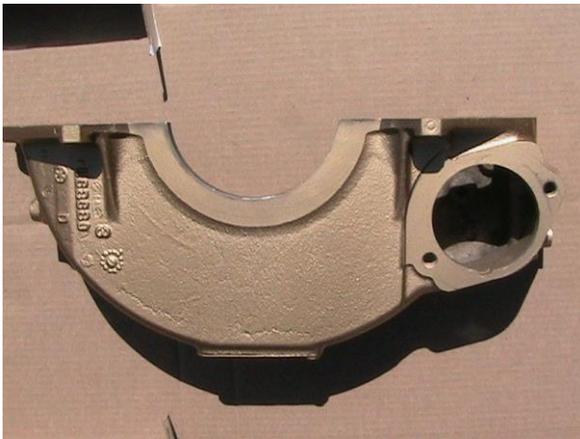
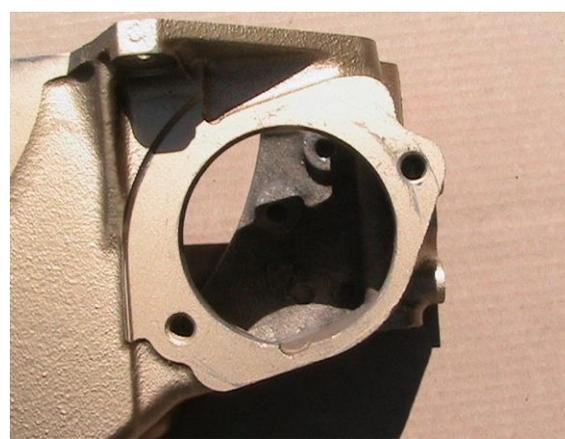
The number of teeth on the original flywheel dictates which inspection cover / starter combination you will use. Of course these can be changed as a unit to accommodate using a different flywheel than the engine originally had.
