Interactive Troubleshooting Guide for Frequently Seen Issues

Last Updated: 07/19/18

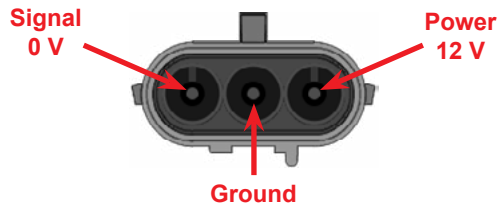
1. Check Voltage at the Fan RPM Sensor Connector

Console Cable and Extension Cables		
Pin	Voltage	Description
1	-	Ground
5	0 V	Signal
14	12 V	Power

If voltages are present on the console cable and any extension cables but not on the 3-pin connector then the product cable is bad and needs to be replaced.

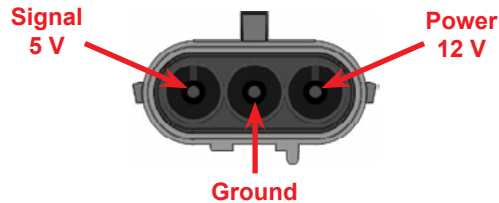
1. Check Voltage at the Fan RPM Sensor Connector

Multi-Product / ISO Node 063-0173-236 / 063-0173-006			Single Product Node 063-0172-373 or 063-0173-304		
Pin	Voltage	Description	Pin	Voltage	Description
L3	12 V	S. Power (Orange Wire)	9	12 V	Power (Red Wire)
Frame Ground	-	-	7	-	Ground (White Wire)
X3	5 V	Signal (Violet Wire)	8	5 V	Signal (Violet Wire)

If voltages are present at the node but not on the 3-pin connector then the spinner control cable or product controller cable is bad and needs to be replaced.

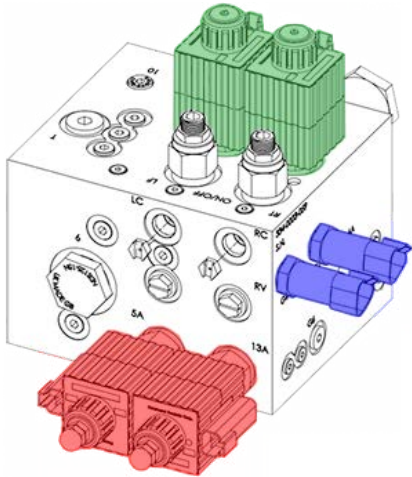
Old Hydraulic Block

Proportional Valves

Pressure Transducers

Blockers

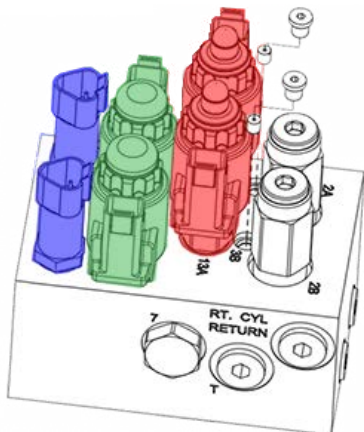
New Hydraulic Block

Verify that the electrical connections are connected correctly. The 2-pin Deutsch connectors labeled “Solenoid” connect to the blockers. The “Prop” connectors connect to the proportional valves.

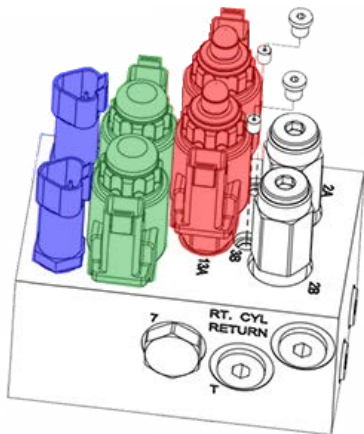
New Hydraulic Block

Verify that the hydraulics are connected and working correctly. This can be done directly from the AutoBoom hydraulic valve block.

If you suspect a faulty proportional or blocker valve, first troubleshoot the electrical connections. If the fault is not found, swap the left and right valves (do not swap a proportional valve with a blocker valve).

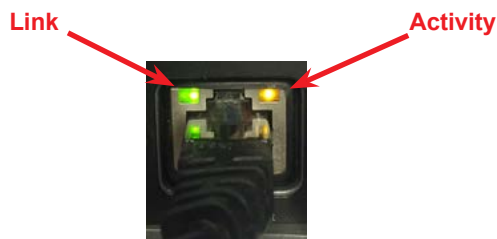
Multi-Colored Lights

Link

Illuminated when a link is established with an Ethernet device (i.e. Raven field computer)

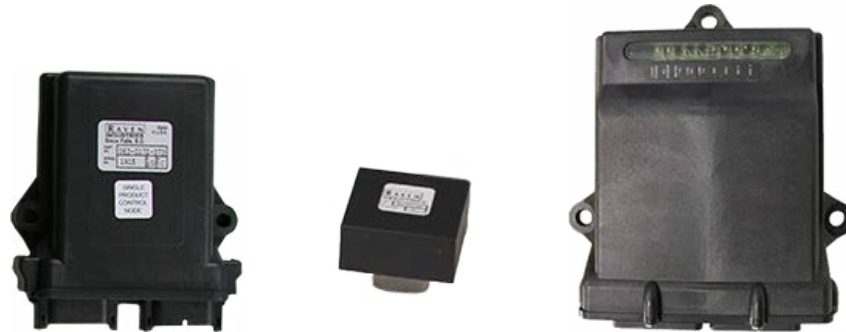
Node Lights

Logic Power: Lights up solid when 12V are seen for Logic Power

CAN Rx: Flashes intermittently when CAN communication is present going to the node.

CAN Tx: Flashes intermittently when CAN communication is present going away from the node.

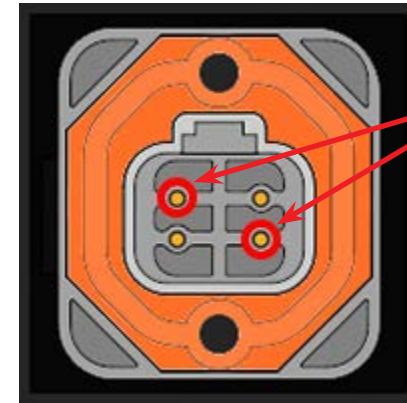
063-0172-369 Terminator

1 to 3	+12 VDC
2	CAN High Signal		2 to 3	2.5 VDC (± 1 VDC)
3	CAN Ground		3 to 4	2.5 VDC (± 1 VDC)
4	CAN Low Signal		2 to 4 Resistance	75 Ohms (2 Terminators) 150 Ohms (1 Terminator)

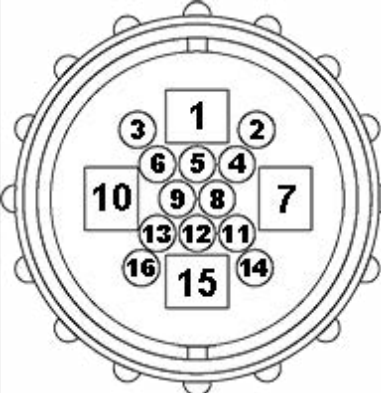
Generation II

Pin	Description	Pin	Description	Gen II Connector	Pins	Multimeter Test
1	High Current Ground 1	9	CAN Low Signal

1 to 10	+12 VDC
2	(Not Populated)	10	High Current Power 1		7 to 15	+12 VDC
3	Switched Logic Power	11	(Not Populated)		3 to 4	+12 VDC
4	Logic Ground	12	(Not Populated)		5 to 8	+12 VDC
5	CAN Power	13	(Not Populated)		6 to 8	2.5 VDC (± 1 VDC)
6	CAN High Signal	14	Remote Master Signal		8 to 9	2.5 VDC (± 1 VDC)
7	High Current Ground 2	15	High Current Power 2		6 to 9 Resistance	75 Ohms (2 Terminators) 150 Ohms (1 Terminator)
8	CAN Ground	16	(Not Populated)

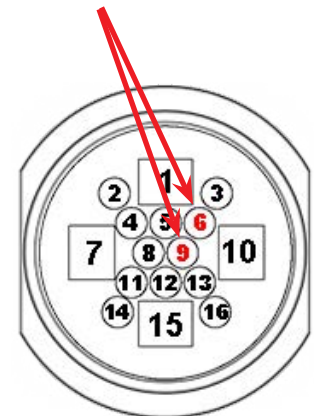
063-0173-224 Terminator

150 Ohms

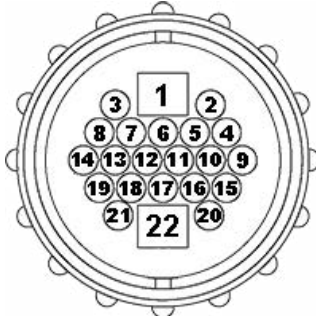
Pin	Description	Pin	Description	To Terminator Adapter Cable	Pins	Multimeter Test
1	High Current Ground 1	8	CAN Ground

22 to 1	+12 VDC
2	(Not Populated)	9	CAN Low Signal		3 to 4	+12 VDC
3	Switched Logic Power	10-13	(Not Populated)		5 to 8	+12 VDC
4	Logic Ground	14	Remote Master Signal		9 to 6	+12 VDC
5	CAN Power	15-21	(Not Populated)		6 to 8	2.5 VDC (±1 VDC)
6	CAN High Signal	22	High Current Power 1		8 to 9	2.5 VDC (±1 VDC)
7	(Not Populated)				14 to 1	+12 VDC when switch is active.

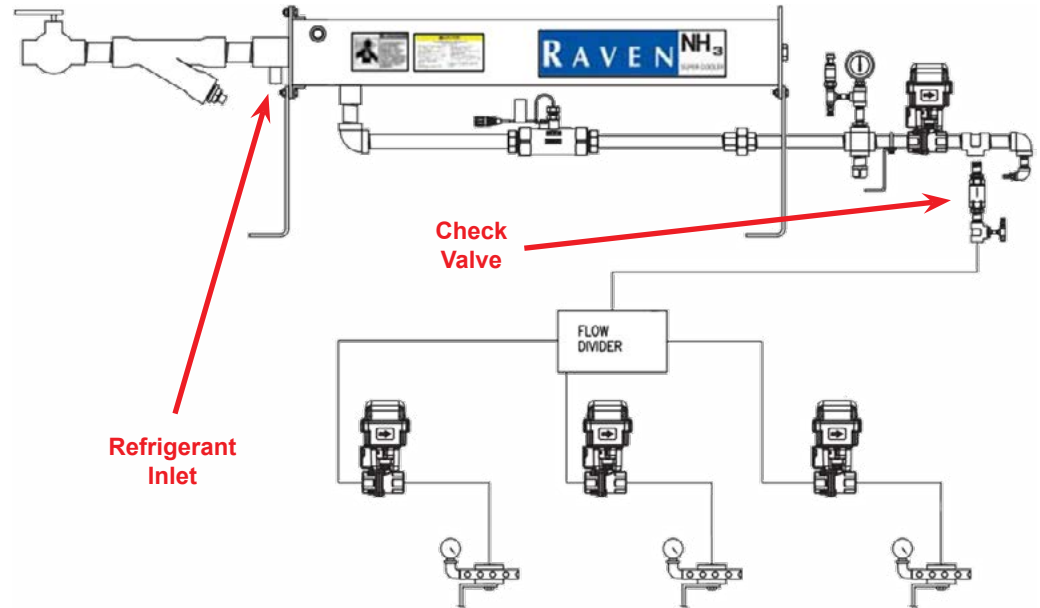
Check Valve (For Multi-Section Setups)

A check valve must be installed between the cooler and the flow divider. When the manifold valves are closed, the pressure in the lines will cause leftover vapor and eventually liquid to come out of the vapor tubes.

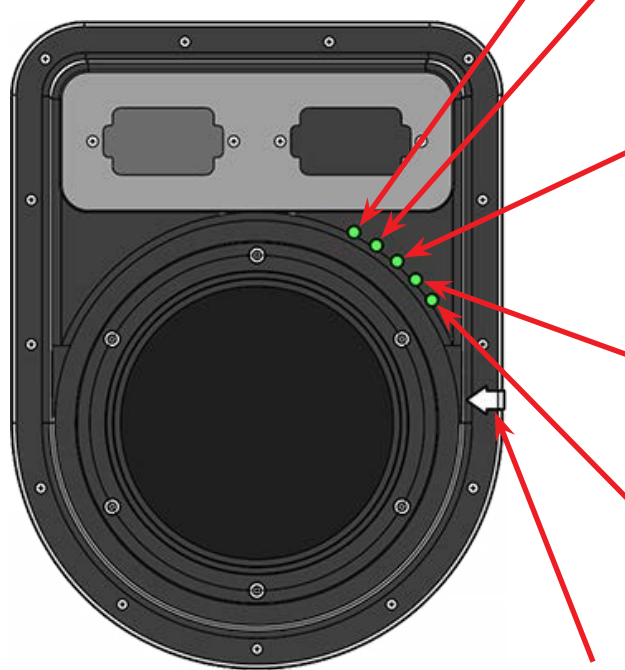
Sidekick Pro Node Lights

Light	Light Definition
Logic Power	The logic power indicator will be illuminated (solid) if logic power is present at the motor control node.
High Current Power	The high current indicator will be illuminated (solid) if high current power is present at the motor control node.
Micro 1Hz	The Micro 1Hz light indicates the node processor is communicating with the CANbus system. This indicator will flash: <ul style="list-style-type: none">• once per second if the motor control node is communicating via the CANbus.• four times per second if the motor control node cannot communicate via the CANbus.
Flow Switch State	The flow switch light will flash once per revolution of the injection pump shaft.
Calibration Switch State	The calibration switch light will flash when a metal object is passed by the internal calibration switch sensor. This can be engaged only after the CANbus control console (e.g. Viper Pro, Envizio Pro, SCS 4400, etc.) has calibrated the pump for the first time.

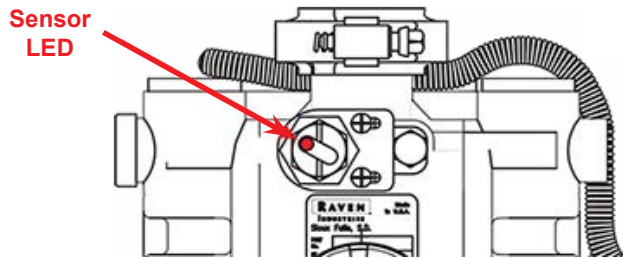
The sensor is designed to have the line running vertically with the LED light on the left side of the line.

If the sensor appears as below but the light is not flashing, adjust the sensor while running the pump at its lowest injection rate (1 oz/min for 1-40 oz/min or 5 oz/min for 5-200 oz/min).

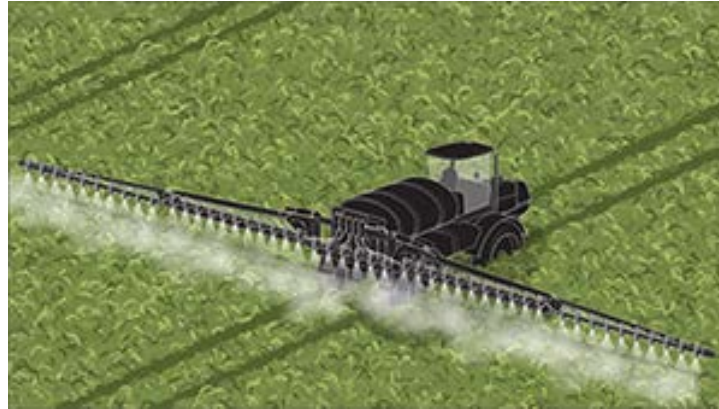
Hawkeye Nozzle Control

Nozzle Control Valve Lights

LED Activity	Rate	Color	State
Flashing	1 Hz	Green	Ready. If in actuating mode, the NCV is ready but requires calibration.
		Blue	Actuating Mode (Auto)
		Red	Loading New Software
		Amber	Alarm Active
	5 Hz	Amber	No ISOBUS Communication
Alternating	1 Hz	Blue/Green	Actuating Mode (Manual)
		Green/Magenta	Not Calibrated - Switch Input High
		Red/Magenta	Not Calibrated - Switch Input has not changed.
		Amber/Red	No ECU Detected or Invalid ISO Name
		Amber/Green	Ready - Warning Alarm Active
		Amber/Blue	Actuating mode - Warning Alarm Active
Solid	-	Any Color	Nozzle Control Valve Failure

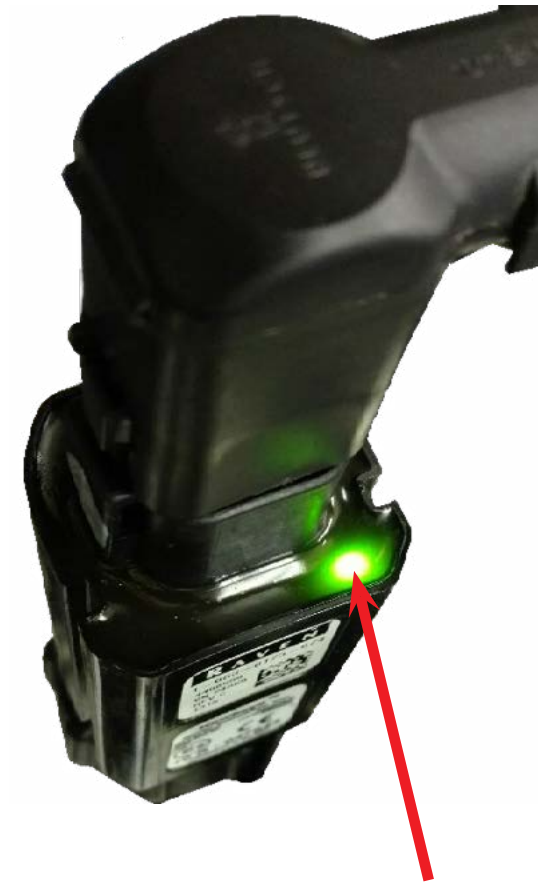
1 Hz = Once per Second

5 Hz = Five Times per Second

1. Visually inspect the NCV LEDs for power by the light color and blinking frequency.
2. On the boom cabling, disconnect all 19-pin boom cable connections, all 6-pin NCV connections, and terminator connections and visually inspect each for the following:
 - Corrosion
 - Pulled/pushed pins
 - Water
 - Broken wires
3. Reconnect all 19-pin boom cable connections. This will ensure that the entire boom nozzle-bus cabling is terminated on both ends.
4. Connect 5-10 NCVs on both the left and right boom cables. Start from the middle of the boom and work your way out.
5. Go into the Calibration Wizard and proceed until you get to the Nozzle Setup screen.

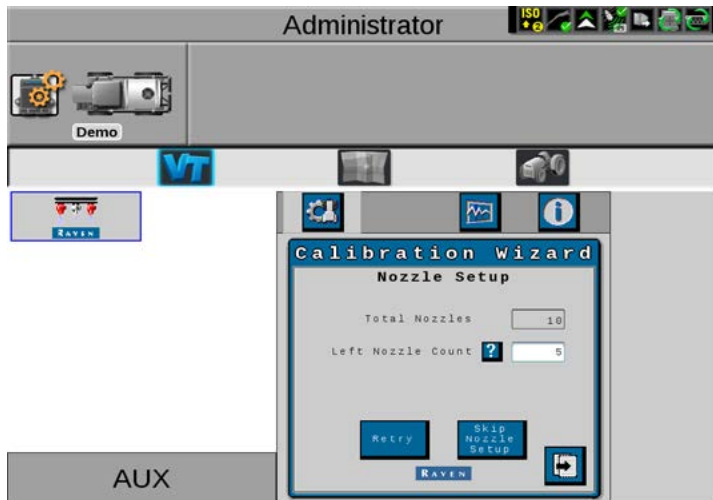
6. Verify the number of NCVs is correct, and ensure the correct number for the Left Nozzle Count. If the total number of nozzles on the left side does not match what you have installed, change the value on the VT to be accurate.

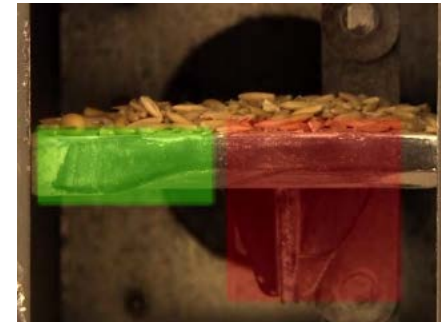
SmartYield Pro

Note: Make sure the sensors are reading completely off of the green portion of the paddle and not anywhere in the red. The Frequency reading will “bounce” if the sensors are mounted in between the green and red areas.

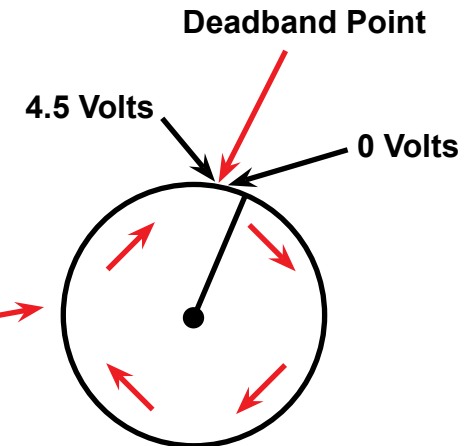
Most systems use a 360 degree header height sensor. There is only one deadband on the sensor, meaning the sensor will range from 0 volts to 4.5 volts, and once the sensor moves past the 4.5 volt position, it will pass over to the 0 volt position. This is demonstrated to the right. Make sure that when installing this type of sensor, that the it does will not cross this deadband point when raised or lowered.

Note: The sensor can be installed in multiple ways. The voltage reading will depend on what you calibrate as “Up” and what you calibrate as “Down.”
