POLARIS PATRIOT BOOST

10979 HIGH FLOW AUXILIARY INTAKE INSTALLATION INSTRUCTIONS

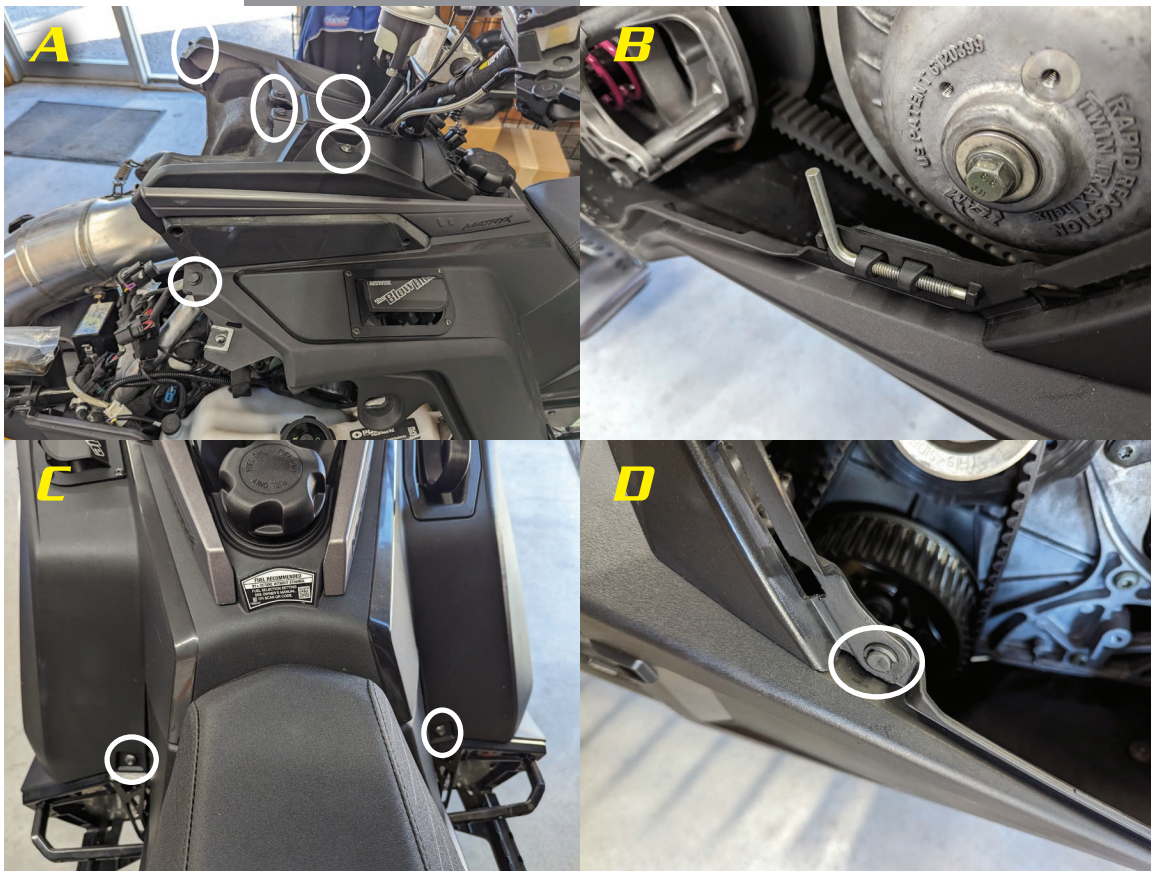
**STEP 4**

- Remove the plastic Tuflok rivets & the torx head screws from the locations shown in (A,C,D).
- Remove the belt change tool from the panel. (B)

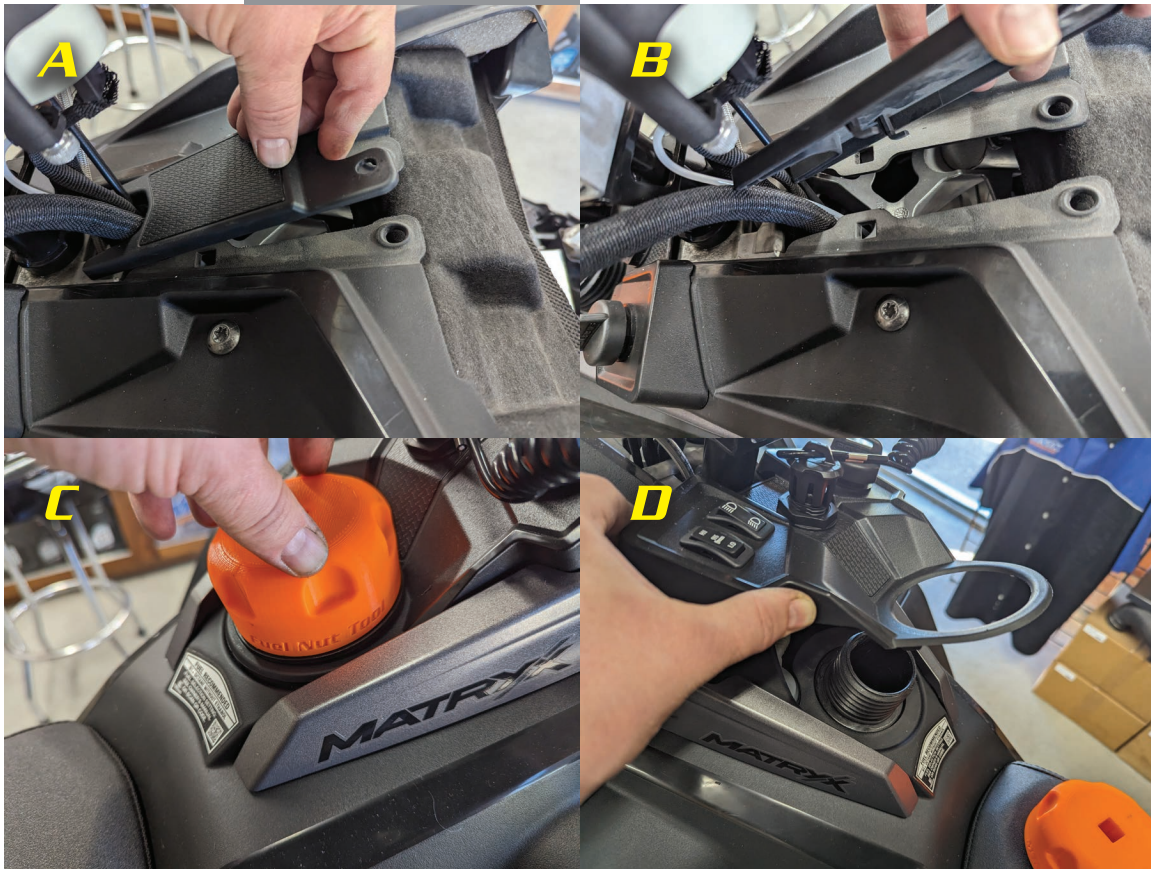
**STEP 5**

- Remove the console closeoff panel (A) by pushing it closer to the steering post so the mount tabs will pass out of the mounting hole. (B)
- Use a suitable tool to remove the fill neck nut. (C, MTNTK Fuel Nut Tool works amazing in this spot!)
- By flexing the switch panel you can lift it over and off of the fuel tank fill neck. You don't need to remove any wires, just get it loose so it will not be causing problems in the next steps.

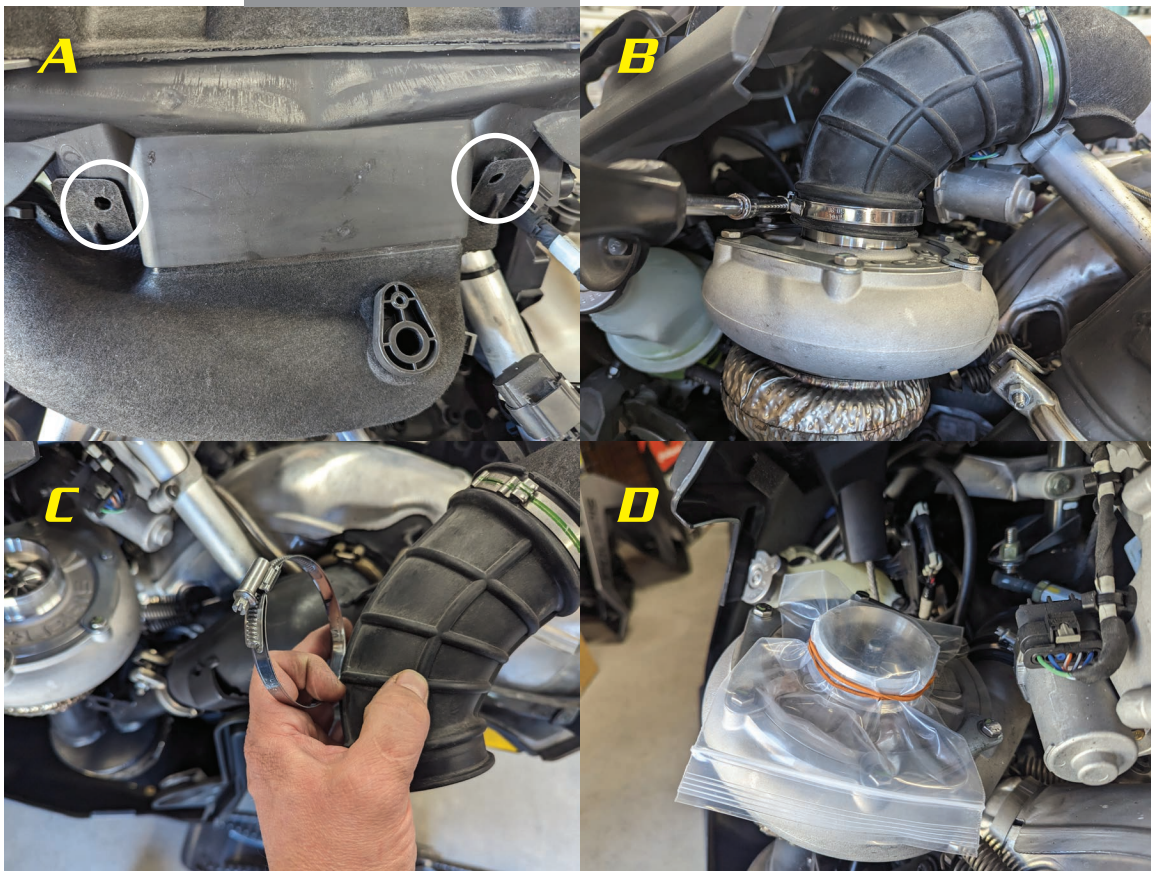
**STEP 6**

- Remove the (2) Tuflok plastic rivets securing the turbo intake tube assembly to the intake plenum. (A)
- Loosen and remove the hose clamp securing the intake tube to the turbo inlet. (B)
- Remove the intake tube, saving the clamp for reinstallation. (C)
- Place something over the turbo inlet! (D) If a foreign object falls into the turbo, it can at the very least cause yourself major work to retrieve the object. Worst case you don't know you dropped something and it causes total failure of turbo and/or engine.

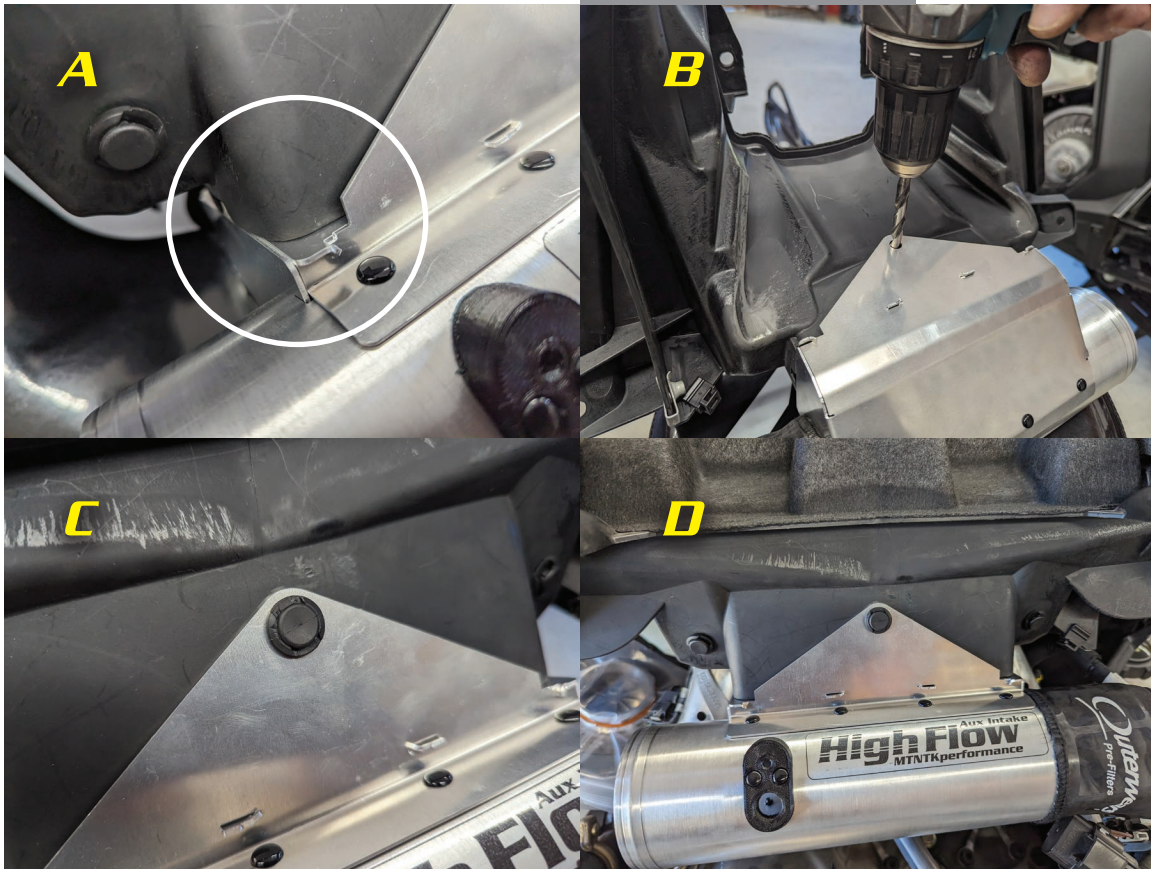
**STEP 8**

- Install the new High Flow Aux Intake assy fully onto the intake plenum ensuring the seal plate is flush to the plenum shelf. (A)
- While ensuring the intake assy is fully on, drill the holes (front and back) with a 5/16" drill bit through the plastic of the intake plenum.
- Remove the assy and fully clean out all debris from drilling. Failure to clean out the debris could result in turbocharger damage and/or engine damage.
- Re-install intake to plenum and insert the plastic Tuflok rivets (C,D). Install plenum/intake assy back onto the sled. Ensure the plenum is back in the correct location for reassembly.

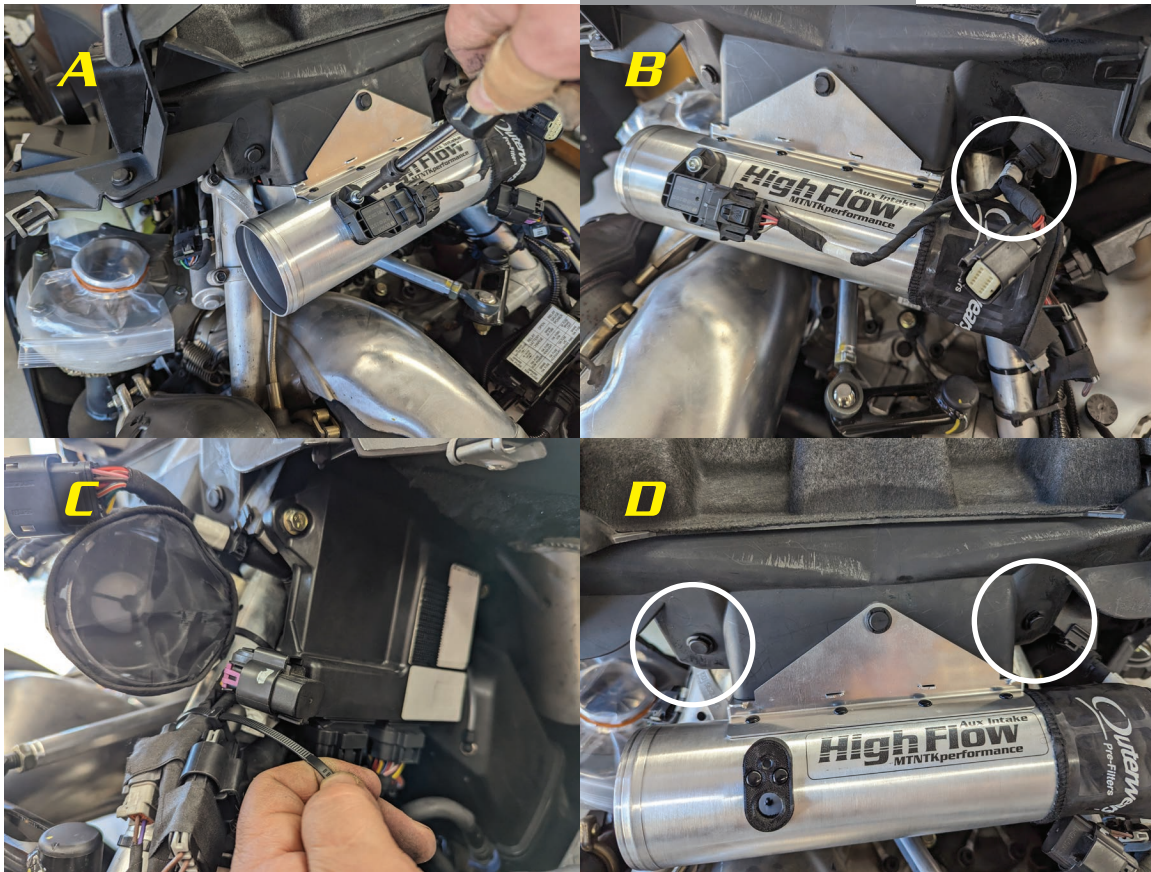
**STEP 9**

- Carefully insert the pressure sensor into the new sensor mount and reuse the original mounting screw. Tighten until snug, over tightening could damage the mount.
- Reinstall the cable tie securing the harness to the plenum (B) that was removed in STEP 2 picture C.
- Secure the diagnostic connector to the frame. Try to position it so it will not have opportunity to rub against the prefilter sock.
- Insert the (2) provided Tuflok rivets into the original mounting holes to plug the openings.

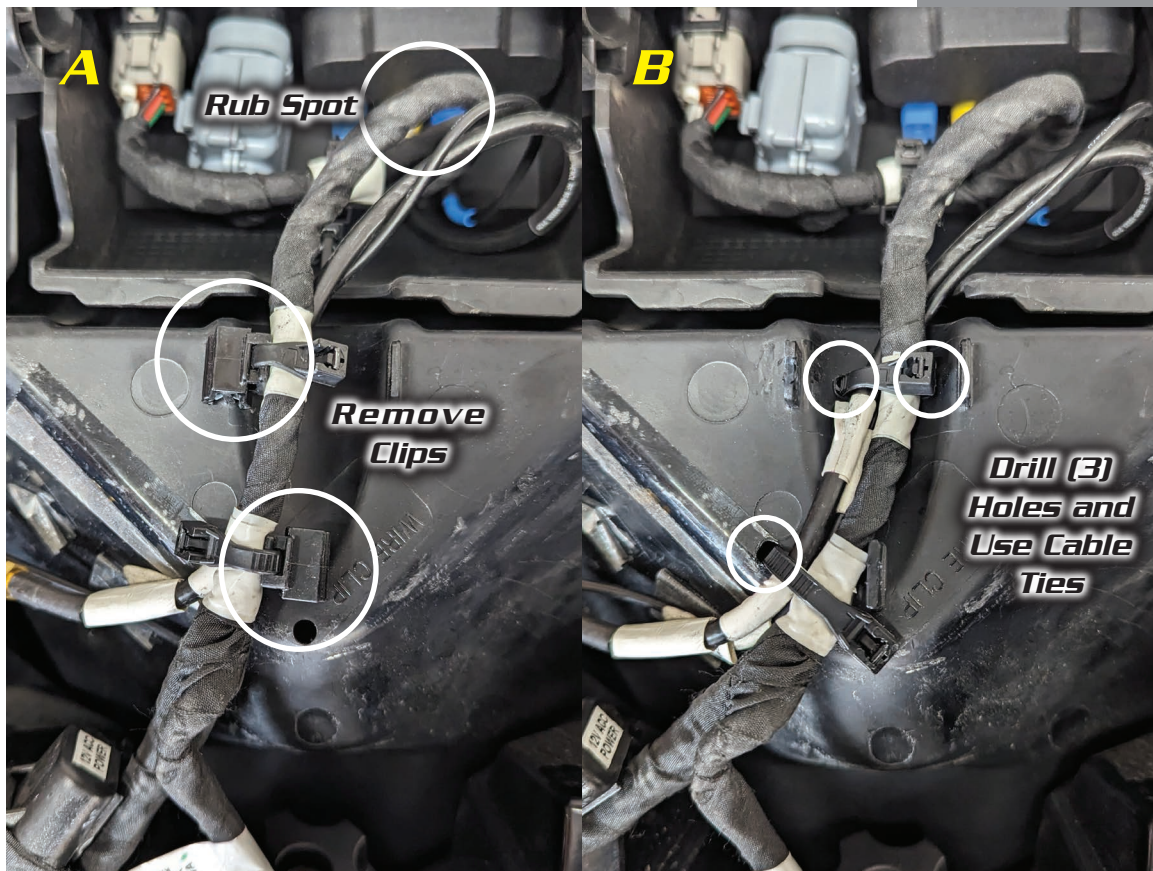
**STEP 12**

Optional Steps

- We have found the hood wiring to be poorly positioned from the factory and rubs on the harness even stock. (A)
- Picture (A) shows how many sleds were sent from the factory.
- Picture (B) shows how we recommend drilling holes into the storage compartment and threading cable ties around the harness. This pulls the wires up tighter to the hood and prevents rubbing.
- Reinstall hood and check fit of the harness. Adjust as required.
